Pit, Closed-Loop System, Below-Grade Tank, or Proposed Alternative Method Permit or Closure Plan Application

BELOW-GRADE TANK CLOSURE PLAN

Mudge A # 4A – Tank ID: A
API #: 3004522545
Unit Letter C, Section 1, T31N, R11W

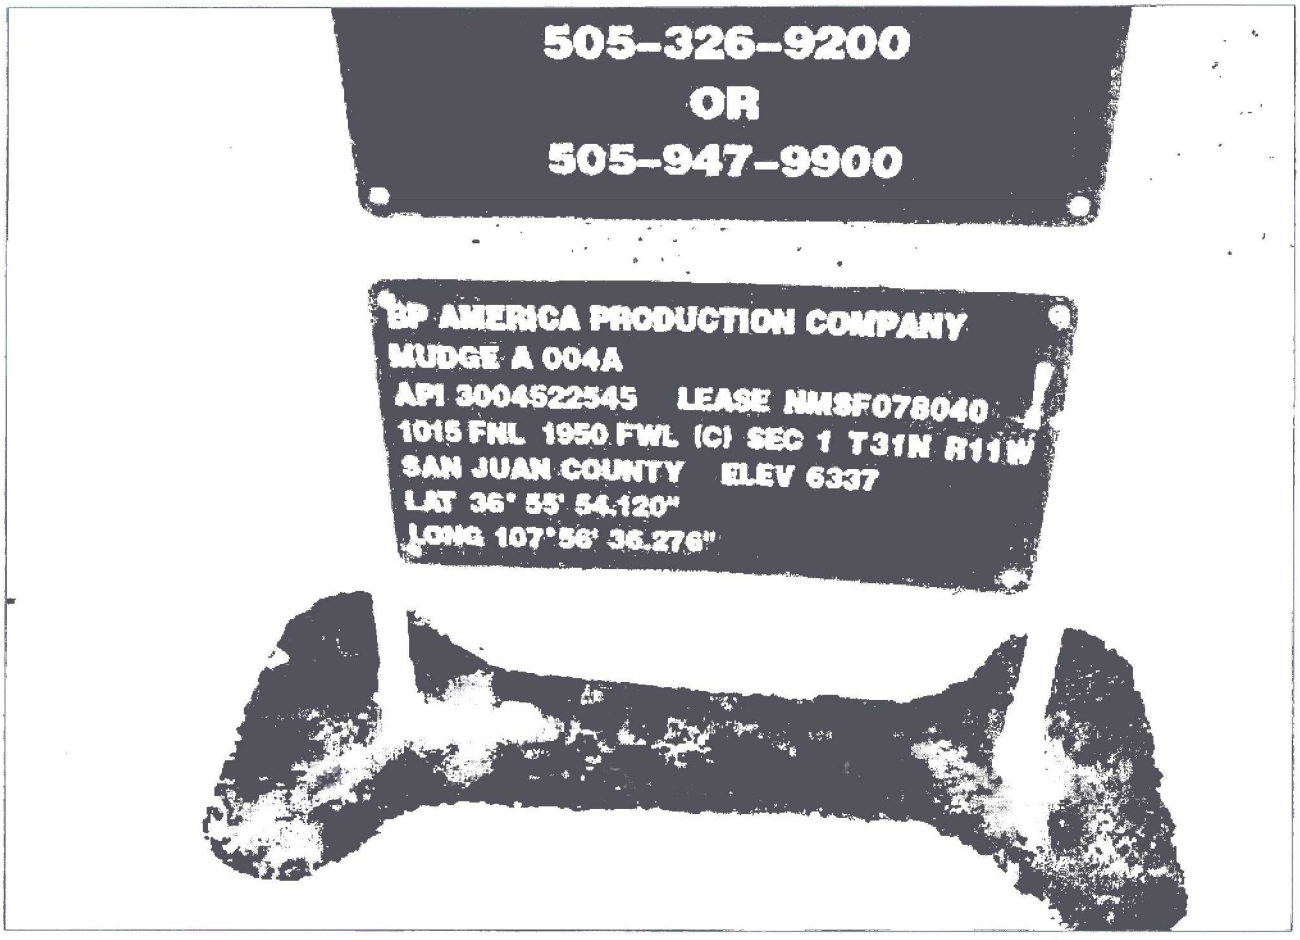
505-326-9200
OR
505-947-9900
BP AMERICA PRODUCTION COMPANY
MUDGE A 004A
API 3004522545 LEASE NMSF078040
1015 FNL 1950 FWL (C) SEC 1 T31N R11W
SAN JUAN COUNTY ELEV 6337
LAT 36° 55' 54.120"
LONG 107°56' 36.276"
