PERTINENT DRILLING INFORMATION

HORSESHOE GALLUP UNIT, WELL No. 292 Unit J - 2474' f/South & 2463' f/East lines Sec. 24-31N-17W, San Juan County, New Mexico

DEVELOPMENT PLAN FOR SURFACE USE

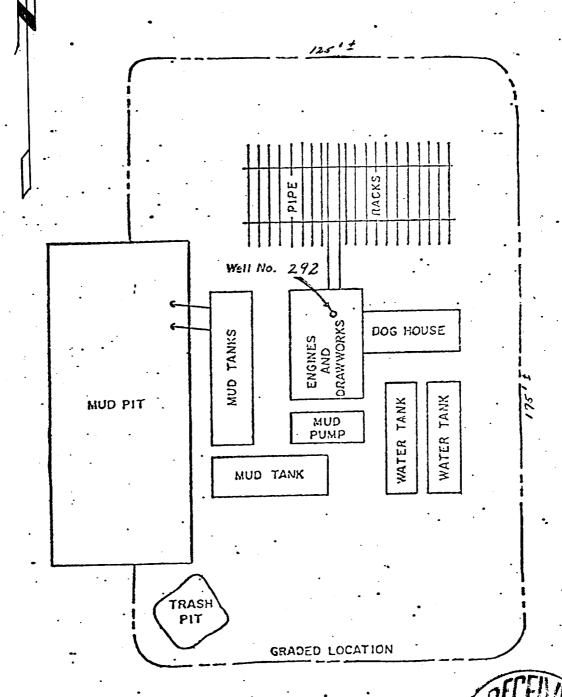
2' Fill >

- 12. This location slopes generally from north to south. It is sandy with rock outcroppings and boulders. There is very little vegetation, a few clumps of of sage brush and isolated clumps of pasture grasses. The northern part of the location will require an approximate 5' cut and a 2' fill will be required on the south side. With restoration of the surface any disturbance to wildlife and local environment will be minimal and of temporary duration.

- 8. Location of Camps: None
- 9. Location of Airstrips: None
- 10. Rig Layout: Per the attached drawing.
- 11. Restoration of Surface: Upon completion of drilling operations, the disturbed surface will be restored as near as practical to its original contours. If sufficient topsoil is encountered, it will be stockpiled for restoration of the surface. Restoration will be to the satisfaction of the United States Geological Survey.
