Pit, Below-Grade Tank, or Proposed Alternative Method Permit or Closure Plan Application

1.
Operator: BP America Production Company OGRID #: 778
Address: 200 Energy Court, Farmington, NM 87401
Facility or well name: GALLEGOS CANYON UNIT 290
API Number: 3004523821 OCD Permit Number:
U/L or Qtr/Qtr J Section 15 Township 28N Range 12W County: San Juan
Center of Proposed Design: Latitude 36.65907 Longitude -108.09518 NAD: ☐1927 ☒ 1983
Surface Owner: ☐ Federal ☐ State ☒ Private ☐ Tribal Trust or Indian Allotment

BELOW-GRADE TANK CLOSURE PLAN

GALLEGOS CANYON UNIT 290
API No. 3004523821
Unit Letter J, Section 15, T28N, R12W

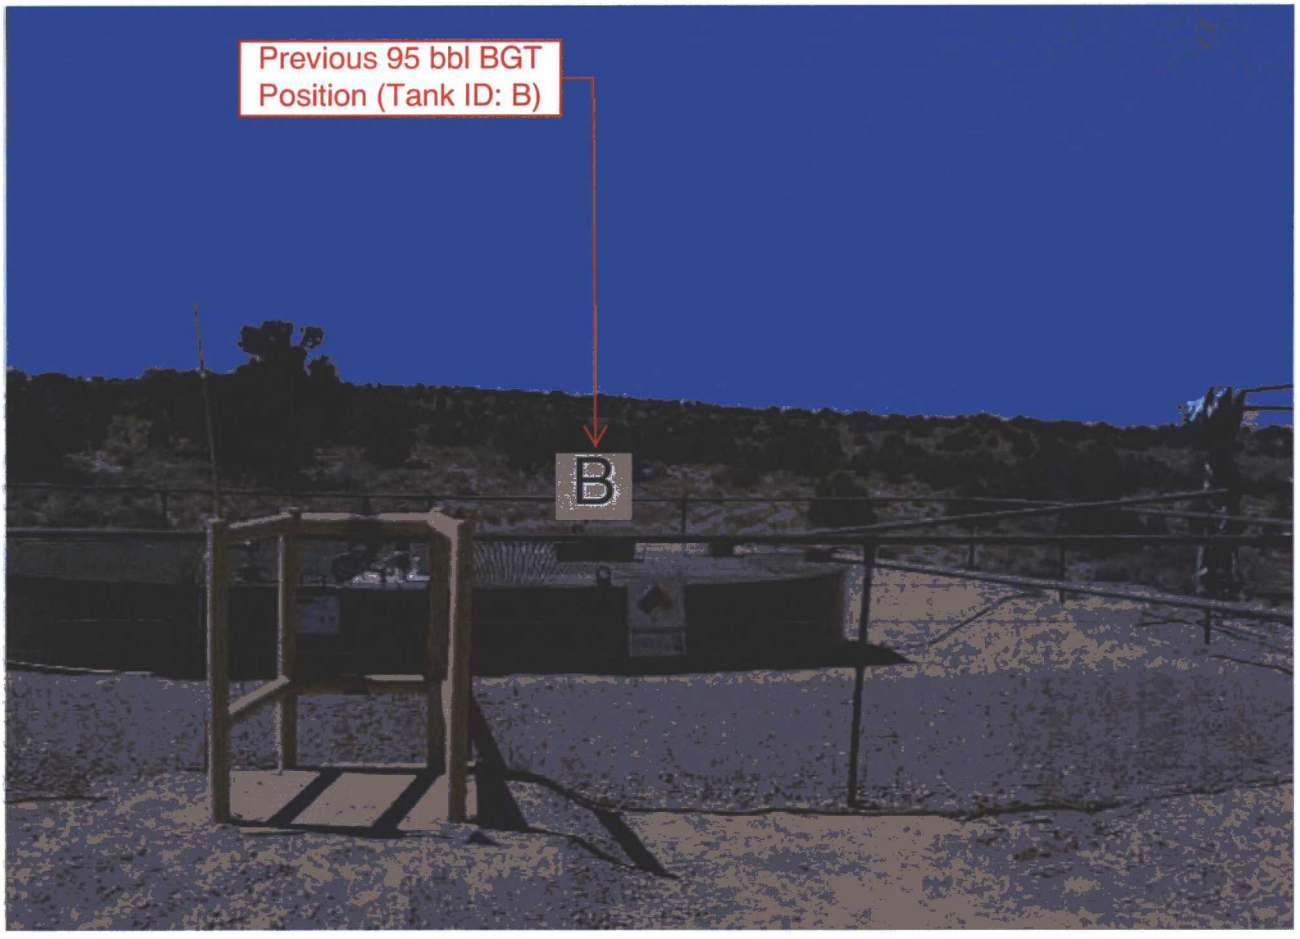
Previous 95 bbl BGT
Position (Tank ID: B)
B

The area has been backfilled. The location will be reclaimed once the well is plugged and abandoned.
