Sundry Notices and Reports on Wells

## WORKOVER PROCEDURE - TUBING REPAIR

Atlantic Com A 7A  
DPNO 48994A  
Blanco Mesaverde  
SE, Section 23, T31N, R10W  
San Juan County, New Mexico

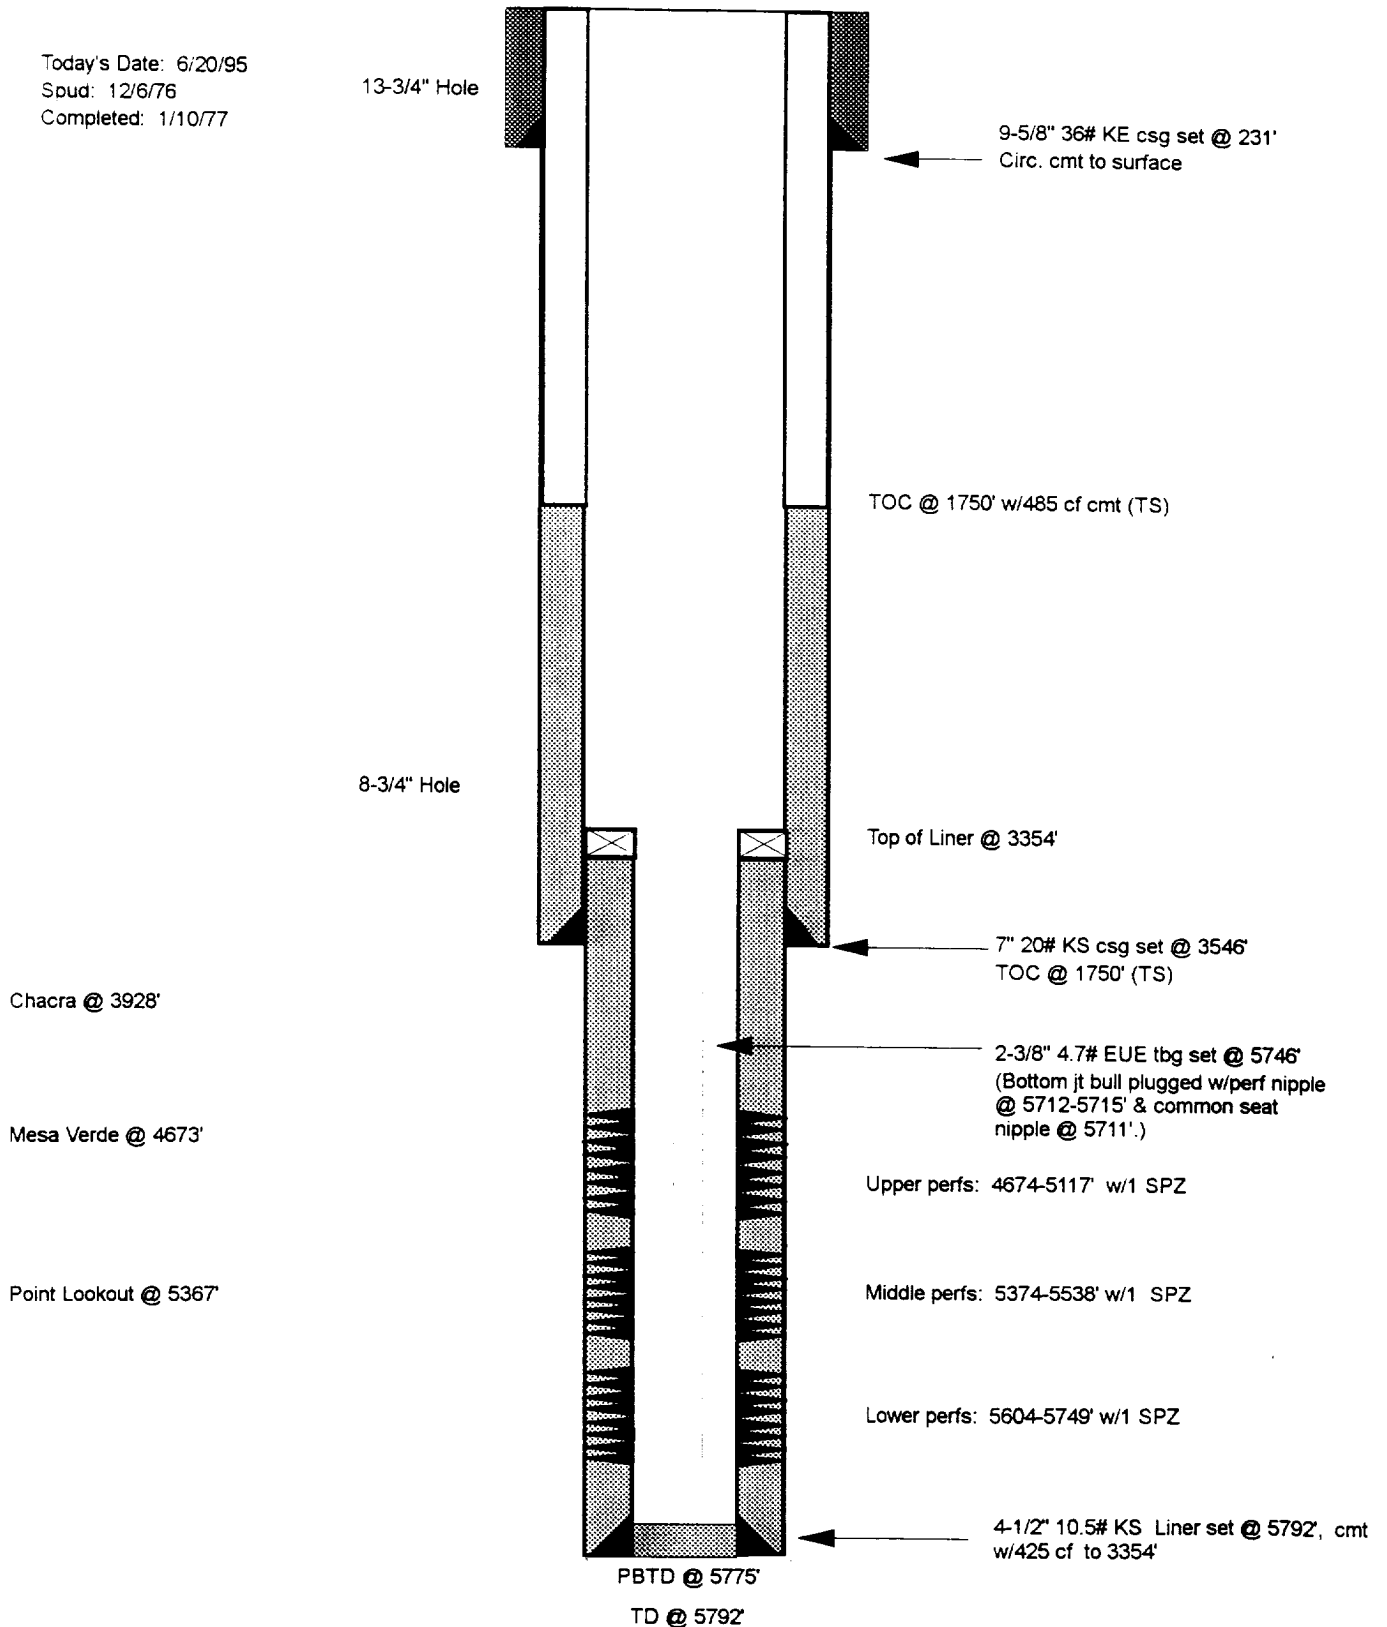
Spud: 12/6/76

Completed: 1/10/77

It is intended to workover and repair the tubing in the subject well according to the attached procedure and wellbore diagram.
