Pit, Closed-Loop System, Below-Grade Tank, or Proposed Alternative Method Permit or Closure Plan Application

1.
Operator: BP AMERICA PRODUCTION COMPANY OGRID #: 778
Address: 200 Energy Court, Farmington, NM 87401
Facility or well name: WARREN LS 010
API Number: 3004520280 OCD Permit Number:
U/L or Qtr/Qtr P Section 13.0 Township 28.0N Range 09W County: San Juan County
Center of Proposed Design: Latitude 36.65809 Longitude -107.73387 NAD: ☐ 1927 ☒ 1983
Surface Owner: ☒ Federal ☐ State ☐ Private ☐ Tribal Trust or Indian Allotment

BELOW-GRADE TANK CLOSURE PLAN

Warren LS # 10 – Tank ID: A
API #: 3004520280
Unit Letter P, Section 13, T28N, R09W

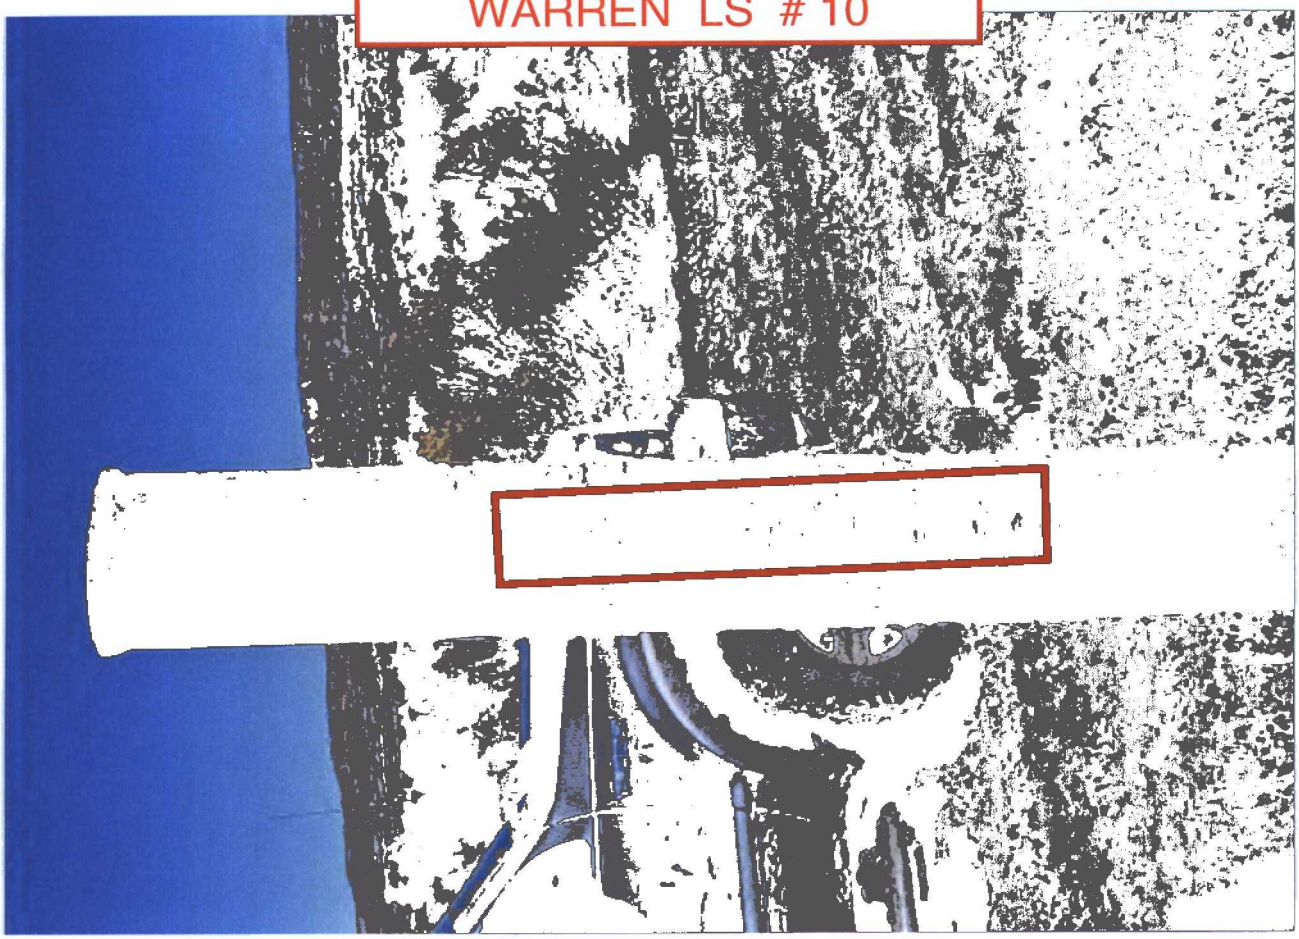
WARREN LS # 10

Previous 21 bbl BGT
Position (Tank ID: A)
Plugged & Abandoned
Marker
A

Closure report on C-144 form is included & contains a photo of the reclamation completion.
