WORKOVER PROCEDURE

SAN JUAN 32-9 UNIT # 4A Mesa Verde SE/4 Sec. 12, T31N, R10W San Juan Co., New Mexico

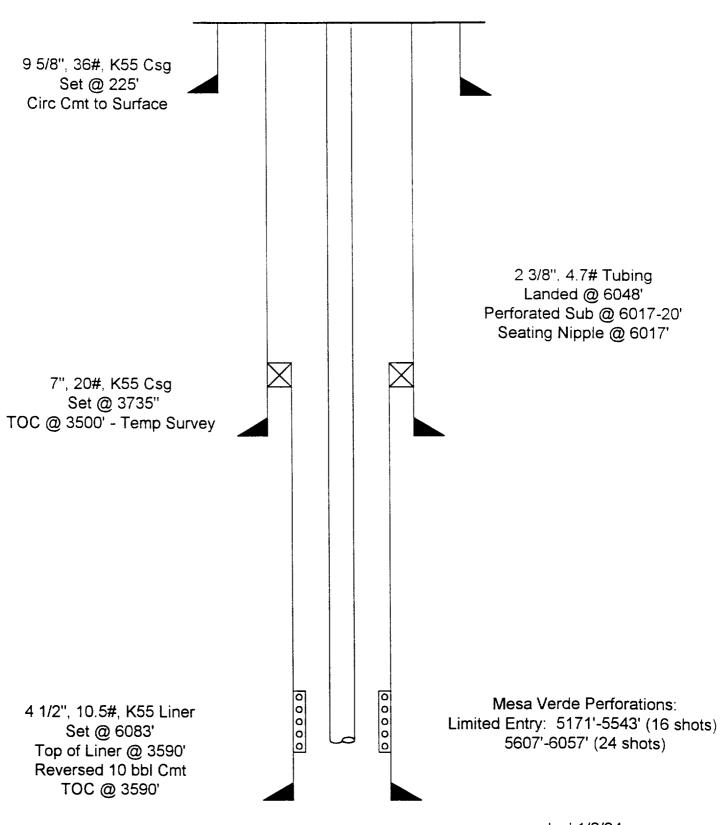
SE/4, Sec 12, T31N, R10W, San Juan Co, New Mexico

MESA VERDE

Workover History: December 1985: Temporary packer set at 3500' to isolate casing failure.

January 1986: Fish temp packer, and squeeze casing leak between 965'
