# Pit, Closed-Loop System, Below-Grade Tank, or Proposed Alternative Method Permit or Closure Plan Application

# BP AMERICA PRODUCTION COMPANY

BELOW-GRADE TANK CLOSURE PLAN

**Marsrow Gas Com # 1E – Tank ID: B**
**API #: 3004524007**
**Unit Letter L, Section 15, T29N, R12W**

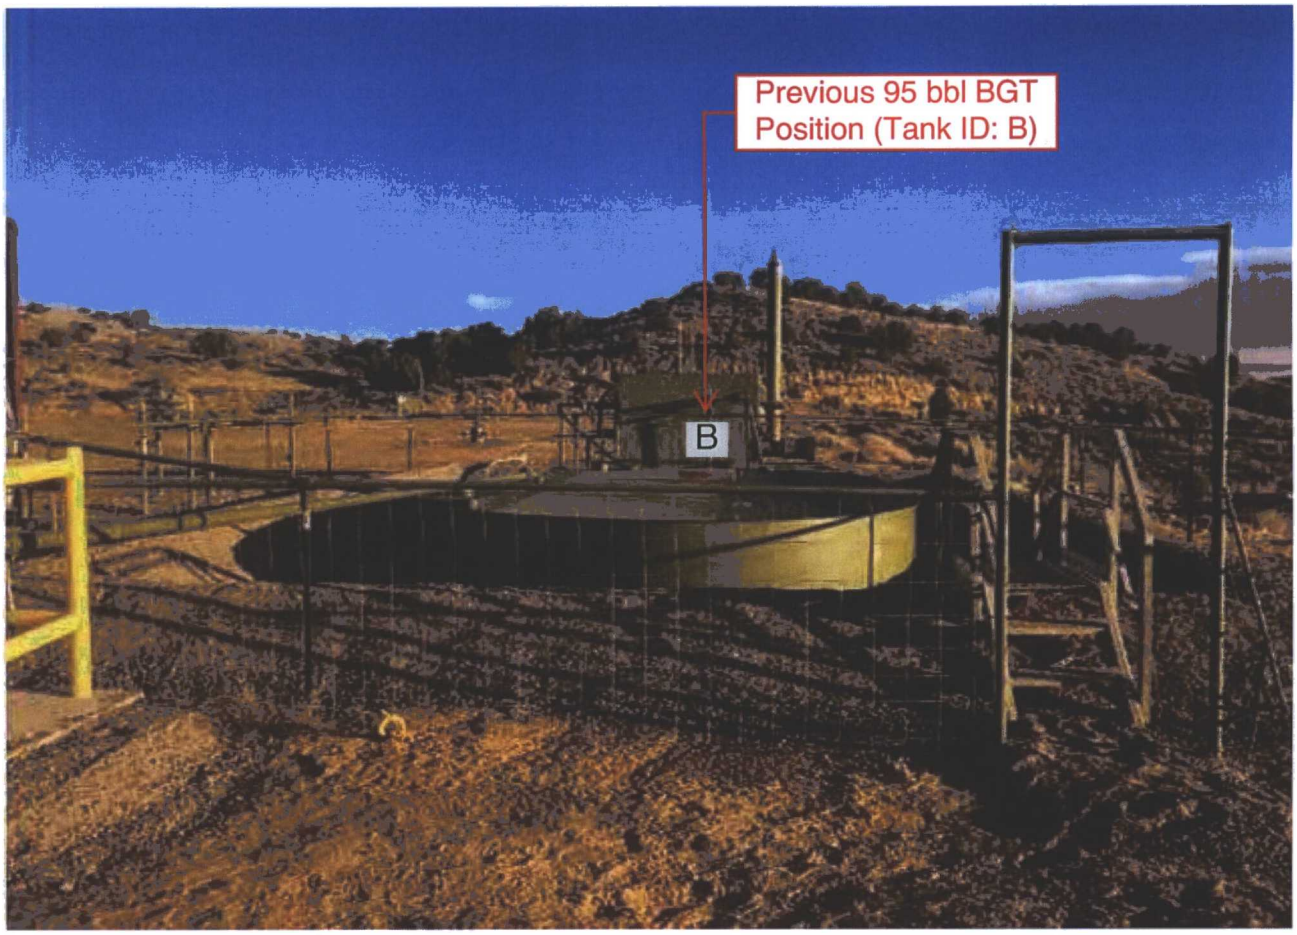
Previous 95 bbl BGT
Position (Tank ID: B)
B

10. BP shall reclaim the BGT location and all areas associated with the BGT including associated access roads to a safe and stable condition that blends with the surrounding undisturbed area. BP shall substantially restore the impacted surface area to the condition that existed prior to oil and gas operations by placement of the soil cover as provided in Subsection H of 19.15.17.13 NMAC, re-contour the location and associated areas to a contour that approximates the original contour and blends with the surrounding topography and re-vegetate according to Subsection I of 19.15.17.13 NMAC.
**The BGT area has been backfilled and will be reclaimed once the well has been plugged & abandoned.**
