DEPARTMENT OF THE INTERIOR BUREAU OF LAND MANAGEMENT

ports on Well			
	17.77			Lease Number
				SF-075794
1. Type of Well GAS	(73 View	en garage (1990)	6.	If Indian, All. or Tribe Name
			7.	Unit Agreement Name
. Name of Operator				
BURLINGTON				
RESOURCES OIL & GAS COMP.	ANY		8.	Well Name & Number
. Address & Phone No. of Operator				Hughes #1
PO Box 4289, Farmington, NM 87499 (50	05) 326-9700		9.	API Well No.
FO BOX 42037 142111211300117 1111				30-045-07358
. Location of Well, Footage, Sec., T, R,	M		10.	Field and Pool
990'FNL, 1650'FEL, Sec. 23, T-28-N, R-1	1-W, NMPM		11.	Fulcher Kutz Pict.Clif County and State San Juan Co, NM

Hughes #1 **Pertinent Data Sheet**

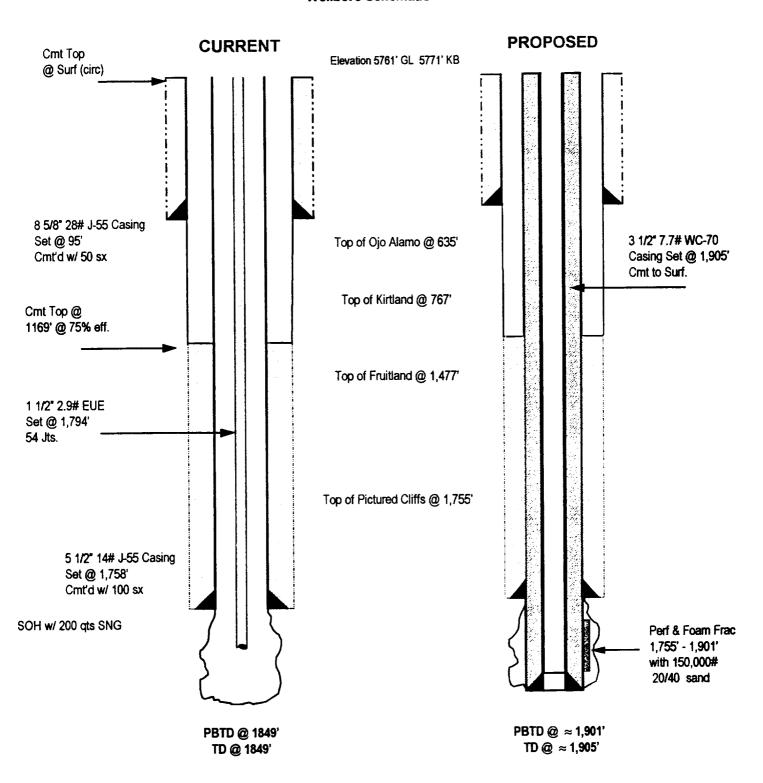
Fulcher Kutz Pictured Cliffs Field Wellbore Schematic

Section 23 B, T-28 -N R-11 -W San Juan, New Mexico
