CLOSURE REQUEST REPORT

On July 19, 2001, a reportable release was discovered by Chesapeake at the Benson Shugart Waterflood Unit #019 site (Release Site). The injection line developed a leak due to internal corrosion. Approximately two-hundred fifty (250) barrels of produced water was released with forty (40) barrels recovered, resulting in a net loss of approximately two-hundred ten (210) barrels of produced water.

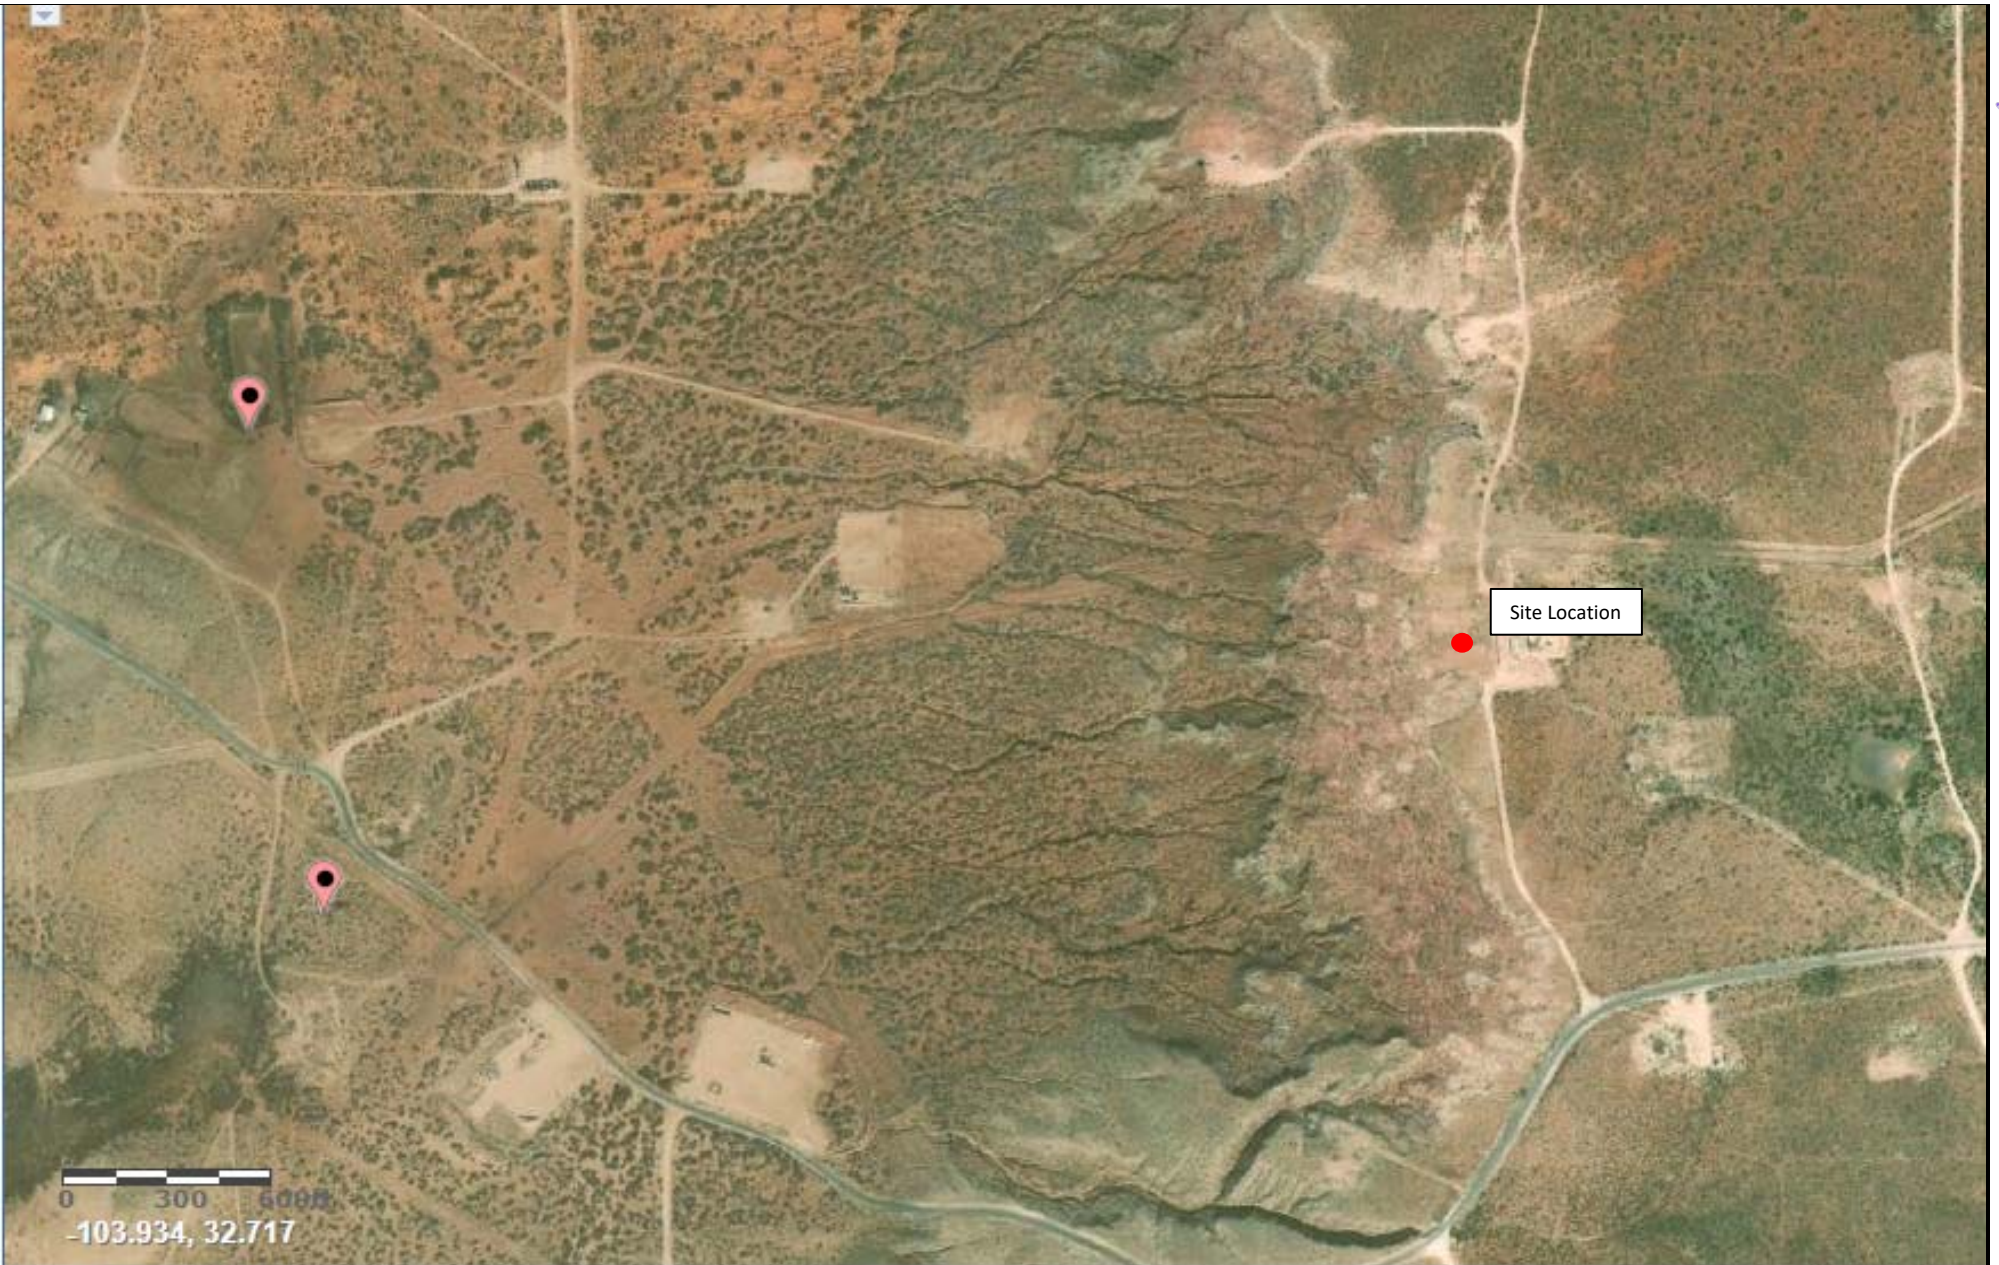
Legend:

- Site Location
- USGS Water Well
