Pit, Closed-Loop System, Below-Grade Tank, or Proposed Alternative Method Permit or Closure Plan Application

1.
Operator: BP AMERICA PRODUCTION COMPANY OGRID #: 778
Address: 200 Energy Court, Farmington, NM 87401
Facility or well name: GALLEGOS CANYON UNIT 133E
API Number: 3004525234 OCD Permit Number:
U/L or Qtr/Qtr C Section 17.0 Township 29.0N Range 12W County: San Juan County
Center of Proposed Design: Latitude 36.73200 Longitude -108.12550 NAD: ☐1927 ☒1983
Surface Owner: ☒ Federal ☐ State ☐ Private ☐ Tribal Trust or Indian Allotment

BELOW-GRADE TANK CLOSURE PLAN

Gallegos Canyon Unit # 133E – Tank ID: B
API #: 3004525234
Unit Letter C, Section 17, T29N, R12W

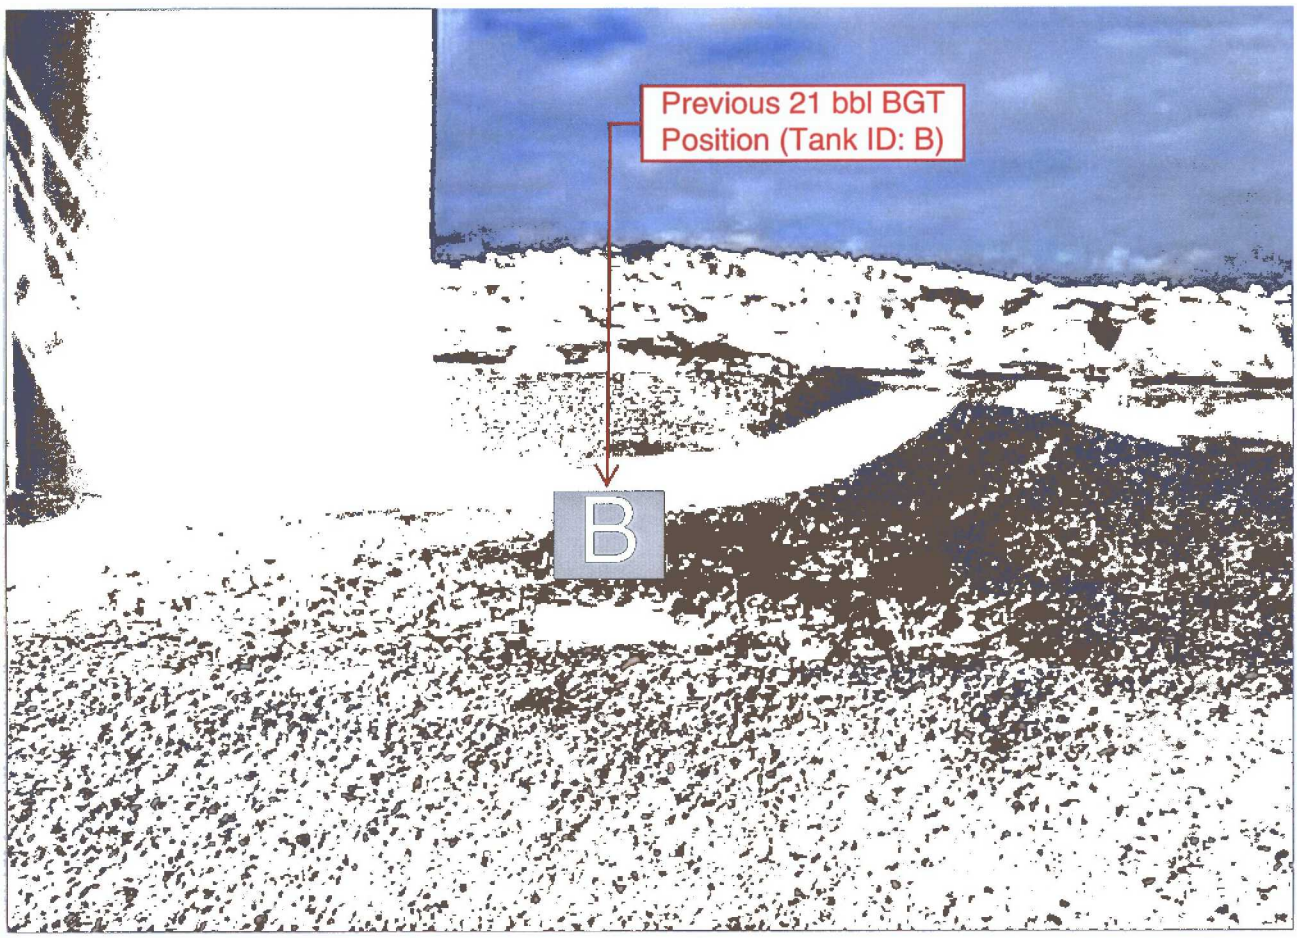
Previous 21 bbl BGT
Position (Tank ID: B)
B

Closure report on C-144 form is included & contains a photo of the reclamation completion.

9. If the sampling demonstrates that a release has not occurred or that any release does not exceed the concentrations specified above, then BP shall backfill the excavation, with compacted, non-waste containing, earthen material; construct a division-prescribed soil cover, re-contour and re-vegetate the location. The location will be reclaimed if it is not with in the active process area.
Sampling results reveal no evidence of a release has occurred. Area was backfilled with clean, earthen material and is within the active well pad.
