From: Amanda Trujillo [atrujillo@yatespetroleum.com]
Sent: Friday, May 11, 2012 2:47 PM
To: Jerry Fanning; Jim Amos (James_Amos@blm.gov); Bratcher, Mike, EMNRD
Subject: (release) Benson Deep BDX Fed Com #1
Attachments: Benson Deep BDX Fed Com #1.pdf

Benson Deep BDX Fed Com #1

Attached is C-141 and site work plan for remediation for consideration

Re. Senson Deep BDX Fed Com #1
30-015-22793
Section 33, T18S-R30E
Eddy County, New Mexico

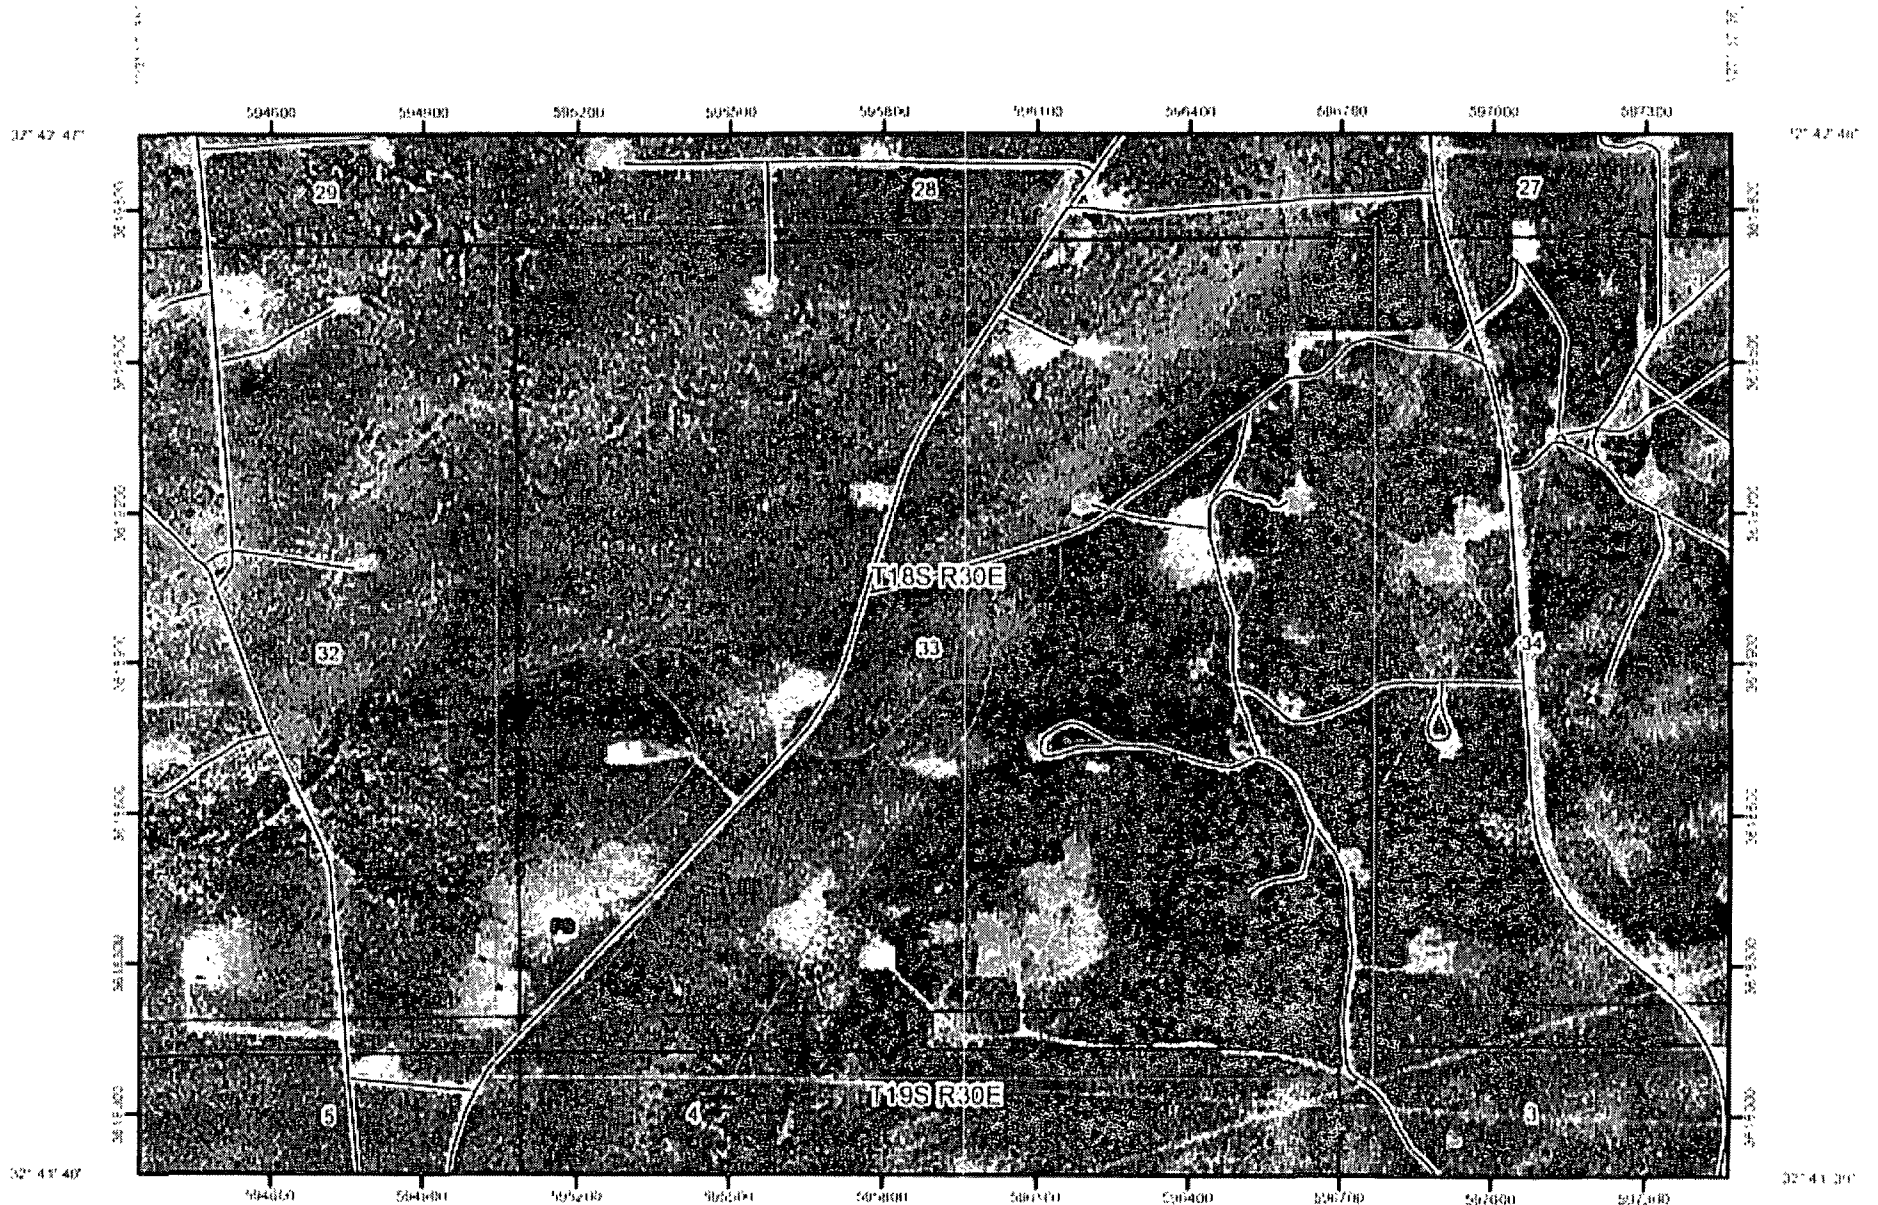
Soil Map--Eddy Area, New Mexico
(Benson Deep BDX Fed Com #1)

Survey Area Data: Version 9, Feb 20, 2009
