# Pit, Below-Grade Tank, or Proposed Alternative Method Permit or Closure Plan Application

Facility or well name: Fields A 004A

BELOW-GRADE TANK CLOSURE PLAN

**Fields A 004A**
**API No. 3004522462**
**Unit Letter O, Section 28, T32N, R11W**

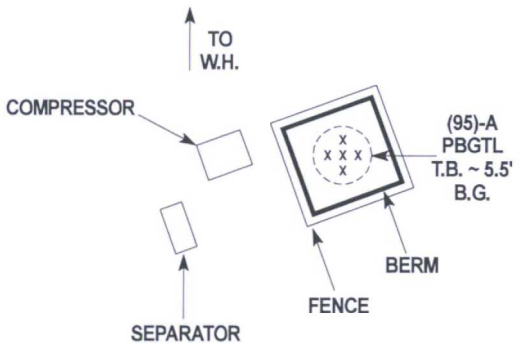
PLOT PLAN circle: attached

X - S.P.D.
