# Merit Energy Turner B North Battery Closure Report Unit L, Section 20, Township 17S, Range 31E Eddy County, New Mexico

**September 15, 2004**

Safety & Environmental Solutions, Inc. 703 E. Clinton Suite 102 Hobbs, New Mexico 88240 (505) 397-0510

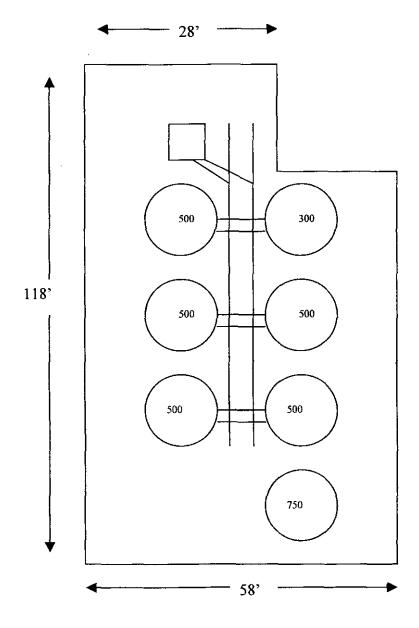
Figure 2 Site Plan

The suspected contaminant is produced water associated with the tank battery at the site. The release was contained inside the bermed area of the battery. The affected area was not grossly stained with hydrocarbons. (Site Plan)

The contaminated area at the SW corner of the tank battery was excavated manually utilizing shovels and wheelbarrows. Approximately 12-inches of oil saturated soils were removed from a 15-ft X 20-ft area. The contaminated soil was stockpiled west of the tanks. The excavated area was sprayed with ammonium-nitrate solution to facilitate bio-remediation; the excavated area was filled with clay up to the bottoms of the adjacent tanks, and then contoured with rakes. One area of the firewall that had washed out was replaced. Wire fencing that had been removed was replaced.
