Pit, Below-Grade Tank, or Proposed Alternative Method Permit or Closure Plan Application

BELOW-GRADE TANK CLOSURE PLAN

Florance Gas Com J 016A
API No. 3004521790
Unit Letter P, Section 6, T30N, R09W

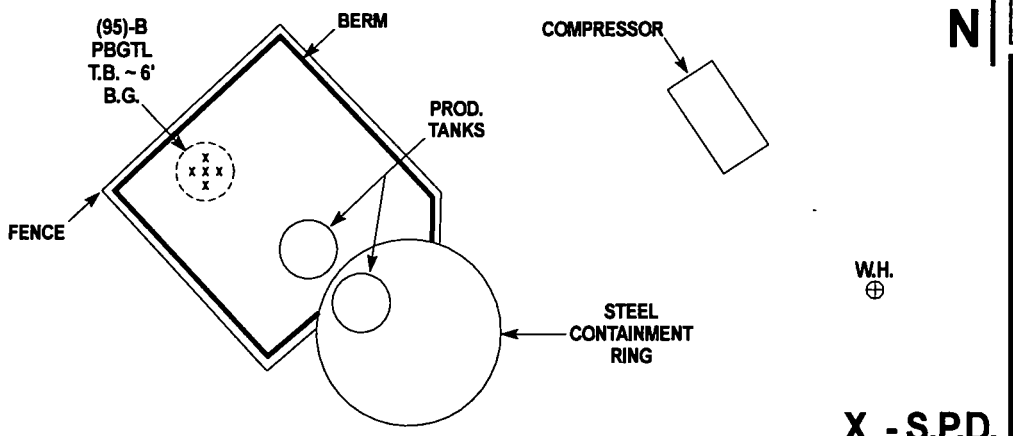
PLOT PLAN circle: attached

DISCOLORATION/STAINING OBSERVED: YES / NO EXPLANATION - LIGHT TO DARK OLIVE GRAY

APPARENT EVIDENCE OF A RELEASE OBSERVED AND/OR OCCURRED: YES / NO EXPLANATION: PHYSICALLY VISUALLY & BY HYDROCARBON ODOR.

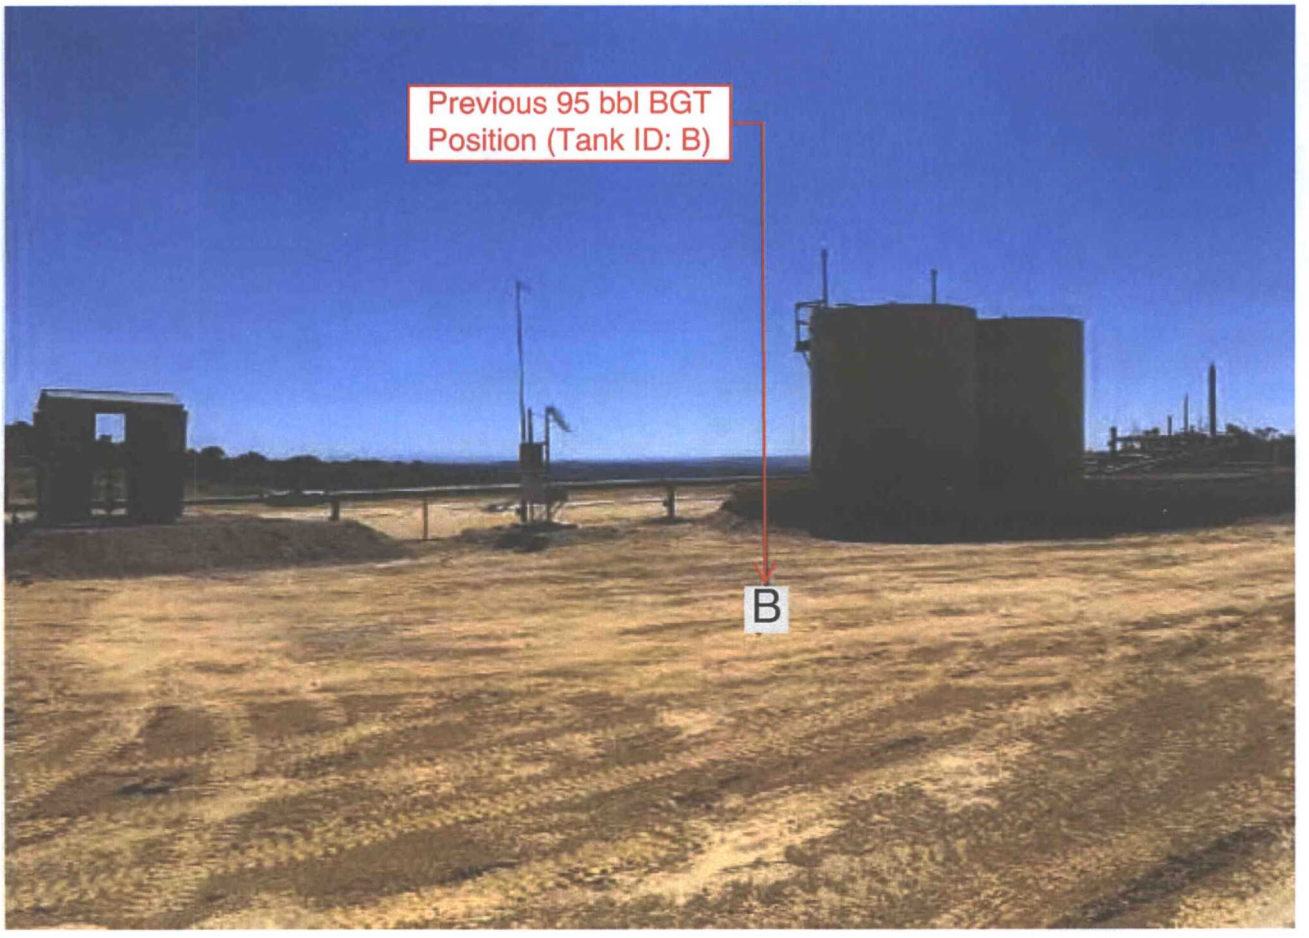
Previous 95 bbl BGT
Position (Tank ID: B)
B

10. BP shall reclaim the BGT location and all areas associated with the BGT including associated access roads to a safe and stable condition that blends with the surrounding undisturbed area. BP shall substantially restore the impacted surface area to the condition that existed prior to oil and gas operations by placement of the soil cover as provided in Subsection H of 19.15.17.13 NMAC, re-contour the location and associated areas to a contour that approximates the original contour and blends with the surrounding topography and re-vegetate according to Subsection I of 19.15.17.13 NMAC.
The area has been backfilled and will be reclaimed once the well has been plugged and abandoned.
