Release Notification and Corrective Action

Name of Company	Devon Energy Production Company <u>6137</u>	Contact	Wesley Ryan
Address	6488 Seven Rivers Hwy Artesia, NM 88210	Telephone No.	575-390-5436
Facility Name	Mizar 11 Fed Com 1H	Facility Type	Oil

MIZAR 11 FEDERAL COM 1H-P
(DVN)

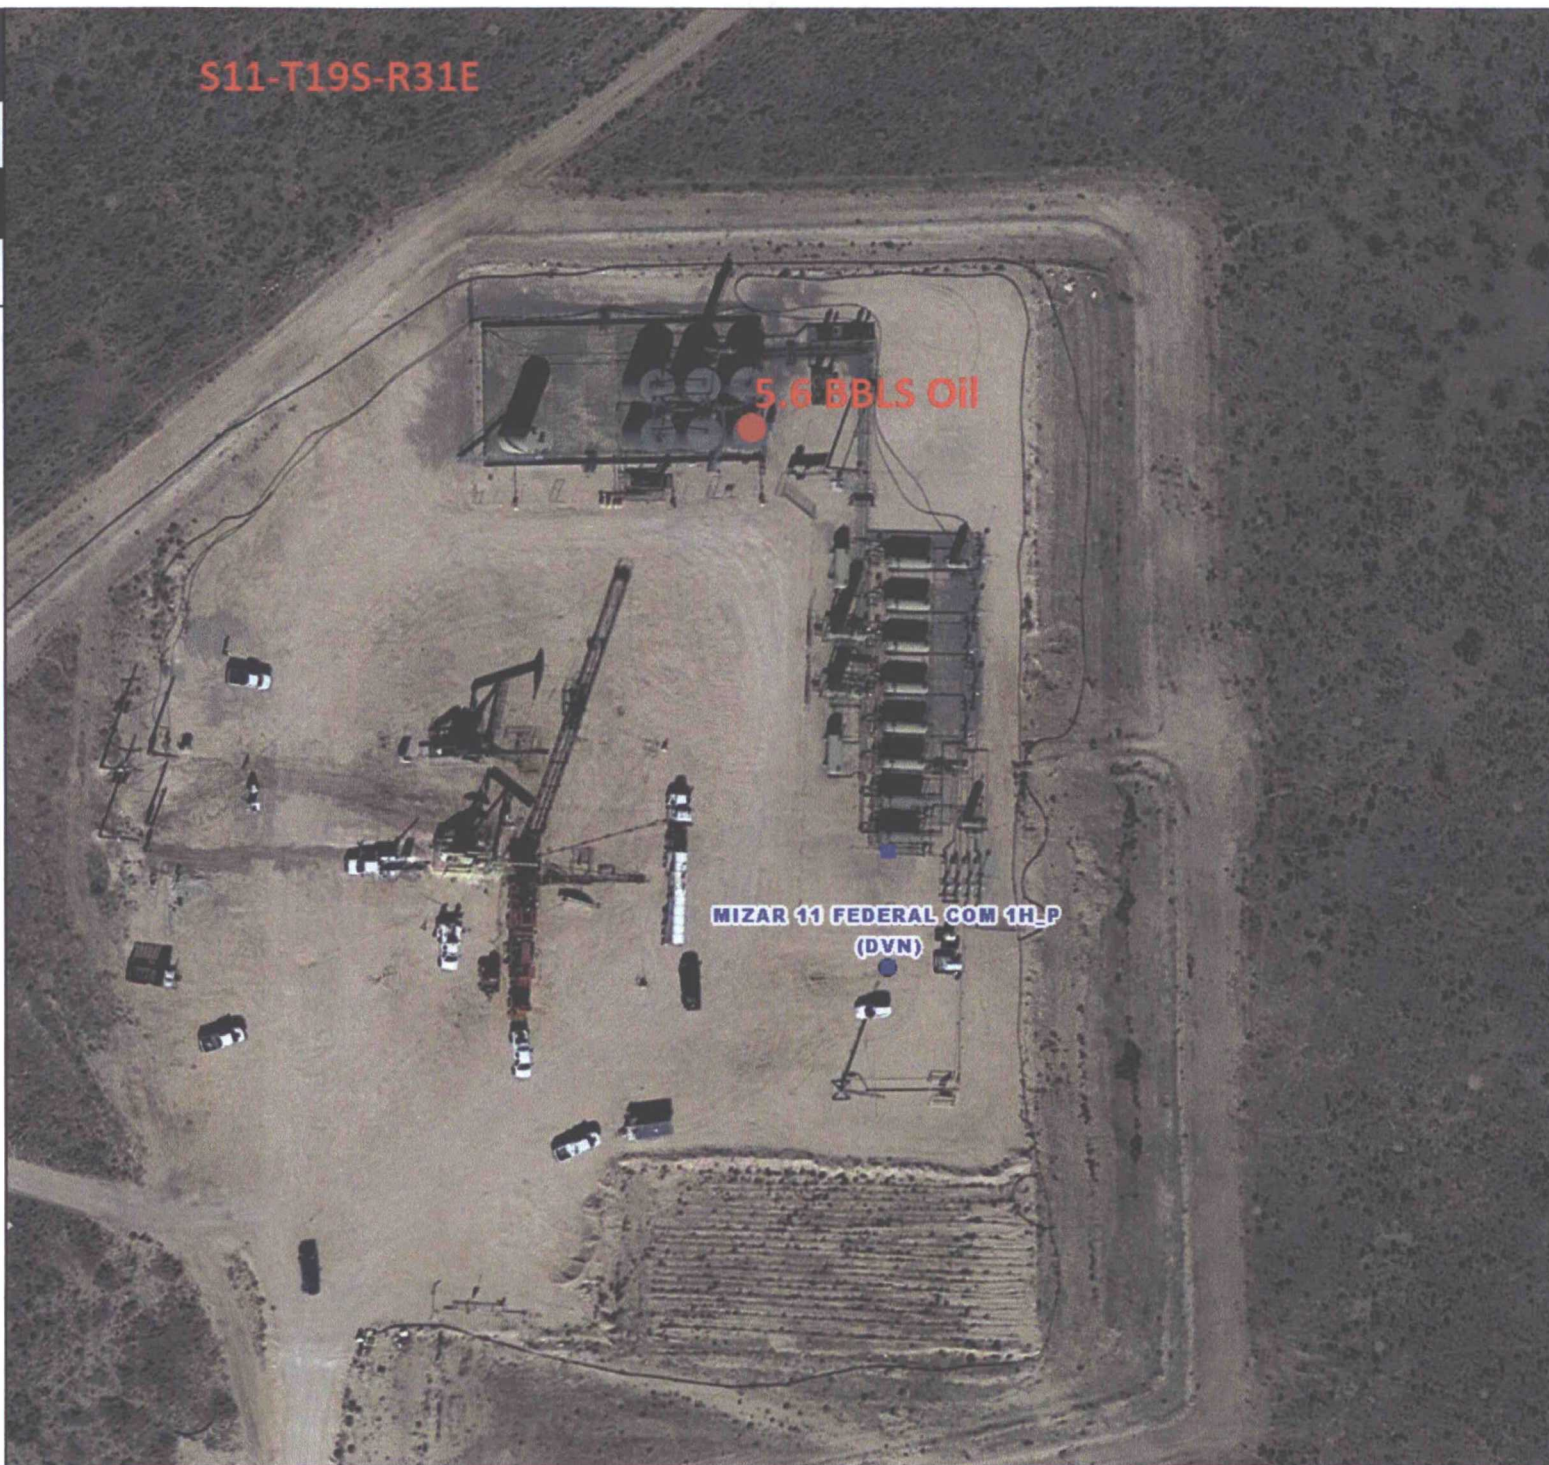
5.6 BBLS OIL

Approximately 5.6 BBLS of Oil was released from the water tank. A vacuum truck was dispatched and recovered approximately 5.6 BBLS of Oil from the lined SPCC containment ring. All released fluid remained on pad and inside the lined containment. Once fluids were removed the liner was visually inspected by Devon field staff for any pinholes or punctures and none were found. Based on this inspection there is no evidence that the spill fluids left containment.
