Pit, Below-Grade Tank, or Proposed Alternative Method Permit or Closure Plan Application

BELOW-GRADE TANK CLOSURE PLAN

NEBU 006

API No. 3003907770

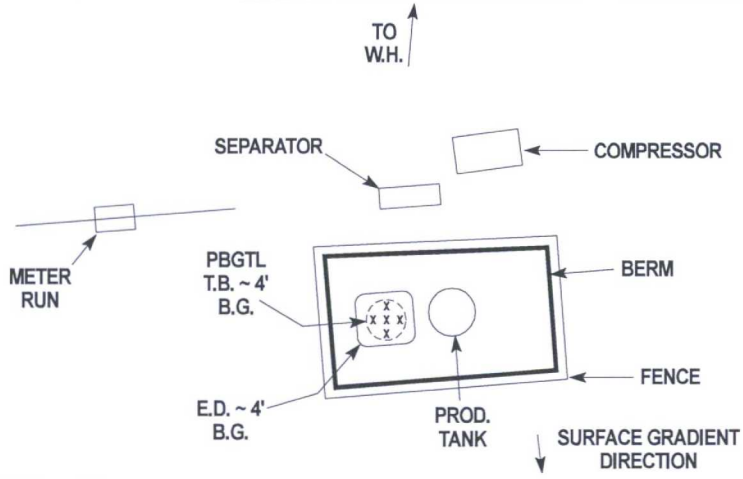
SITE SKETCH

LOST INTEGRITY OF EQUIPMENT: YES / NO EXPLANATION - UNKNOWN; NOT CONFIRMED
APPARENT EVIDENCE OF A RELEASE OBSERVED AND/OR OCCURRED: YES / NO EXPLANATION: DISCOLORATION & STRONG PHYSICAL HYDROCARBON ODOR.
EQUIPMENT SET OVER RECLAIMED AREA: YES / NO EXPLANATION - 105 BBL SHALLOW LOW PROFILE ABOVE-GRADE TANK TO BE SET ATOP BGT LOCATION.
OTHER: NMOCD OR BLM NOT PRESENT TO WITNESS CONFIRMATION SAMPLING. BGT WAS OBSERVED TILTED UPON ARRIVAL (LOWEST SIDE ON NORTHERN HALF). MOST OF EXCAVATION CONSIST OF BEDROCK - COMPETENT, WELL CEMENTED.
EXCAVATION DIMENSION ESTIMATION: NA ft. X NA ft. X NA ft. EXCAVATION ESTIMATION (Cubic Yards): NA
DEPTH TO GROUNDWATER: >100' NEAREST WATER SOURCE: >1,000' NEAREST SURFACE WATER: <1,000' NMOCD TPH CLOSURE STD: 1,000 ppm

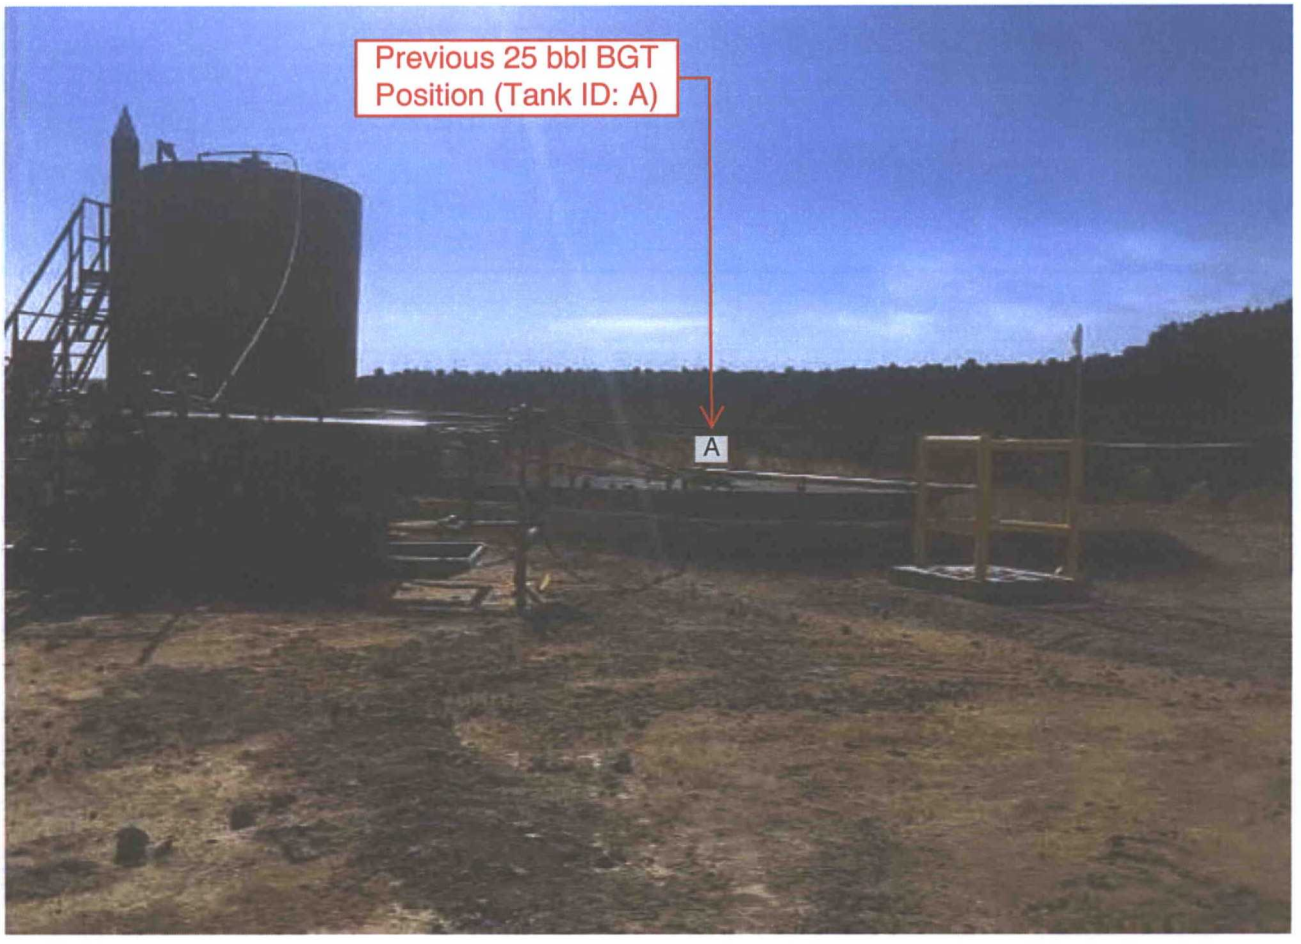
Previous 25 bbl BGT
Position (Tank ID: A)
A

The area has been backfilled and a 105 BBL shallow low profile above-grade tank set atop BGT location. The location will be reclaimed once the well is plugged and abandoned.
