**Oxy USA
Right Hand Canyon #34-2
Sampling Report**

Eddy County, New Mexico

January 28, 2011

**Safety & Environmental Solutions, Inc.
703 East Clinton Street
Hobbs, New Mexico 88240
(575) 397-0510**

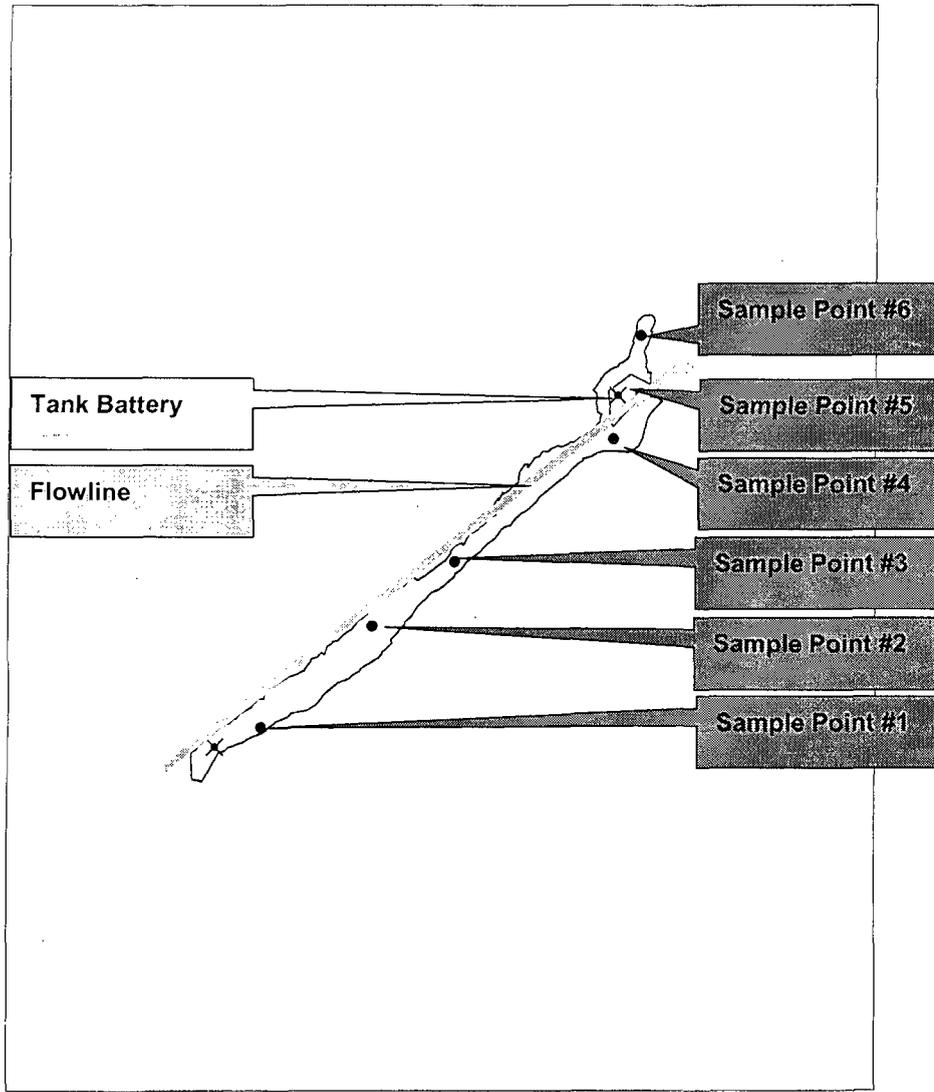
**Figure 2
Site Plan**

OXY-10-009 RHC #34

Scale 1 in : 100 ft
0 150.0
Feet

OXY-10-009 RHC 34 site
~7700 sq. ft.

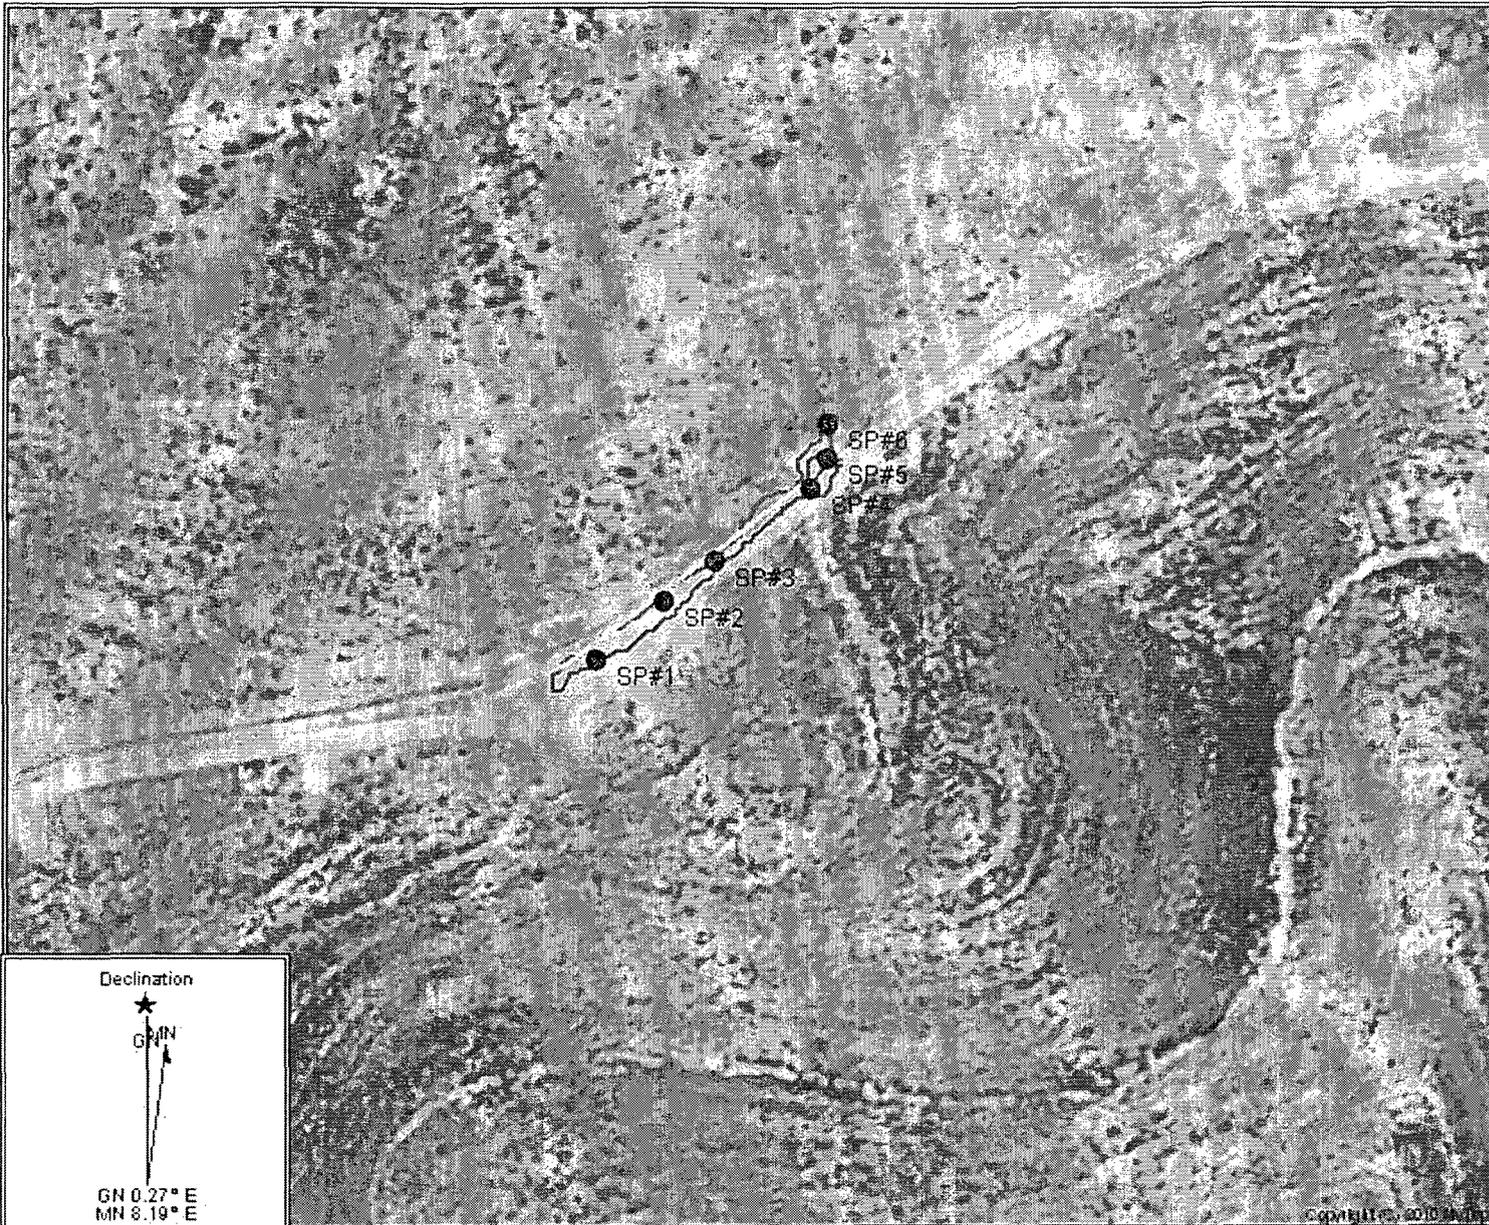
Map Name: SW AZOTEA PEAK, NM
Scale: 1 inch = 200 ft.

Map Center: 032° 25' 48.29" N 104° 29' 45.16" W
Horizontal Datum: WGS84
