Pit, Below-Grade Tank, or Proposed Alternative Method Permit or Closure Plan Application

BELOW-GRADE TANK CLOSURE PLAN

FLORANCE Z 040

API No. 3004509351

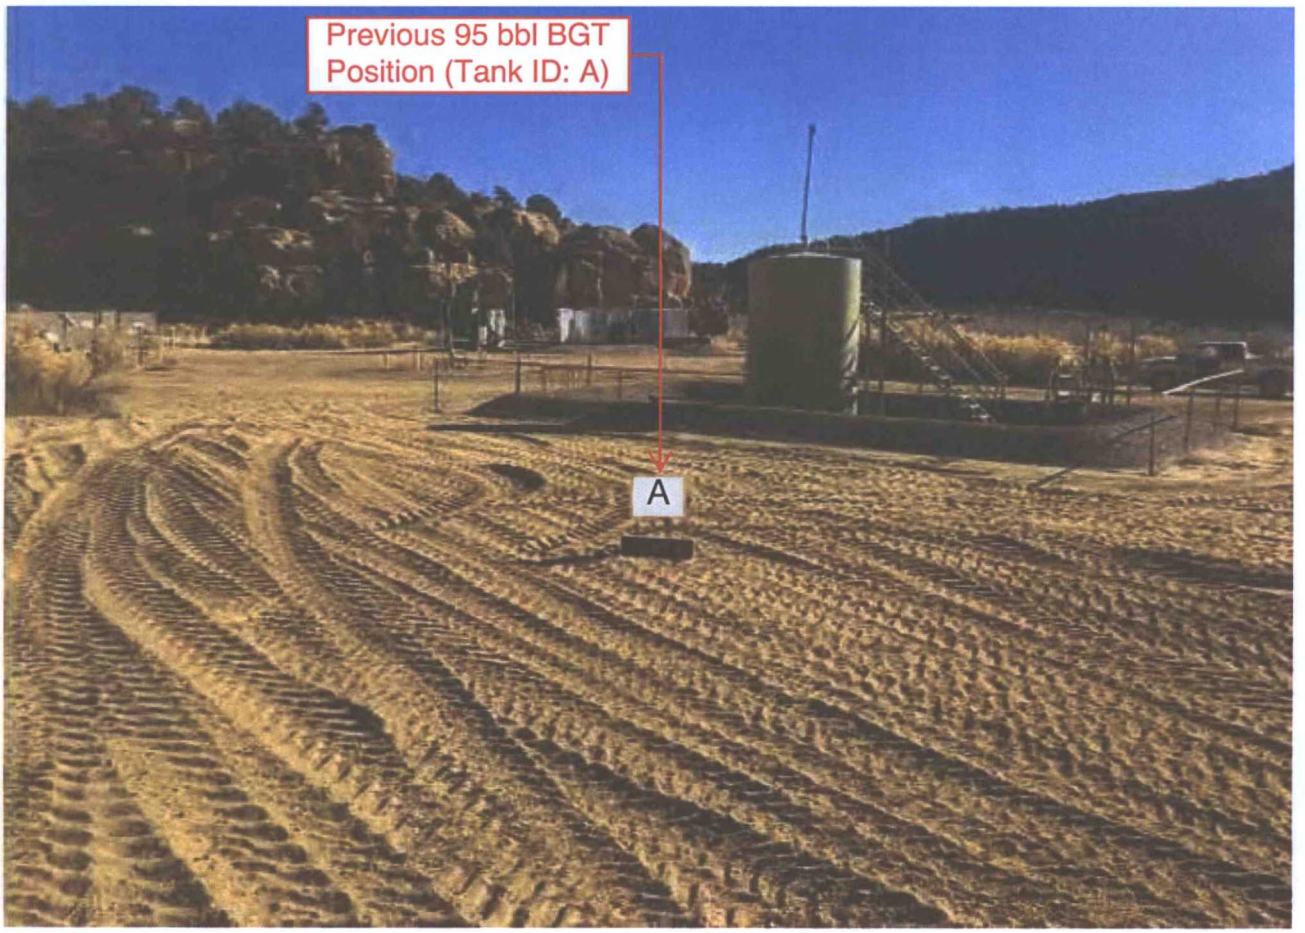
Previous 95 bbl BGT
Position (Tank ID: A)
A

The area has been backfilled. The location will be reclaimed once the well is plugged and abandoned.
