# POKER LAKE UNIT 347H STRUCTURAL CROSS SECTION

# POKER LAKE UNIT 401H - INJECTION AREA LOCATION MAP

Structure Map - Top Delaware Lower Brushy Canyon

Poker Lake Unit, Eddy Co., New Mexico

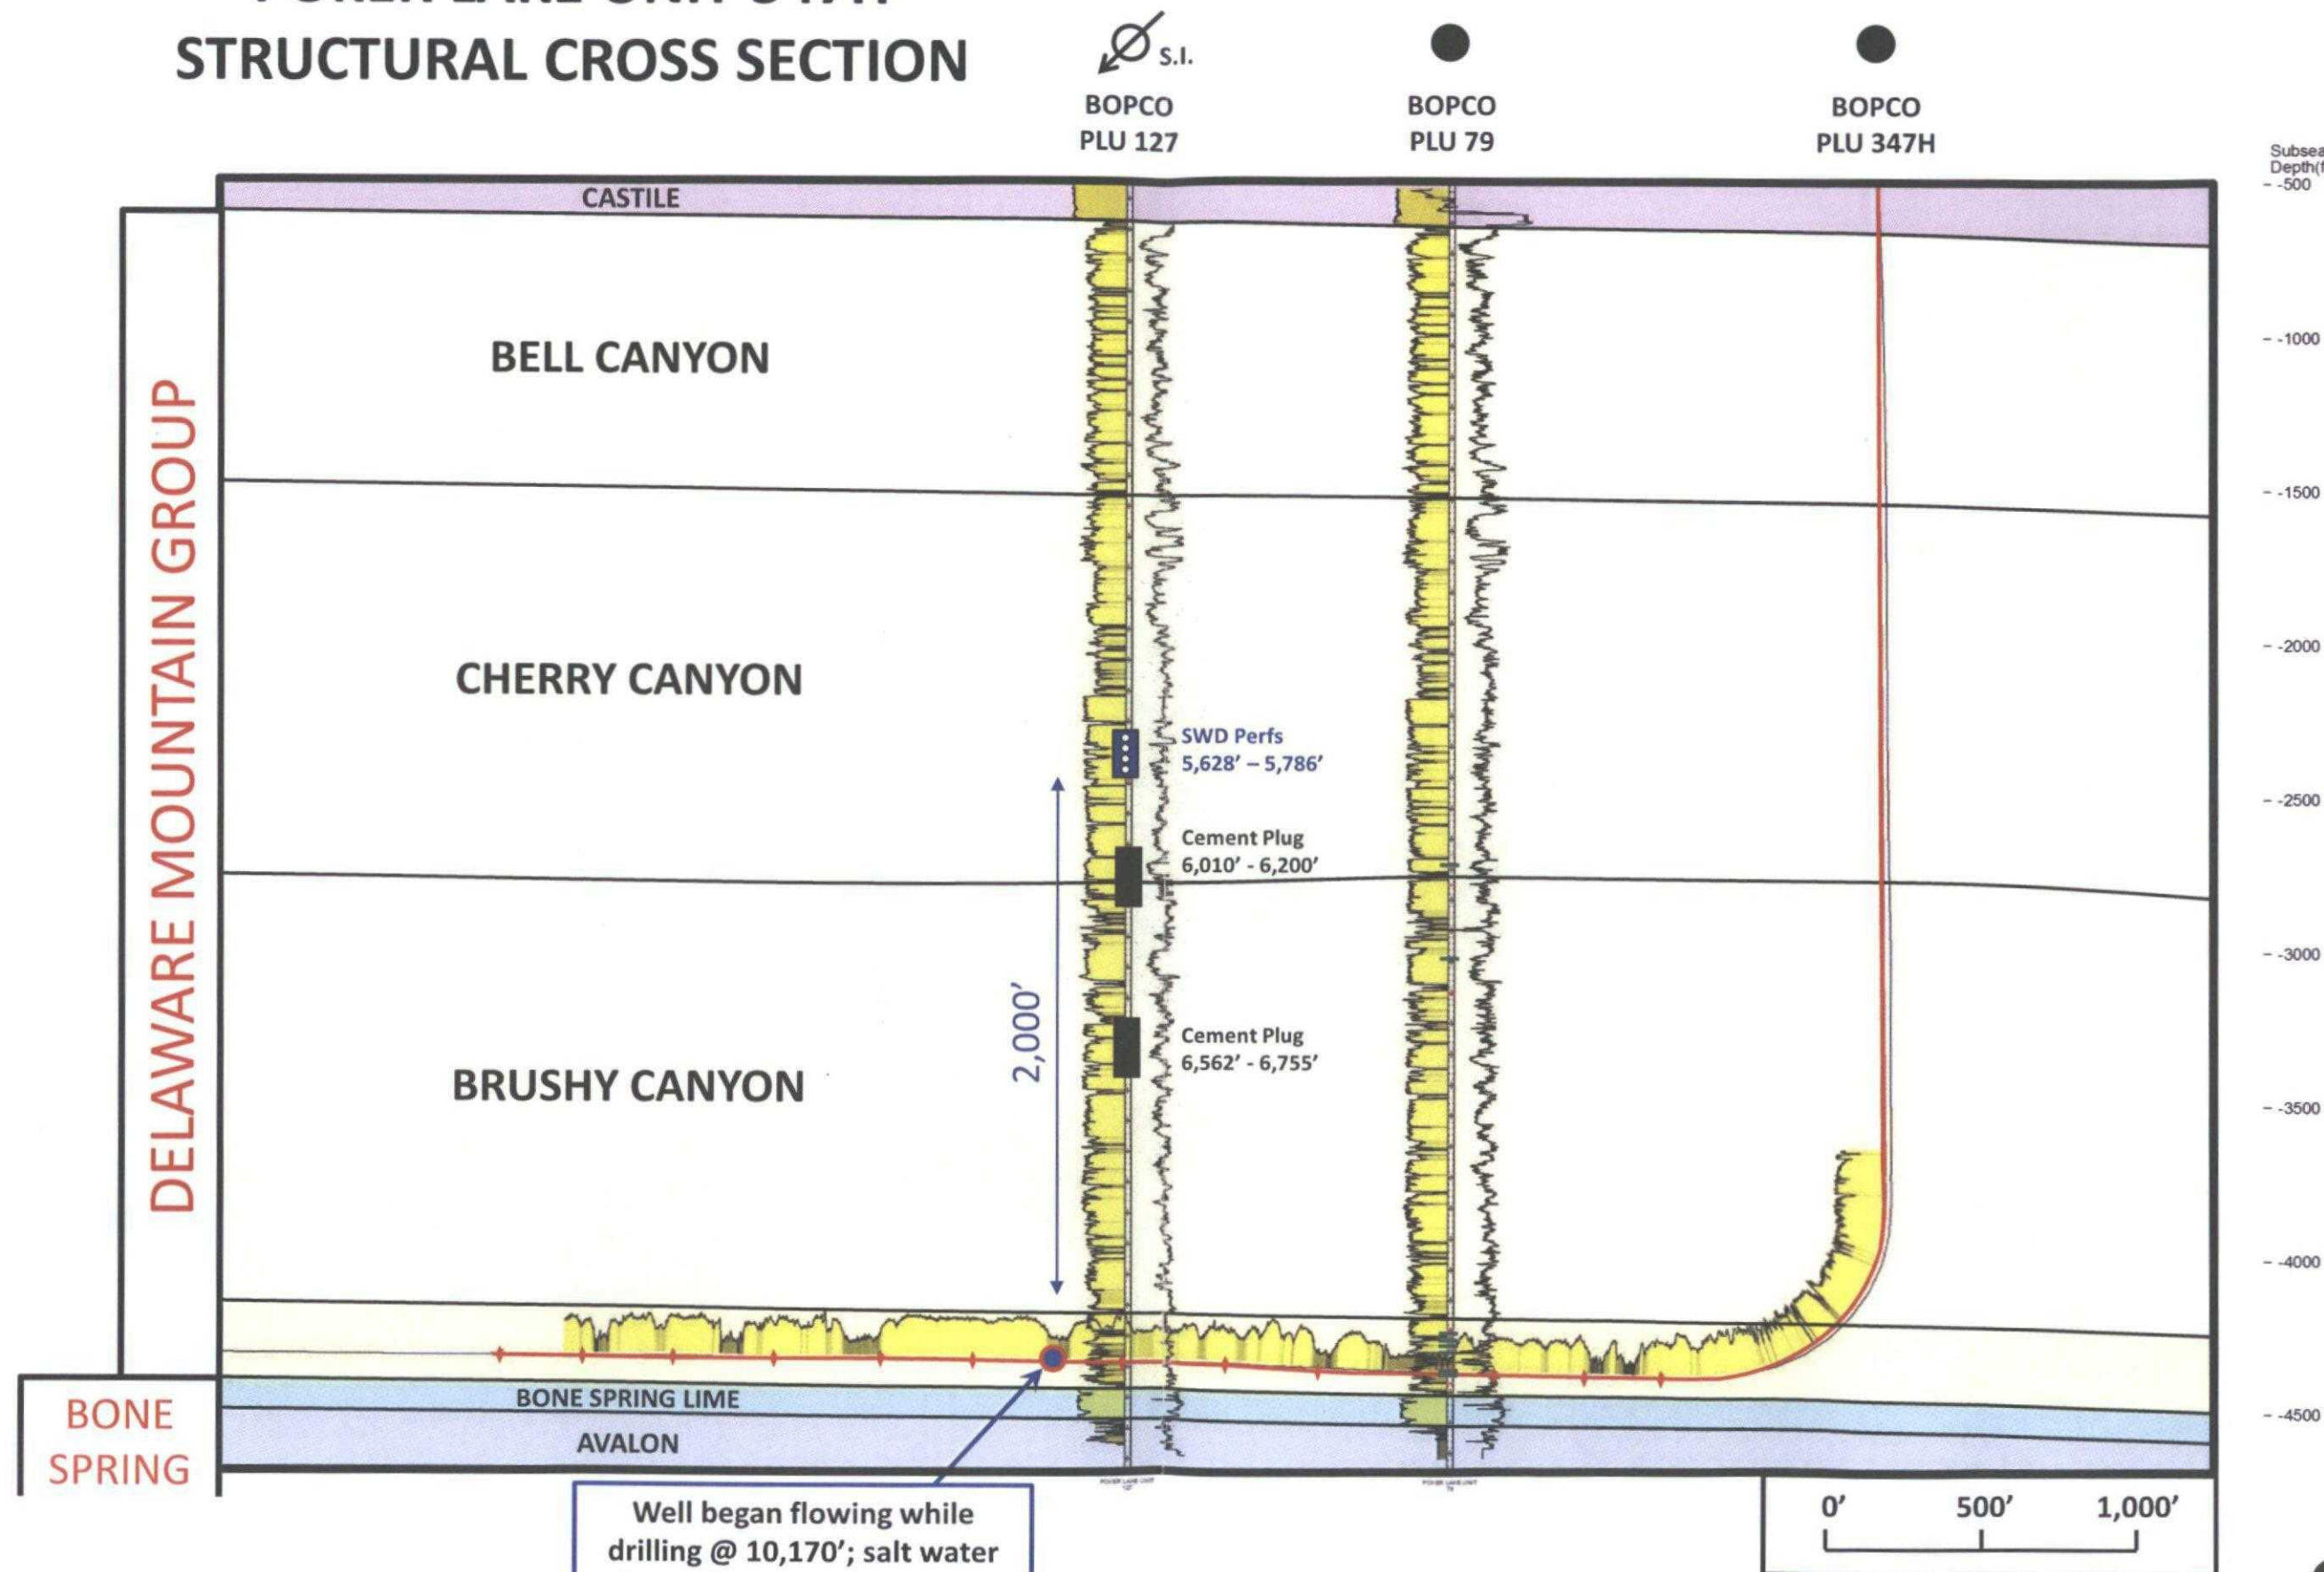
Well began flowing while drilling @ 10,170'; salt water flow. Shut well in, recorded 250 psi on drill pipe, 125 psi on casing.
