Pit, Below-Grade Tank, or Proposed Alternative Method Permit or Closure Plan Application

BELOW-GRADE TANK CLOSURE PLAN

HARDIE LS 001A

API No. 3004522415

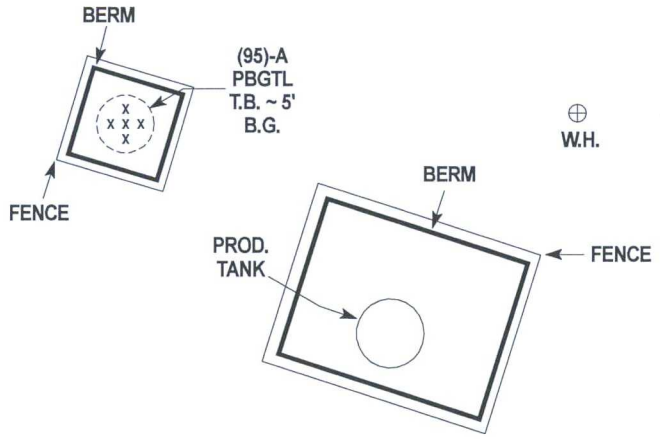
PLOT PLAN circle: attached

DISCOLORATION/STAINING OBSERVED: YES / NO EXPLANATION - 7 FT. DEPTH

APPARENT EVIDENCE OF A RELEASE OBSERVED AND/OR OCCURRED : YES / NO EXPLANATION: APPEARS HISTORICAL

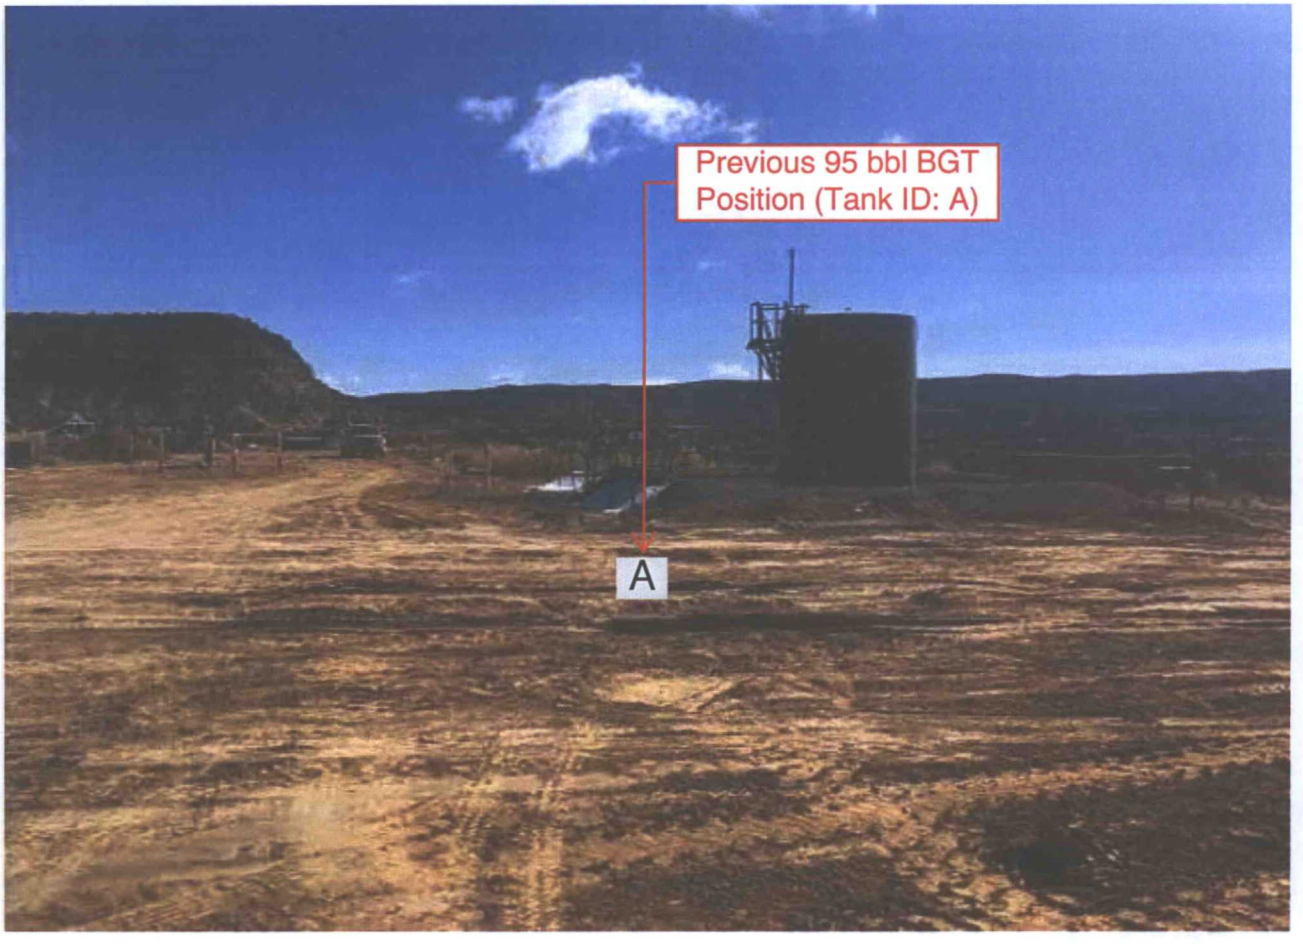
Previous 95 bbl BGT
Position (Tank ID: A)
A

The area has been backfilled. The location will be reclaimed once the well is plugged and abandoned.
