**Americo Energy Resources
East Shugart Unit #42
Work Plan
Eddy County, New Mexico**

February 8, 2008

***Safety & Environmental Solutions, Inc.
703 E. Clinton Suite 102
Hobbs, New Mexico 88240
(575) 397-0510***

BEFORE THE OIL CONSERVATION DIVISION
Santa Fe, New Mexico
Case No. 14079..... Exhibit No. 2
Submitted by:
AMERICO ENERGY RESOURCES, LLC.
Hearing Date: February 21, 2008

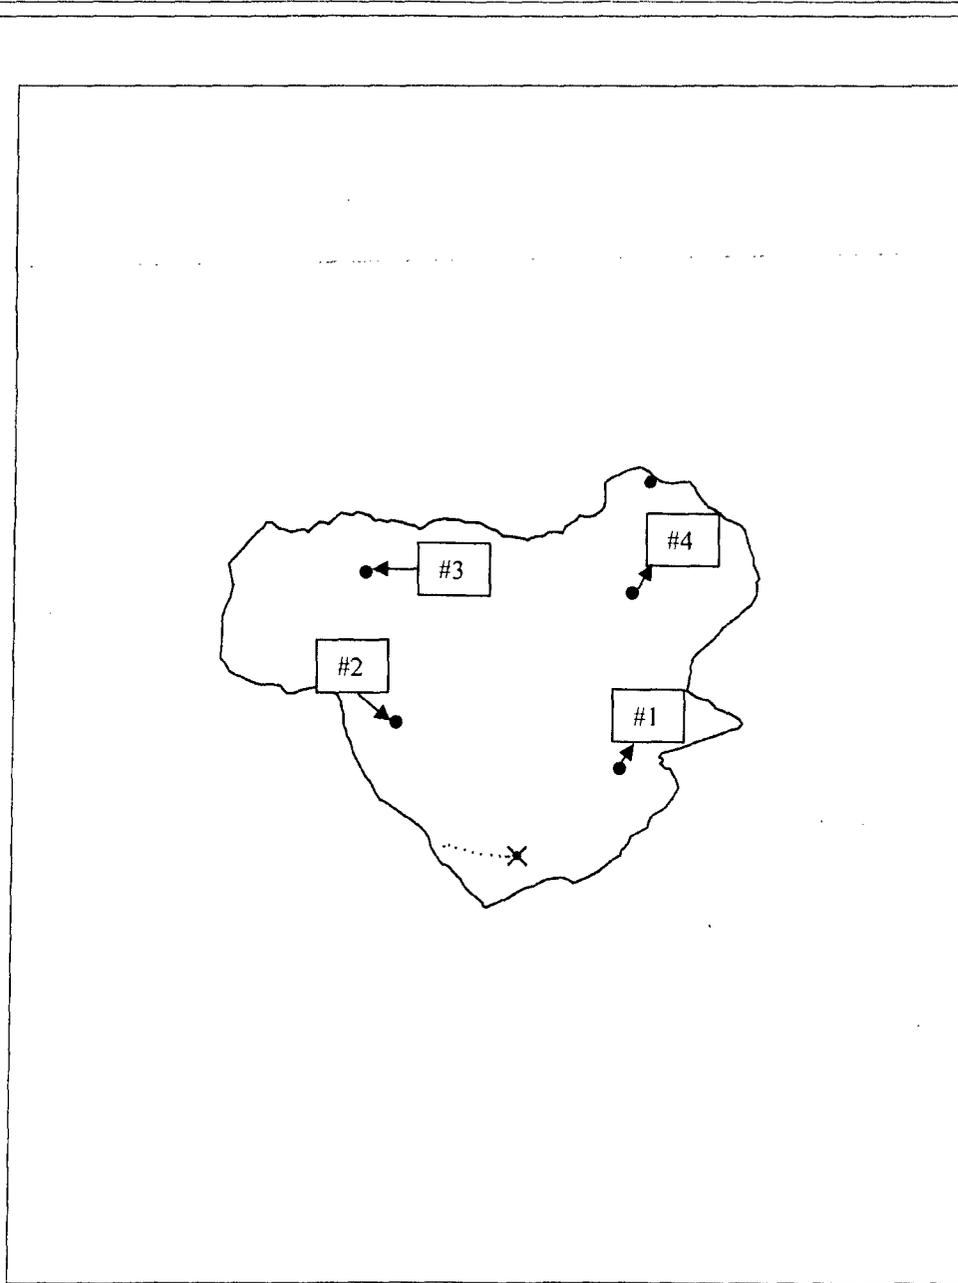
**Figure 2
Site Plan**

Americo East Shugart #42

Lat/Long
WGS 1984

Site Plan.ssf
1/30/2008
GPS Pathfinder[®] Office
 Trimble.

On January 23, 2008, samples were retrieved in four areas of the spill utilizing a hand auger. Samples were taken from the surface and at the depths of 1', 2', 3', and 4'. Field analysis was performed on each sample to determine chloride concentrations. The results of the analysis were as follows:

On January 31, 2008, test trenches were installed to further delineate the site. Grab samples were retrieved from each test trench and field analysis was performed on each sample to determine chloride concentrations. The results of the analysis were as follows:

On February 6, 2008 a borehole was installed via auger rig to complete delineation of the site. Grab samples were retrieved from the borehole at intervals of 5', and field analysis was performed on each sample to determine chloride concentrations. The results of the analysis were as follows:
