Pit, Closed-Loop System, Below-Grade Tank, or Proposed Alternative Method Permit or Closure Plan Application

BELOW-GRADE TANK CLOSURE PLAN

Riddle # 4S – Tank ID: A
API #: 3004525558
Unit Letter G, Section 21, T30N, R9W

RIDDLE 004S

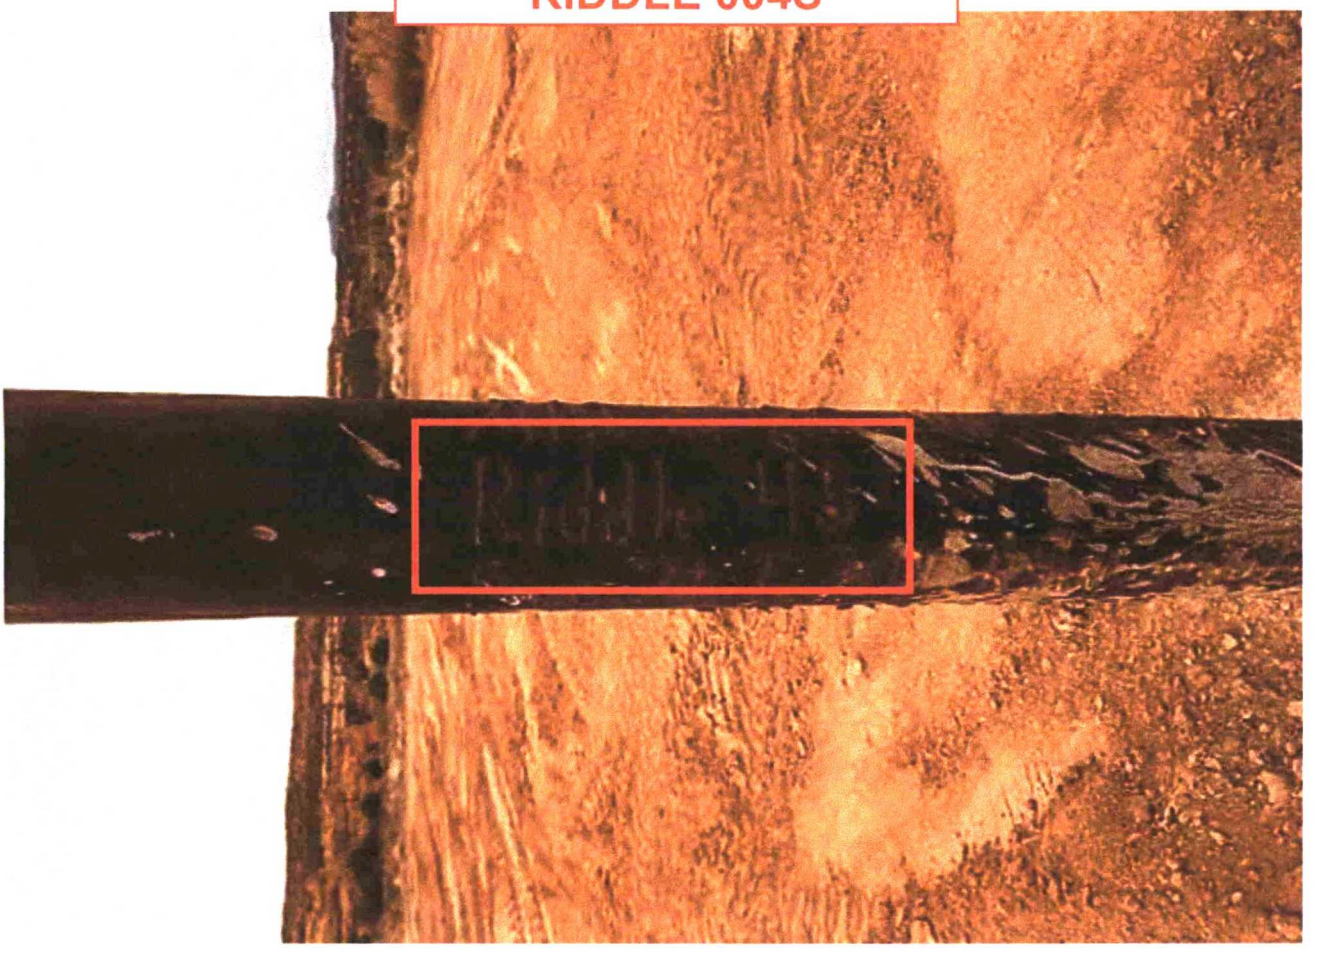
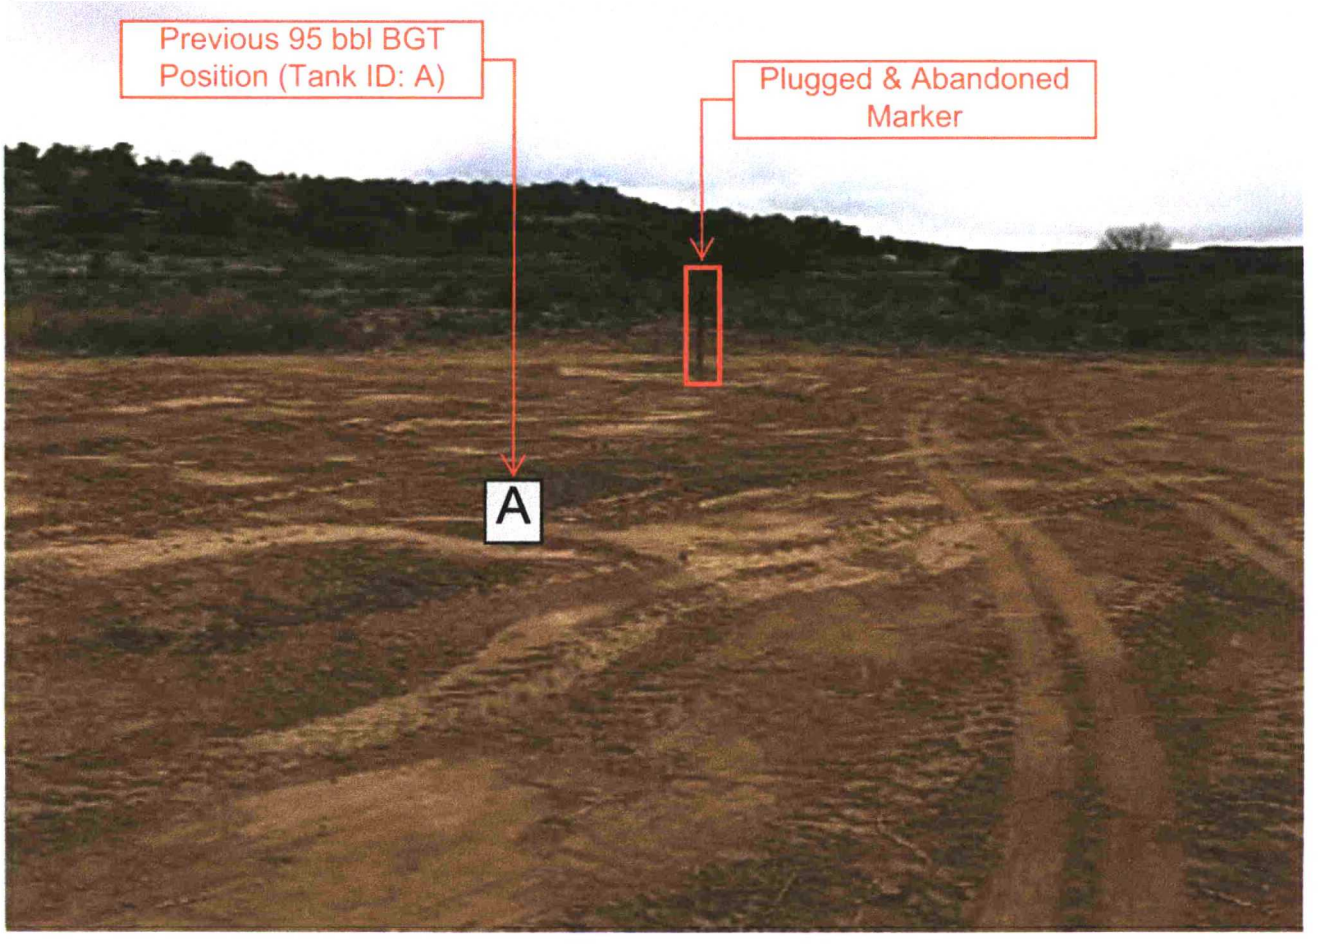
Soil beneath the BGT was sampled for TPH, BTEX, and chloride. All test parameters were below the stated limits. A field and laboratory reports are attached.

Previous 95 bbl BGT
Position (Tank ID: A)
Plugged & Abandoned
Marker
A

9. If the sampling demonstrates that a release has not occurred or that any release does not exceed the concentrations specified above, then BPX shall backfill the excavation, with compacted, non-waste containing, earthen material; construct a division-prescribed soil cover, re-contour and re-vegetate the location. The location will be reclaimed if it is not with in the active process area.
Sampling results reveal no evidence of a release has occurred. Area was backfilled with clean, earthen material and is within the active well pad.
