SUNDRY NOTICES AND REPORTS ON WELLS
(DO NOT USE THIS FORM FOR PROPOSALS TO DRILL OR TO DEEPEN OR PLUG BACK TO A DIFFERENT RESERVOIR. USE "APPLICATION FOR PERMIT" (FORM C-101) FOR SUCH PROPOSALS.)

Closure of on-site landfarm constructed to remediate impacted soils from unlined pit.

FIELD REPORT: LANDFARM/COMPOST PILE CLOSURE VERIFICATION

LOCATION: NAME. SIXTEEN G'S WELL #: 1 PITS: SEP
QUAD/UNIT: E SEC: 7 TWP: 24N RNG: 9W PM: NM CNTY: SJ ST: NM
QTR/FOOTAGE: 1850FNL x 990 FWL CONTRACTOR: DPC

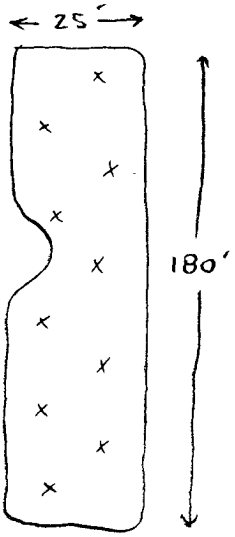
SKETCH/SAMPLE LOCATIONS

X = COMPOSITE SAMPLE POINT

SAMPLE ID	FIELD HEADSPACE PID (ppm)
10-POINT	1.0

SAMPLE ID	ANALYSIS	TIME	RESULTS
10-POINT	8015	0745	420
