Heaton Com LS 009A  
MV  
API # 30-045-24988  
Unit I - Sec. 32 - T31N - R11W  
San Juan, NM

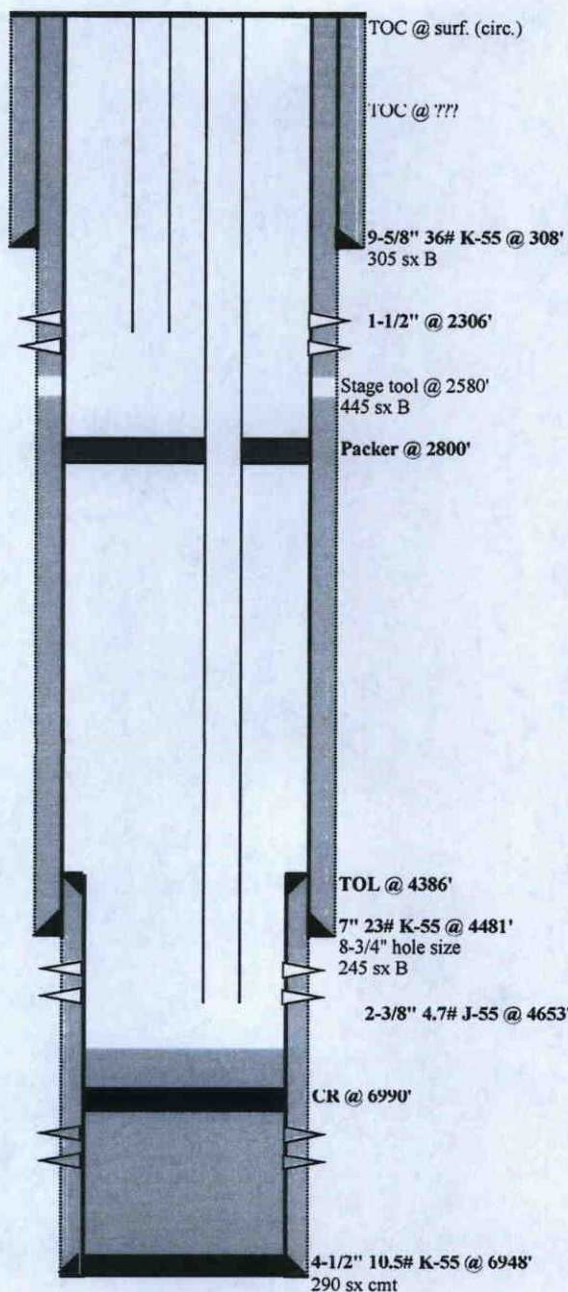
#### Fruitland Perforations

2060' - 2065' 4 jspf  
2068' - 2070' 4 jspf  
2075' - 2082' 4 jspf  
2134' - 2136' 4 jspf  
2140' - 2142' 4 jspf  
2145' - 2147' 4 jspf  
2149' - 2151' 4 jspf  
2153' - 2155' 4 jspf  
2159' - 2162' 4 jspf  
2172' - 2176' 4 jspf  
2183' - 2186' 4 jspf  
2238' - 2241' 4 jspf  
2257' - 2276' 4 jspf  
2314' - 2317' 4 jspf

Frac'd w/ 70% Q foam & 172k# 20/40 sd

#### Mesa Verde Perforations

4565' - 4568' 2 jspf  
4632' - 4658' 2 jspf  
4664' - 4669' 2 jspf

Frac'd w/ 70% Q foam & 75k# 12/20 sd

#### Dakota Perforations

6760' - 6764'  
6812' - 6828'  
6851' - 6860'

Acidized w/ 1200 gal 15% HCl

Frac'd w/ 60k gal 70% Q foam & 112k# 20/40 sd

PBTD: 7525'  
TD: 7559'
