Pit, Below-Grade Tank, or Proposed Alternative Method Permit or Closure Plan Application

Hilcorp Energy Company
San Juan Basin
Below Grade Tank Closure Report

Lease Name: Scott E Federal 23 42
API No.: 30-045-28516

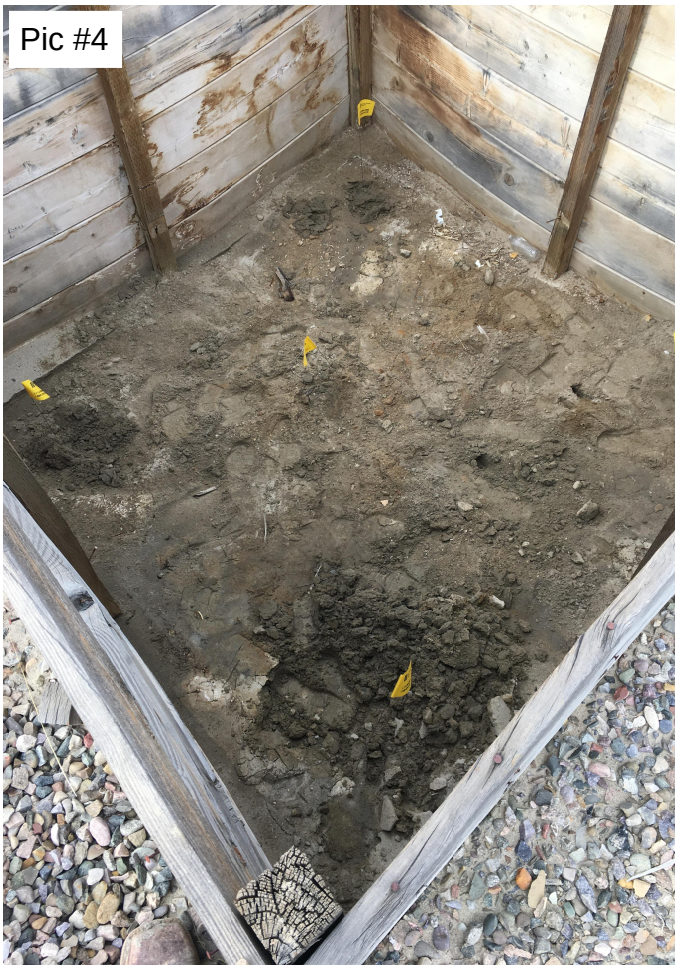
Pic #4

Taken 3-21-22 @ 9:20AM
