Subject: Notice of Completion Pit Closure and Interim Reclamation
Shell Exploration & Production Co., Latigo Ranch 3-3 (API No. 30-019-20138)
Guadalupe County, New Mexico

Subject: **Latigo Ranch 3-3 Gas Well Completion Pit Closure Report**
Singleton Properties, LLC Lease
Cuervo, Guadalupe County, New Mexico

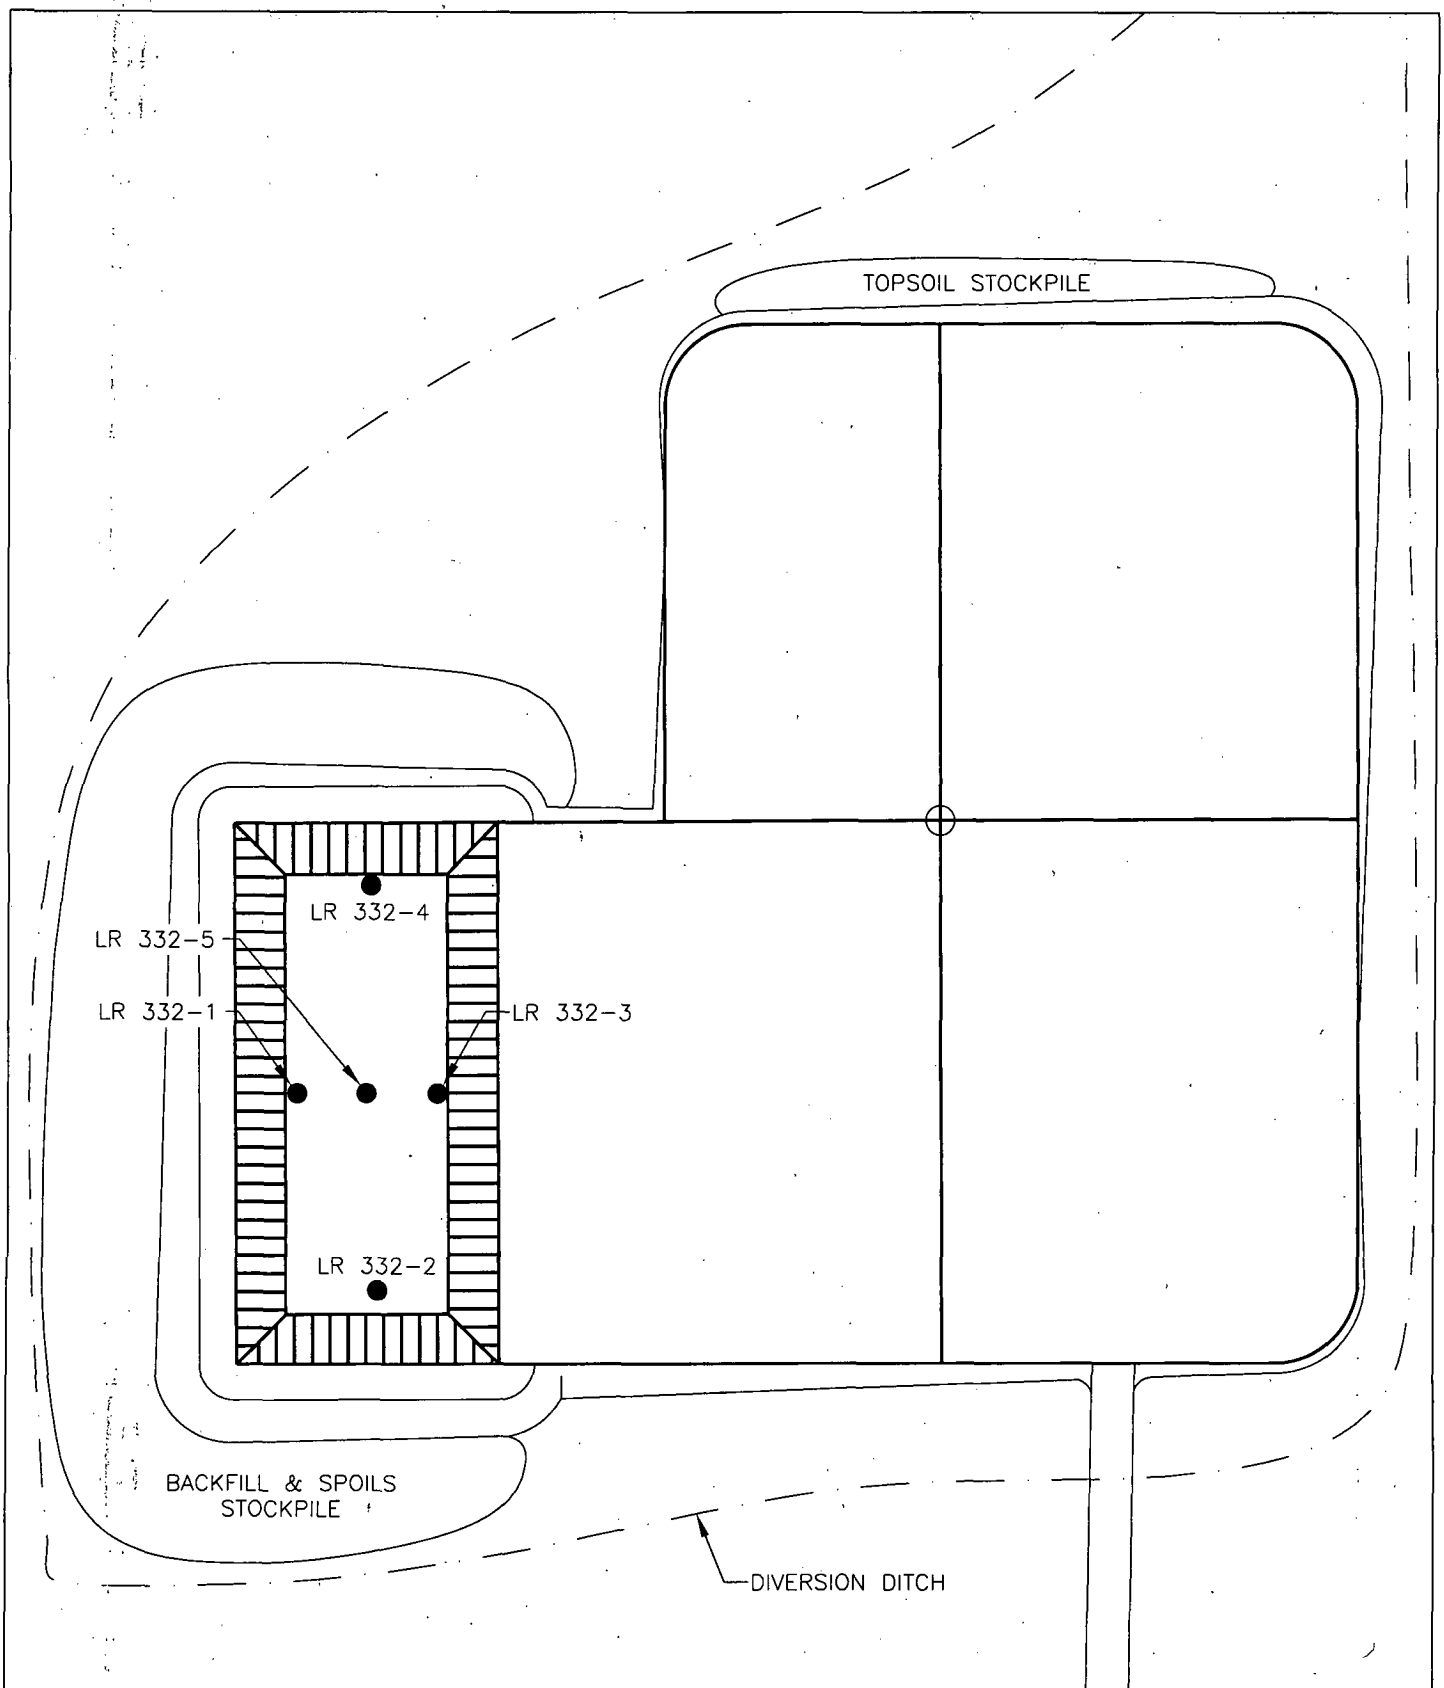
By: BAL	Date: 03/22/11	Project No. HO10160210
AMEC		**Figure 2**

SAMPLE LOCATION MAP
Latigo Ranch #3-3
Shell Exploration & Production
Section 3, Township 10N, Range 23E
Guadalupe County, NM

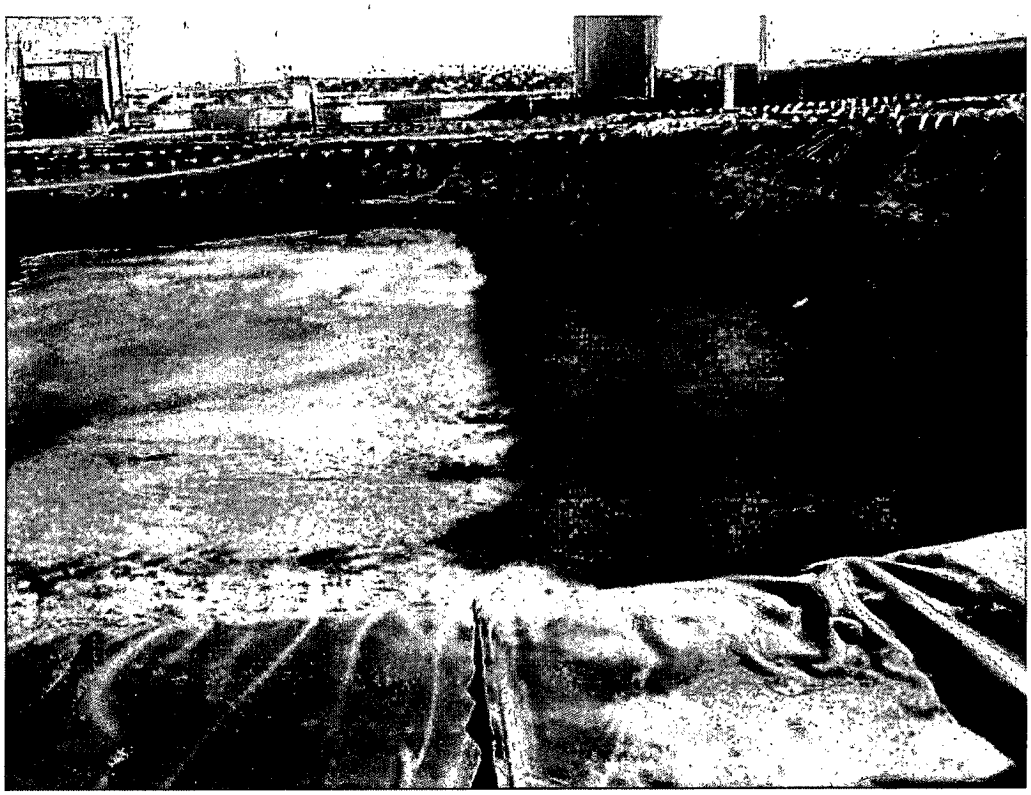
Photo 1: Pit following commencement of fluid removal (looking southwest).

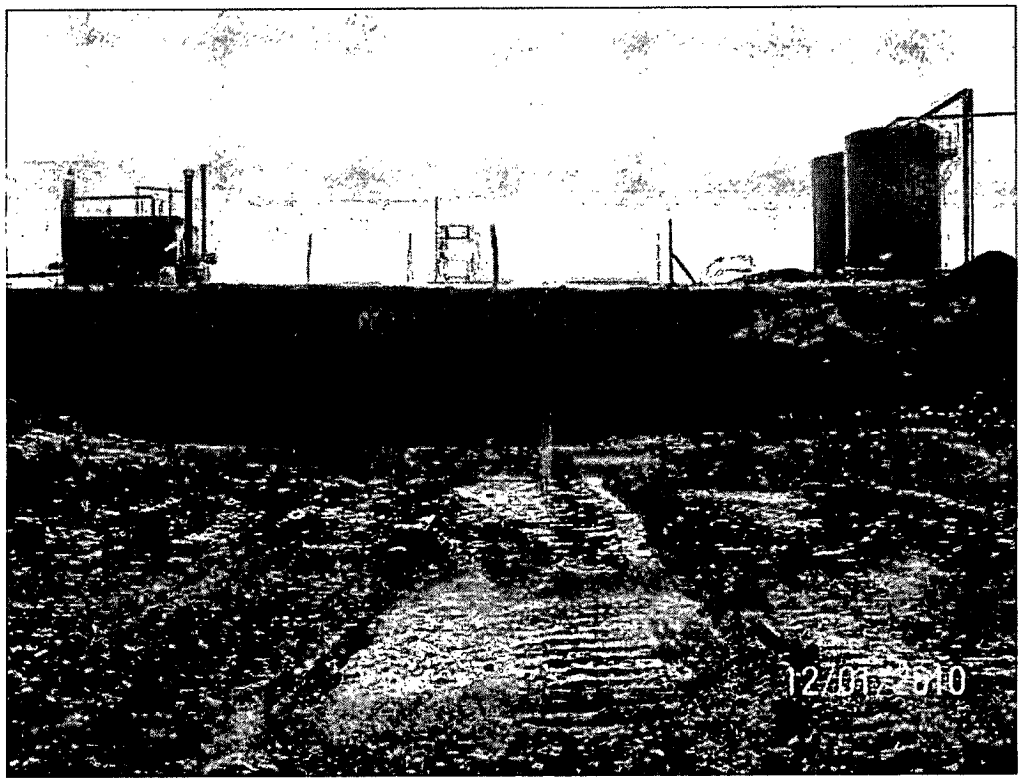
Photo 6: Removing the final portion of the pit liner (looking north).

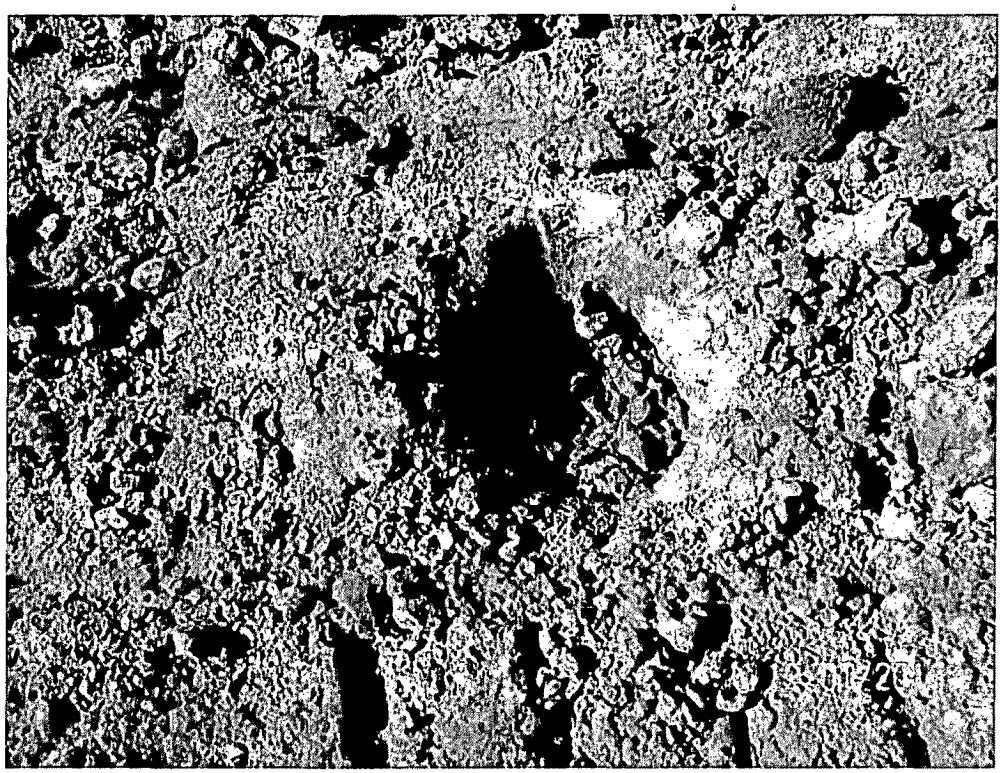
Photo 10: Sample point LR332-2 (excavated area in center).

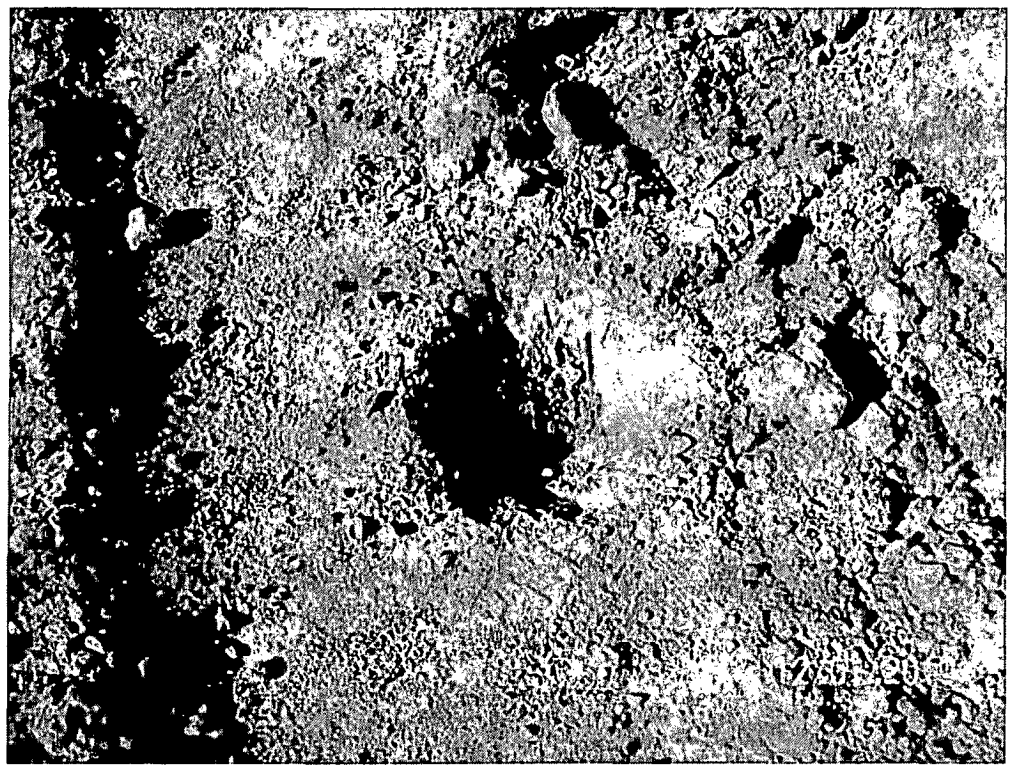
Photo 11: Sample point LR332-3 (excavated area in center).
