**Gallegos Canyon Unit 182E**

Pictured Cliffs  
API # 30-045-24864  
T-28N, R-11-W, Sec. 19 Unit K  
San Juan County, New Mexico

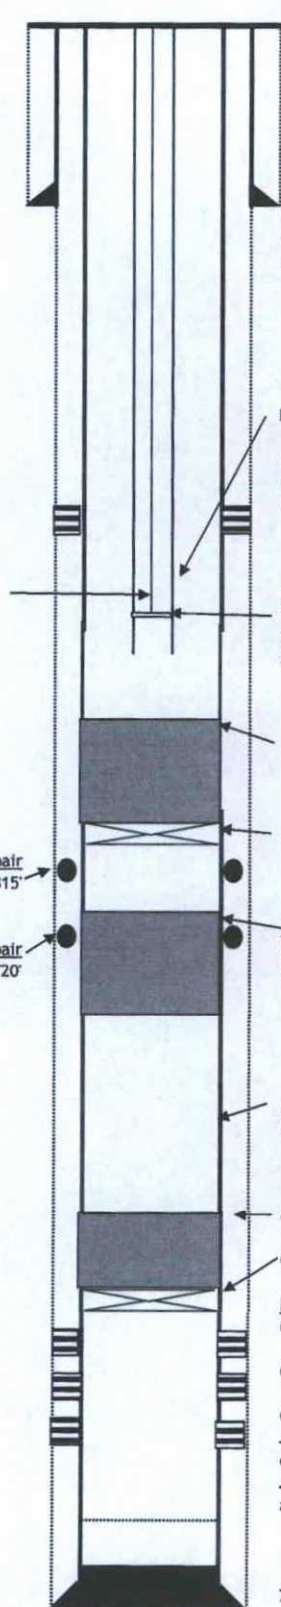
PC Perforations (1995)  
1,530' - 1,550' w/ 4 JSPF

Sucker Rod details (2010)  
ROD, POLISHED: 1.25  
RODS: 0.75 X 25 GRD. D FSSMC  
RODS: 0.75 X 25 GRD. D FSSMC  
RODS, PONY: 0.75 GRD. D  
PUMP, RWAC, 2.0 X 1.25 X 14

EOT @ 1,577'

PC Frac (1995)  
Frac'd w/ 244 bbls 70% foam and  
206,408 SCF N2. and 43,996# 16/30 sand.

Tubing details (2010)  
TUBING, 2.375, 4.7#, J-55, EUE T&C  
SN, API: 2.375 X 1.780 X 12, 8RD EUE  
MULESHOE SUB, 2.375

cement plug @ 1700' (new PBTD)

CIBP set @ 2900'

1984 casing repair  
sqz holes twice at 3260'-3315'

1985 casing repair  
sqz holes at 3557'-3720'

1992 - BH Repair  
Spot cement to cover holes  
from 3376'-4035'

PBTD: 6233'  
TD: 6275'
