### UNITED STATES DEPARTMENT OF THE INTERIOR BUREAU OF LAND MANAGEMENT

# **Huerfano Unit #27 Pertinent Data Sheet**

API #: 300450578600

Location: 790 'FNL & 790 'FEL, Unit A, Section 23, T26N, R09W, San Juan County, New Mexico

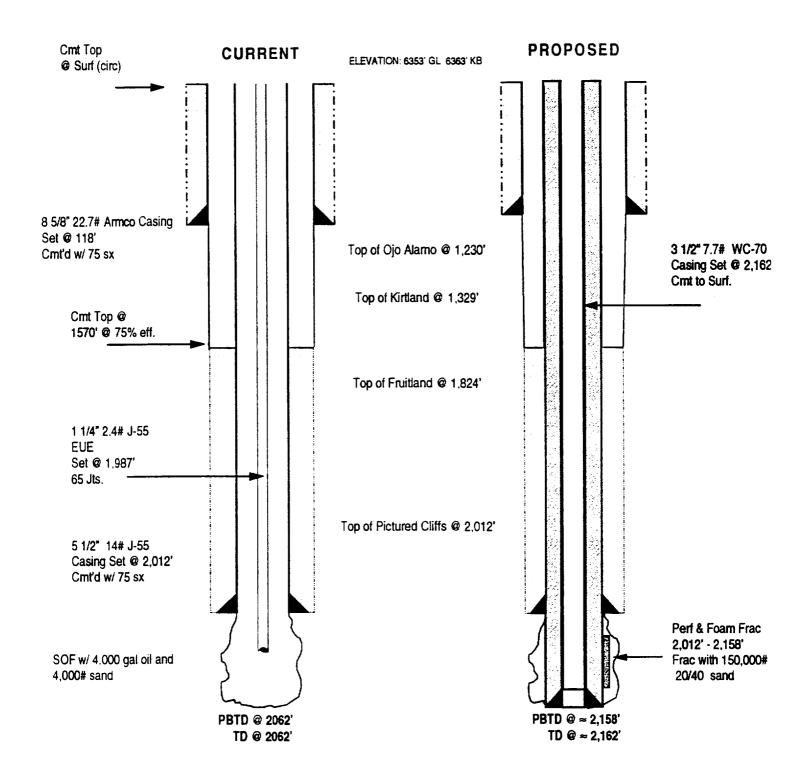
## Ballard Pictured Cliffs Wellbore Schematic

Section 23 A, T-26-N R-09-W San Juan, New Mexico
