Pit, Below-Grade Tank, or Proposed Alternative Method Permit or Closure Plan Application

1.
Operator: BP America Production Company OGRID #: 778
Address: 200 Energy Court, Farmington, NM 87401
Facility or well name: PUMP CANYON WATER TRANSFER
API Number: PLA02123109 OCD Permit Number:
U/L or Qtr/Qtr O Section 12 Township 30N Range 09W County: San Juan
Center of Proposed Design: Latitude 36.818590 Longitude -107.728689 NAD83
Surface Owner: ■ Federal ☐ State ☐ Private ☐ Tribal Trust or Indian Allotment

BELOW-GRADE TANK CLOSURE PLAN

PUMP CANYON WATER

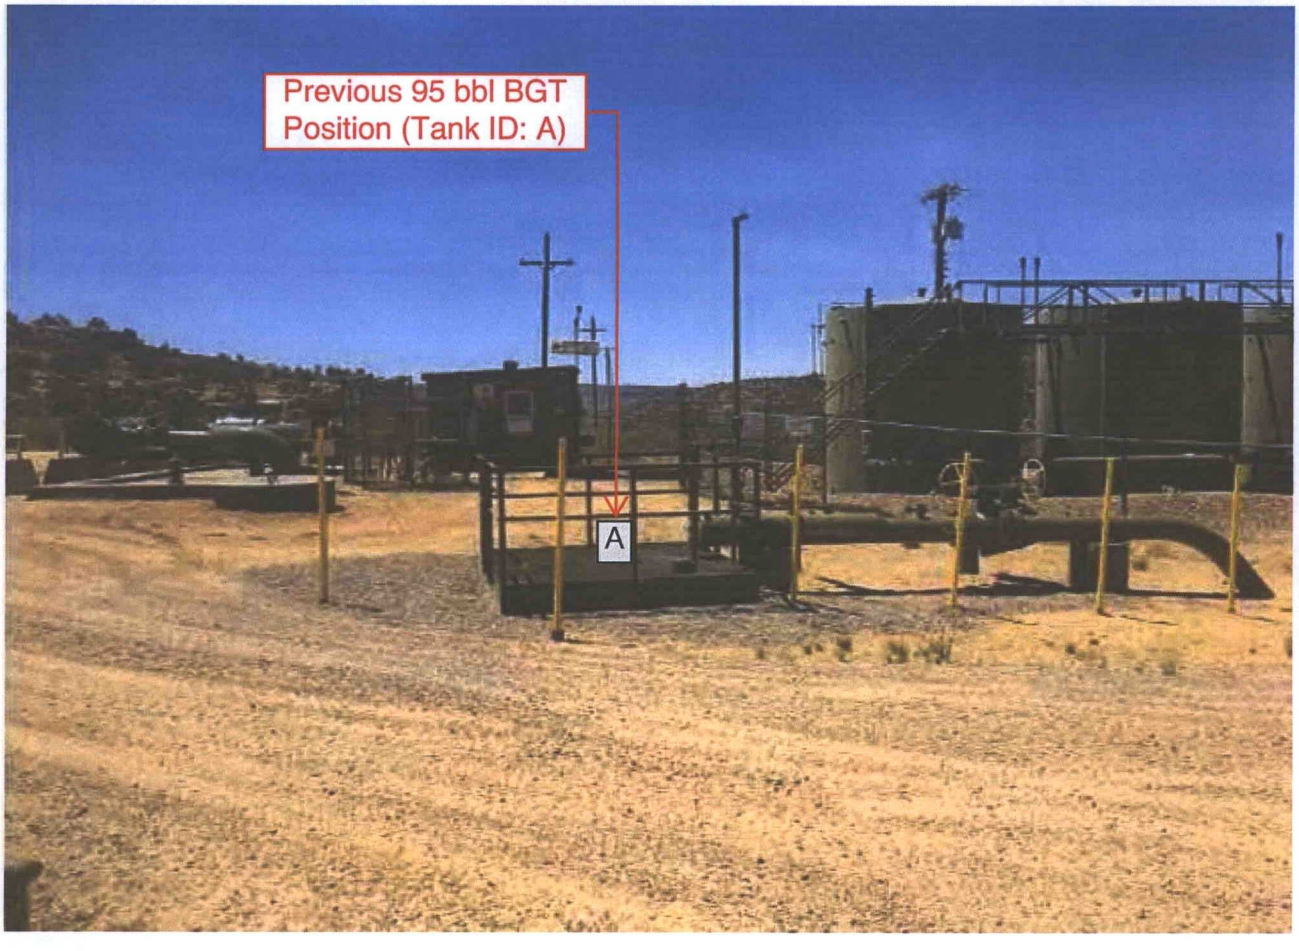
Previous 95 bbl BGT
Position (Tank ID: A)
A

The area has been backfilled and a shallow low profile above-grade tank set atop BGT location. The location will be reclaimed once the well is plugged and abandoned.
