San Juan 28-5 Unit #42

Blanco Mesaverde / Basin Dakota 1800' FSL, 1650' FWL

Unit K. Sec. 31, T-28-N, R-5-W Latitude / Longitude: 36°36.92046' / 107°24.20016' Recommended Commingle Procedure 9/11/98

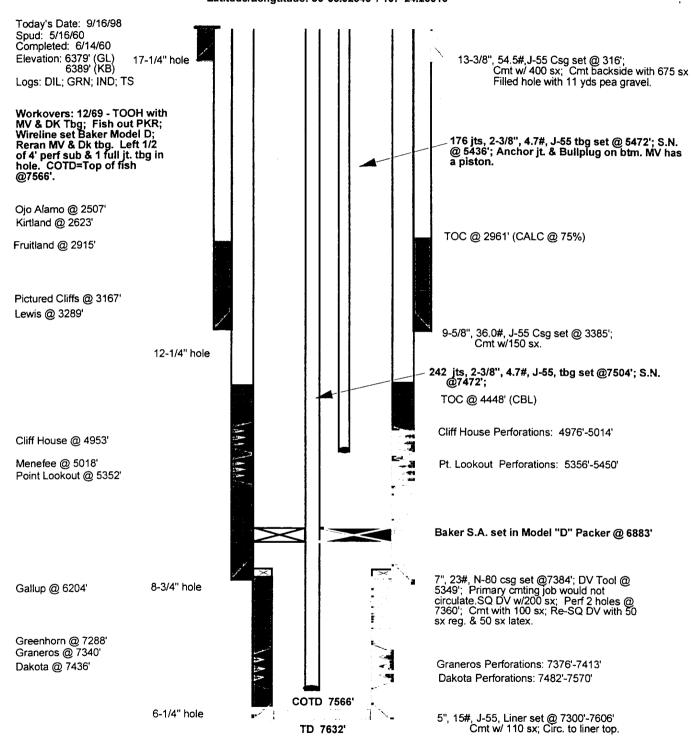
CURRENT

Basin Dakota/Blanco Mesaverde 1800' FSL, 1650' FWL Unit K, Section 31, T-28-N, R-05-W, Rio Arriba County, NM Latitude/Longtitude: 36°36.92046' / 107°24.20016'

History: This well was completed in 1960 with two 2-3/8" tubing strings existing inside 7", 23# casing. In 1969, a tubing leak was discovered in the Dakota tubing during a packer-leakage test. During the subsequent tubing repair, the Dakota tubing was found stuck inside the production packer. The tubing was chemically cut, pulled out of the hole, and the production packer was then recovered. Apparently, the perforated sub had also parted, causing ½ of the 4' perforated sub and 1 full joint of tubing to be left in the hole (COTD at 7566').
