Final Report

RICE OPERATING COMPANY
JUNCTION BOX FINAL REPORT

Vacuum F-30-1 vent

unit 'F', sec. 30, T17S, R35E

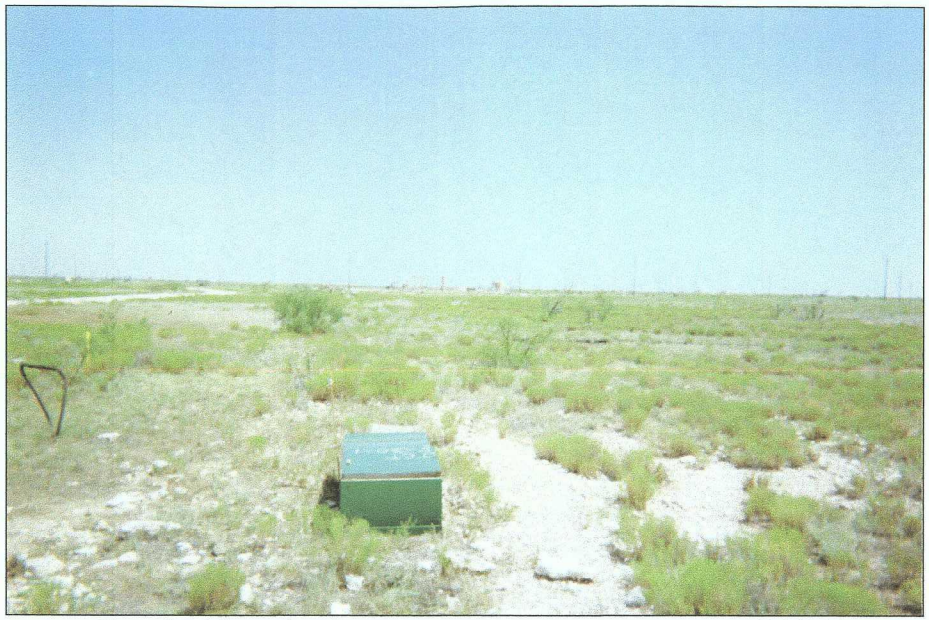
undisturbed junction box 7/11/2005

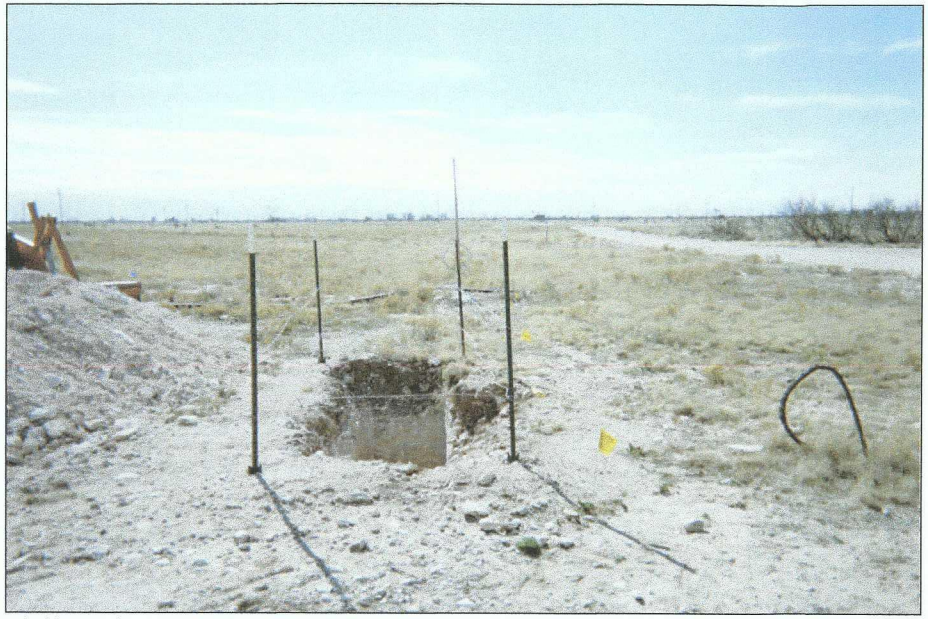
delineation trench to 12 ft BGS make with trackhoe 2/17/2006

backfilling delineation trench 2/17/2006

seeding backfilled location 3/21/2006
