# El Paso Natural Gas Company

This is a request for administrative approval for a well dually completed in the Blanco Mesa Verde Pool and South Blanco Pictured Cliffs Pool. The El Paso Natural Gas Company San Juan 28-7 Unit No. 91 (PM) is located 836 feet from the North line and 1544 feet from the East line of Section 34, Township 28 North, Range 7 West, N.M.P.M., Rio Arriba County, New Mexico.

# SCHEMATIC DIAGRAM OF DUAL COMPLETION El Paso Natural Gas Co. San Juan 28-7 Unit No. 91 (PM) NE/4 Section 34, T-28-N, R-7-W

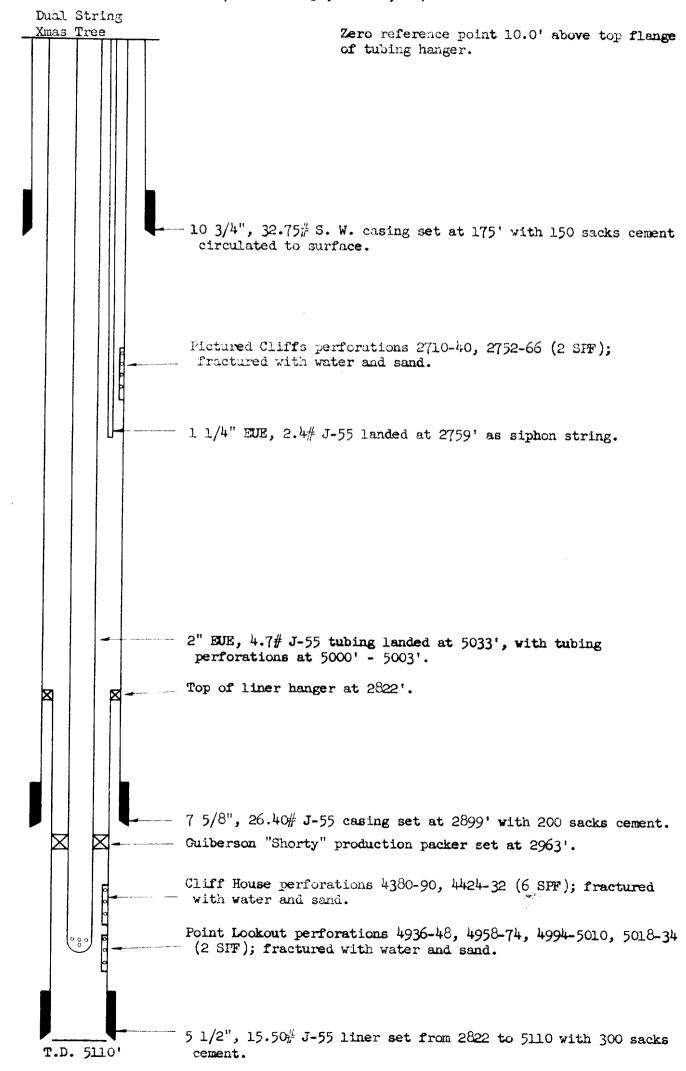
- 1. 10 3/4" surface casing set at 175 feet with 150 sacks of cement circulated to the surface.
- 2. 7 5/8" intermediate casing set at 2899 feet with 200 sacks of cement. Top of the cement is at 1860 feet, which is above the top of the Pictured Cliffs at 2700 feet.

- 3. 5 1/2" liner set from 2822 feet to 5110 feet with 300 sacks of cement.
- 4. The casing and liner were tested for leaks before perforating.
- 5. The Point Lookout section was perforated in four intervals and fractured with water and sand.

- 6. The Cliff House section was perforated in two intervals and fractured with water and sand.
- 7. The Pictured Cliffs formation was perforated in one interval and fractured with water and sand.

- (a) Two copies of the schematic diagram of the mechanical installations.
- (b) Two copies of the affidavit from the packer setting company stating that the packer used was set at the depth shown.
- (c) Two copies of the packer leakage test as observed by a member of the Oil Conservation Commission.
- (d) Two copies of the initial potential test showing commercial production from the two formations.
