Vacuum Jct J-7
2009

RICE OPERATING COMPANY
JUNCTION BOX FINAL REPORT

Vacuum Jct. J-7

Unit J, Section 7, T18S, R35E

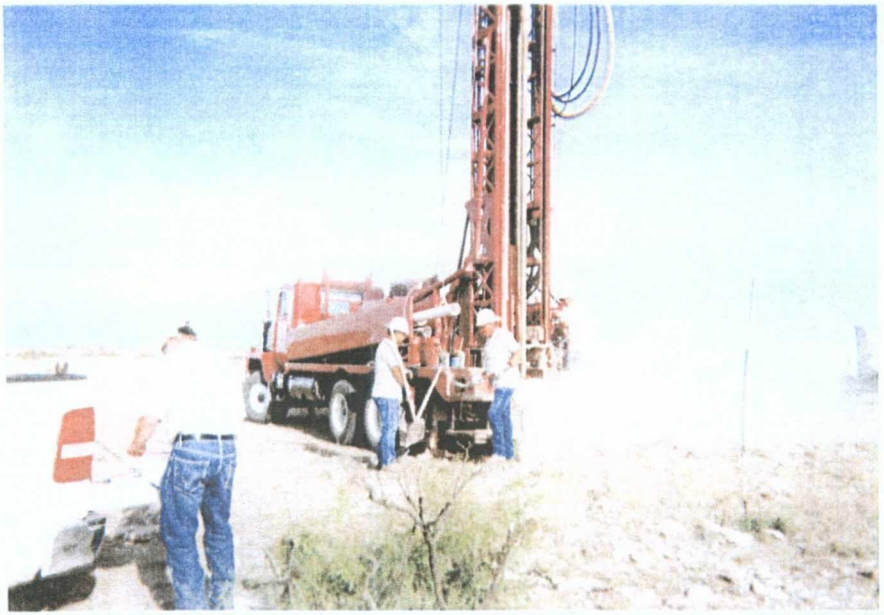
drilling SB #1 at the former junction box site 6/18/2009

plugging SB #1 with bentonite 6/18/2009

backfilling the former junction box site with clean soil 6/25/2009

seeding backfilled site 6/25/2009
