Sundry Notices and Reports on Wells

8. Well Name & Number
Huerfano Unit #258

Huerfano Unit #258
Basin Fruitland Coal / Fulcher Pictured Cliffs
AIN #4507902/03
990' FSL and 990' FEL, Section 36, T-27-N, R-10-W
Latitude: 36 31.6206' / Longitude: -107 50.4594'
San Juan Co., New Mexico
PLUG & ABANDONMENT PROCEDURE 11/10/00

Huerfano Unit #258

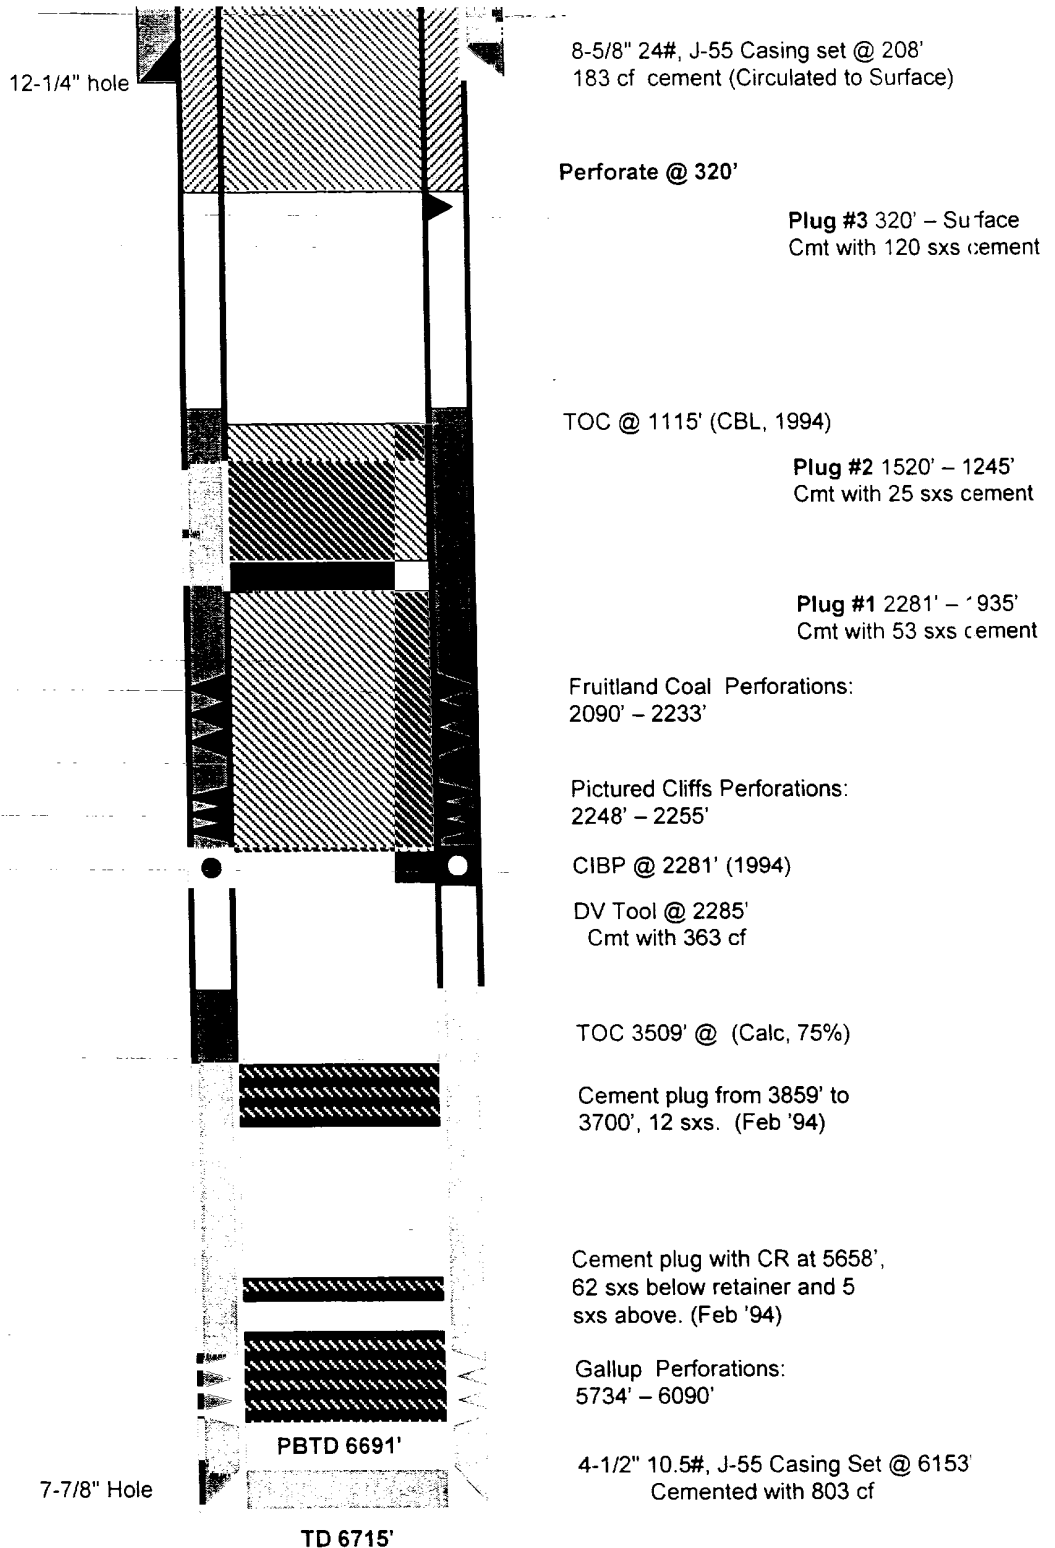
Mesaverde @ 3806'

Gallup @ 5722'

3. **Plug #1 (Pictured Cliffs and Fruitland Coal, 2281' - 1935')**: TIH and tag CIBP at 2281' or as deep as possible. Pump 30 bbls water down tubing. Mix 53 sxs cement and spot a plug to fill Pictured Cliffs and Fruitland Coal perforations and cover tops. PUH and WOC. TIH and tag cement. Load well with water and circulate clean. Pressure test casing to 500#. If casing does not test, then spot or tag subsequent plugs as appropriate. PUH to 1520'.

4. **Plug #2 (Kirtland and Ojo Alamo top, 1520' - 1245')**: Mix 25 sxs cement and spot a balanced plug inside casing to cover Kirtland and Ojo Alamo tops. TOH with tubing.

5. **Plug #3 (Nacimiento top and 8-5/8" casing shoe, 320' - Surface)**: Perforate 3 HSC squeeze holes at 320'. Establish circulation out bradenhead valve. Mix and pump approximately 120 sxs cement down the 4-1/2" casing from 258' to surface, circulate good cement out bradenhead valve. Shut in well and WOC.
