Pit, Closed-Loop System, Below-Grade Tank, or Proposed Alternative Method Permit or Closure Plan Application

1.
Operator: BPX ENERGY INC. (formerly BP America Production Co.) OGRID #: 778
Address: 1199 Main Ave., Suite 101, Durango, CO 81301
Facility or well name: W D HEATH A 005
API Number: 3004508217 OCD Permit Number:
U/L or Qtr/Qtr P Section 17.0 Township 29.0N Range 09W County: San Juan County
Center of Proposed Design: Latitude 36.72083 Longitude -107.79617 NAD: ☐ 1927 ☒ 1983
Surface Owner: ☒ Federal ☐ State ☐ Private ☐ Tribal Trust or Indian Allotment

BELOW-GRADE TANK CLOSURE PLAN

W D Heath A # 5 – Tank ID: B
API #: 3004508217
Unit Letter P, Section 17, T29N, R09W

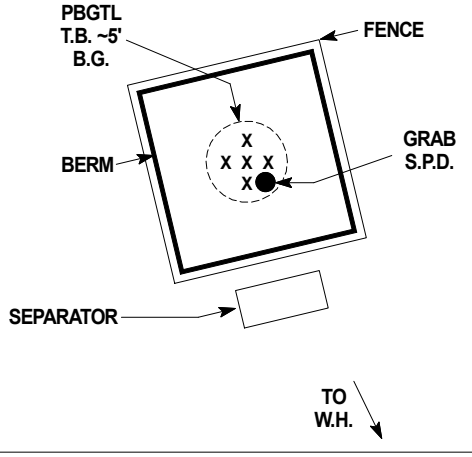
PLOT PLAN circle: attached

OTHER: NMOCD OR BLM REPS. NOT PRESENT TO WITNESS CONFIRMATION SAMPLING. REPLACED SW/DB BGT WITH DW/DB IN FEBRUARY 2018.

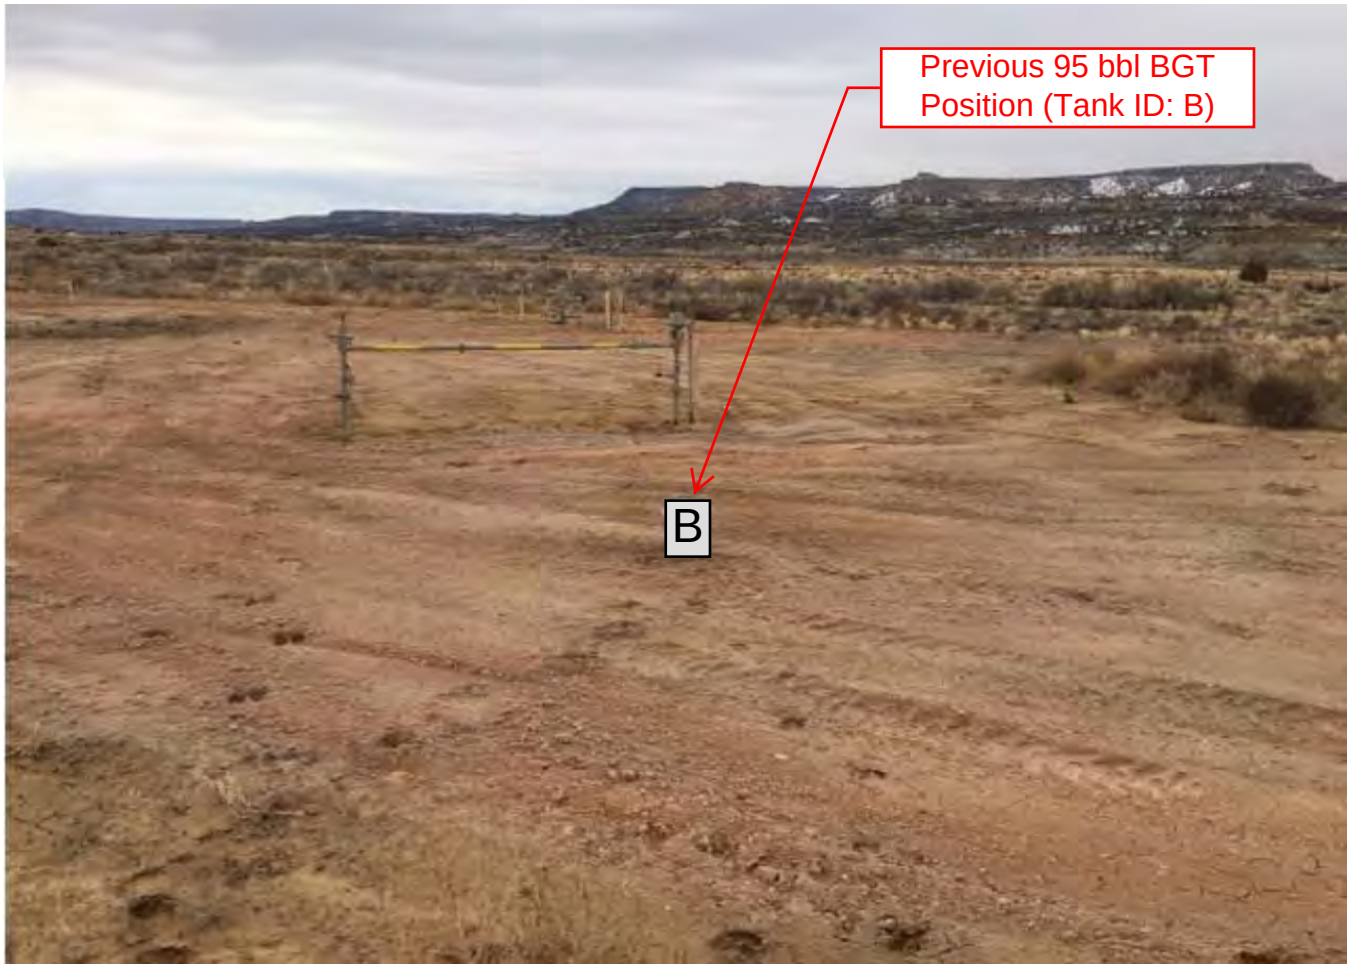
Previous 95 bbl BGT
Position (Tank ID: B)
B

Soil beneath the BGT was sampled for TPH, BTEX, and chloride. Chloride & BTEX test parameters were below the stated limits. TPH exceeded verification threshold. A field and laboratory reports are attached.

Cause of Release **Undetermined. Possible integrity issue with existing below-grade tank (BGT) bottom.**
