Pit, Closed-Loop System, Below-Grade Tank, or Proposed Alternative Method Permit or Closure Plan Application

1.
Operator: Williams Production Co, LLC OGRID #: 120782
Address: PO Box 640/721 So. Main, Aztec, NM 87410
Facility or well name: Rosa Unit #183
API Number: 30-039-26387 OCD Permit Number:
U/L or Qtr/Qtr G Section 19 Township 31N Range 05W County: Rio Arriba
Center of Proposed Design: Latitude 36.88802 Longitude 107.39995 NAD: ☐1927 ☒ 1983
Surface Owner: ☒ Federal ☐ State ☐ Private ☐ Tribal Trust or Indian Allotment

21.
Closure Report (required within 60 days of closure completion): Subsection K of 19.15.17.13 NMAC

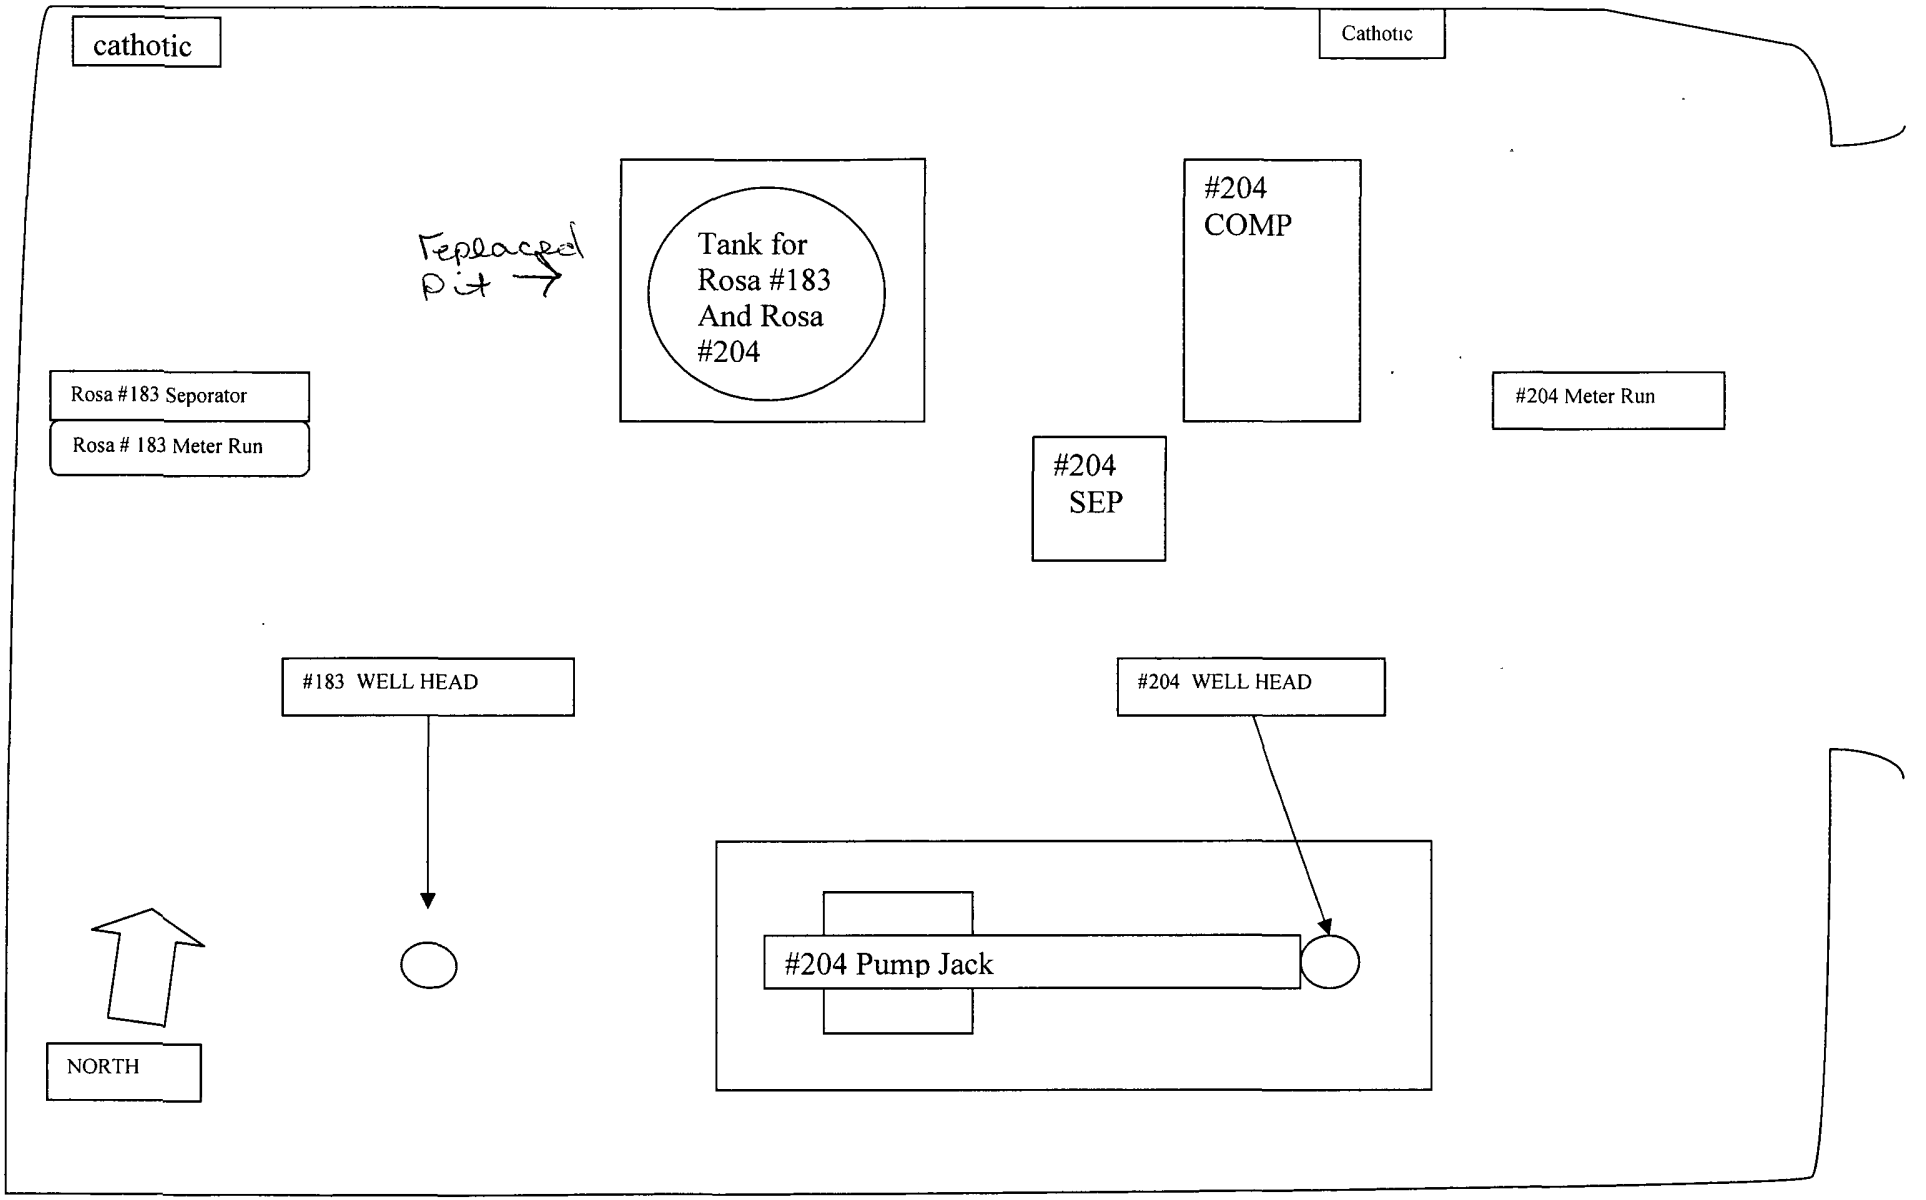
cathotic
Cathotic
Replaced Pit
Tank for Rosa #183 And Rosa #204
#204 COMP
Rosa #183 Seporator
Rosa # 183 Meter Run
#204 Meter Run
#204 SEP
#183 WELL HEAD
#204 WELL HEAD
#204 Pump Jack
NORTH
