Pit, Closed-Loop System, Below-Grade Tank, or Proposed Alternative Method Permit or Closure Plan Application

1.
Operator: BP AMERICA PRODUCTION COMPANY OGRID #: 778
Address: 200 Energy Court, Farmington, NM 87401
Facility or well name: UPTEGROVE GAS COM 001B
API Number: 3004530267 OCD Permit Number:
U/L or Qtr/Qtr O Section 33.0 Township 32.0N Range 10W County: San Juan County
Center of Proposed Design: Latitude 36.936585 Longitude -107.886141 NAD: ☐1927 ☒ 1983
Surface Owner: ☐ Federal ☐ State ☒ Private ☐ Tribal Trust or Indian Allotment

Release Notification and Corrective Action

SITE NAME: UPTEGROVE GC # 1B

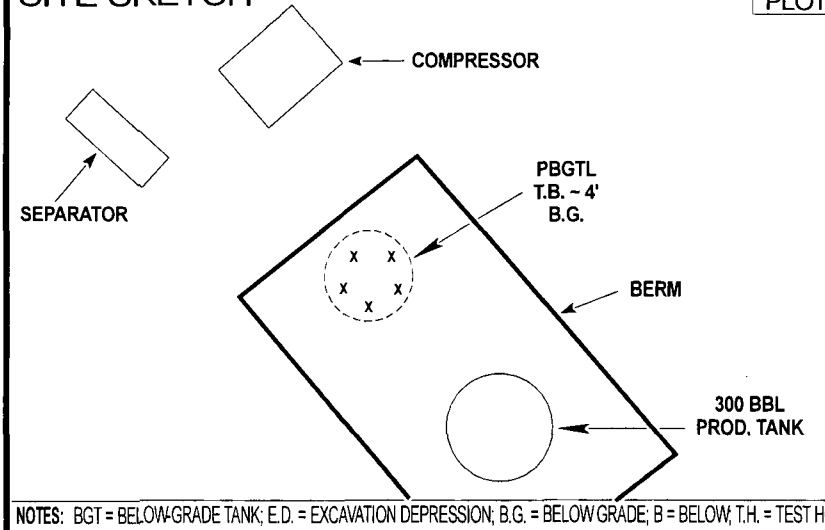
SITE SKETCH

ADDITIONAL COMMENTS: BGT - 15' DIAMETER LPT. WILL SET COMPR. AND SEP. UNITS ON LIFTED PAD @ BGT POSITION.

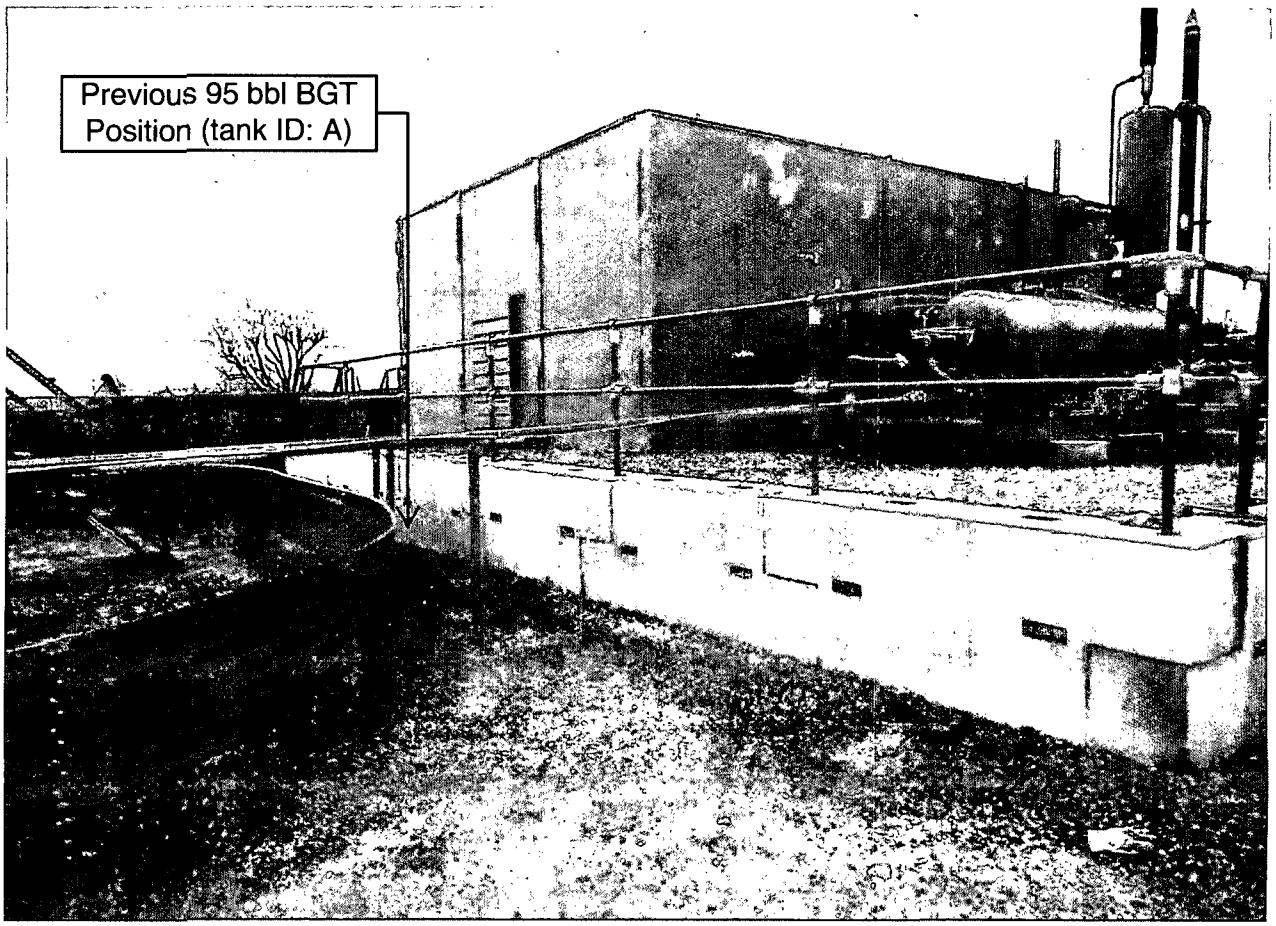
Previous 95 bbl BGT Position (tank ID: A)

Describe Area Affected and Cleanup Action Taken.* BGT was removed and the area underneath the BGT was sampled. The excavated area was backfilled and compacted and is covered by the raised compressor pad.
