Sundry Notices and Reports on Wells.

5. Lease Number
SF-077865
6. If Indian, All. or
Tribe Name
7. Unit Agreement Name
8. Well Name & Number
Albright #5
9. API Well No.
30-045-08000
10. Field and Pool
Aztec Pictured Cliffs
11. County and State
San Juan Co., NM

It is intended to plug and abandon this well per the attached procedure and wellbore diagram.

Albright #5

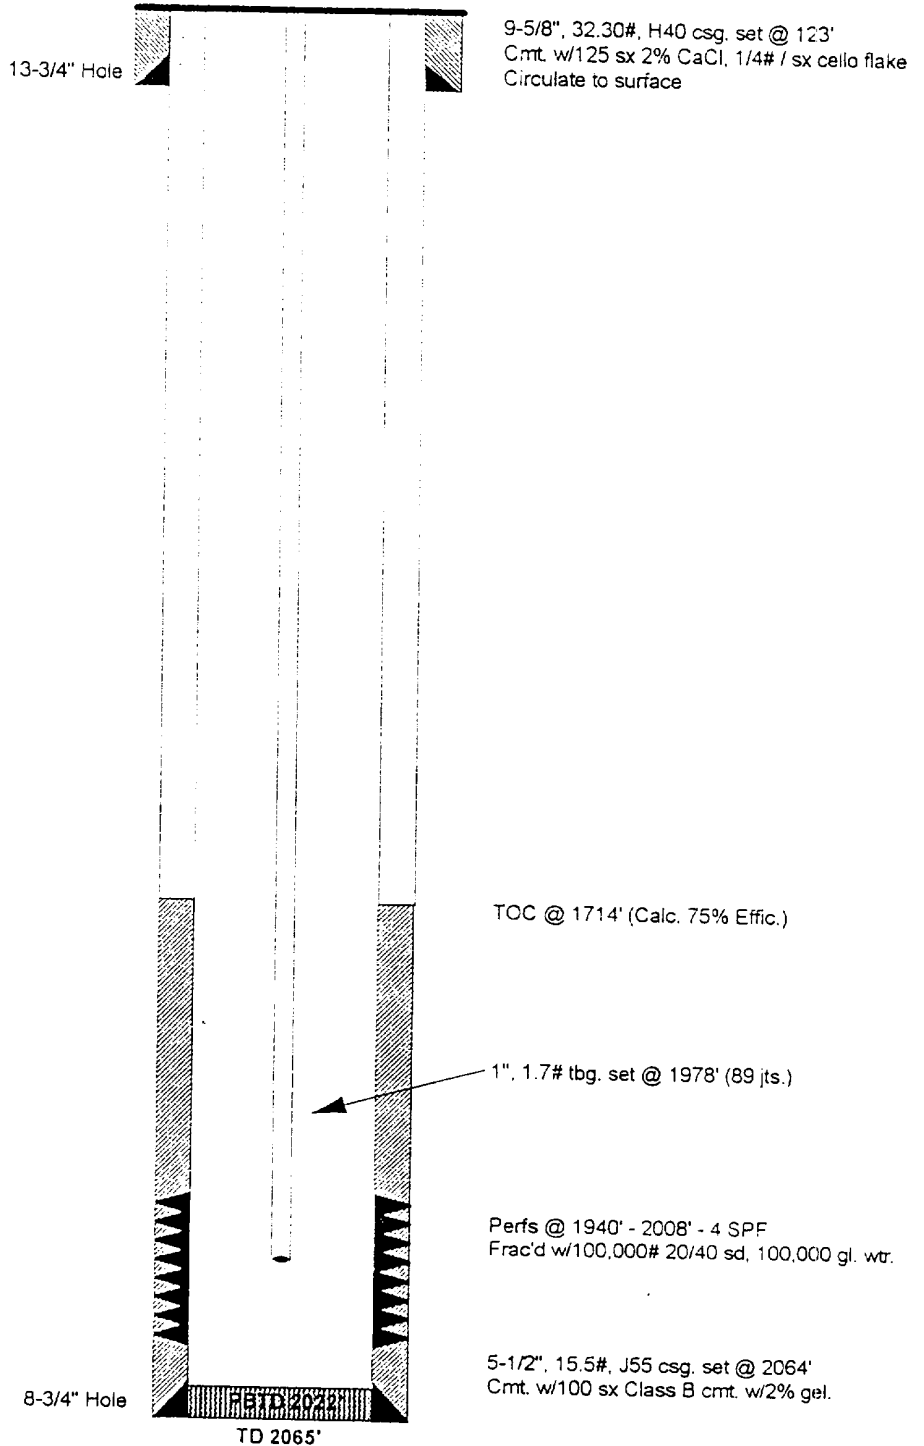
Lat. / Long.: 107.875427 - 36.709549

Spud: 8/29/57
Completed: 9/3/57
Elevation: 5613' (DF)
5606' (GL)
Logs: IE

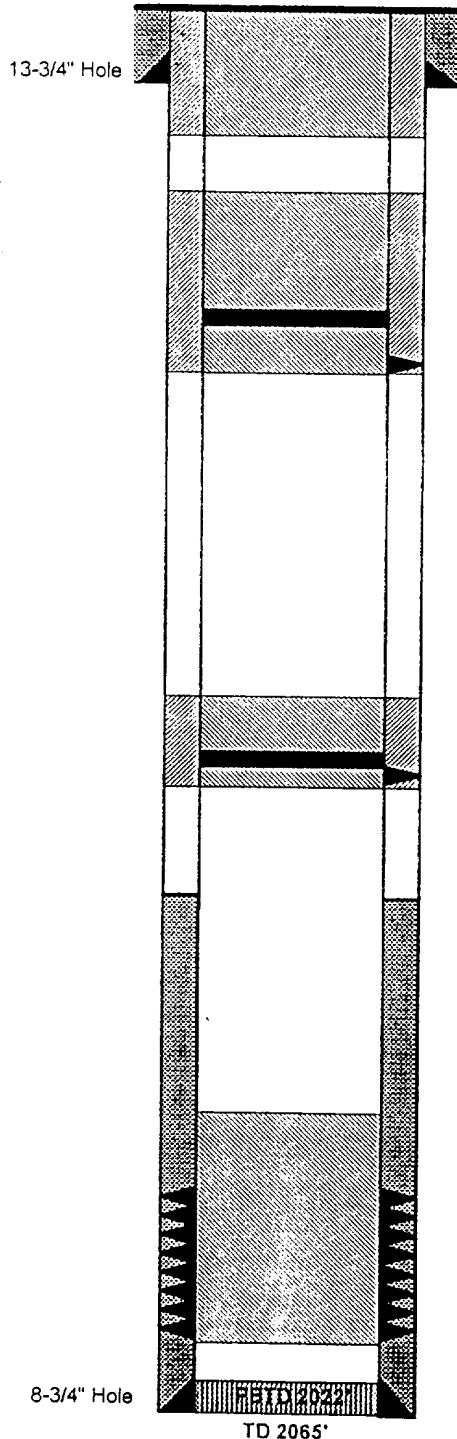
Current 4/16/96

Aztec Pictured Cliffs

Ojo Alamo @ 810'

Kirtland @ 900'

Fruitland @ 1650'

Pictured Cliffs @ 1920'

9-5/8", 32.30#, H40 csg. set @ 123'
Cmt. w/125 sx 2% CaCl, 1/4# / sx cello flake
Circulate to surface

Plug #4: 173' - Surface
