Sundry Not	cices and Repor	ts on Wells	PH 2: 13	-	
		<u> </u>		5.	Lease Number SF-081098
Type of Well GAS					
				7.	Unit Agreement Name
2. Name of Operator MERIDIAN OIL				0	Maria C Number

3. Address & Phone No. of Opera	ator			8.	Well Name & Number Riddle E #3
PO Box 4289, Farmington, NI		326-9700		9.	API Well No. 30-045-26474
4. Location of Well, Footage,	Sec., T, R, M			10.	Field and Pool Blanco Pictured Cliffs
1040'FNL, 1460'FEL, Sec.4, '	T-30-N, R-9-W,	NMPM		11.	County and State San Juan Co, NM

WORKOVER PROCEDURE -- CLEAN OUT

Riddle E #3 Blanco Pictured Cliffs NE/4 Sec. 4, T30N, R9W San Juan Co., New Mexico

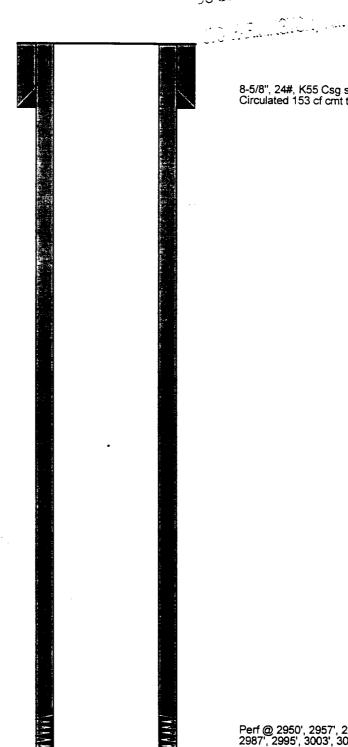
Spud: 8-13-85

Completed: 12-11-85

PBTD 3081

TD 3100'

13. Describe Proposed or Com					•
It is intended to workov		well accor	ding to t	he at	tached procedure and
wellbore diagram	•				the second second
				- 4	
				ş
