Pit, Closed-Loop System, Below-Grade Tank, or Proposed Alternative Method Permit or Closure Plan Application

1.
Operator: BP AMERICA PRODUCTION COMPANY OGRID #: 778
Address: 200 Energy Court, Farmington, NM 87401
Facility or well name: GALLEGOS CANYON UNIT 185
API Number: 3004507085 OCD Permit Number:
U/L or Qtr/Qtr D Section 33.0 Township 28.0N Range 12W County: San Juan County
Center of Proposed Design: Latitude 36.62438 Longitude -108.12305 NAD: ☐ 1927 ☒ 1983
Surface Owner: ☒ Federal ☐ State ☐ Private ☐ Tribal Trust or Indian Allotment

Release Notification and Corrective Action

FIELD REPORT:

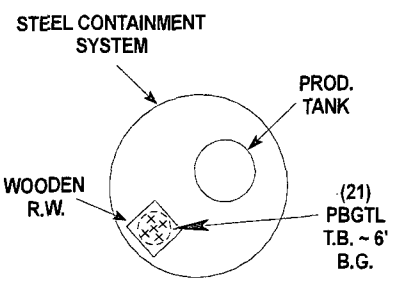
SITE SKETCH

DISCOLORATION/STAINING OBSERVED: [YES] / NO EXPLANATION - 1' BENEATH 95 BGT (MED. GRAY TO BLACK SAND).

APPARENT EVIDENCE OF A RELEASE OBSERVED AND/OR OCCURRED : [YES] / NO EXPLANATION : APPEARS HISTORICAL IN ORIGIN.

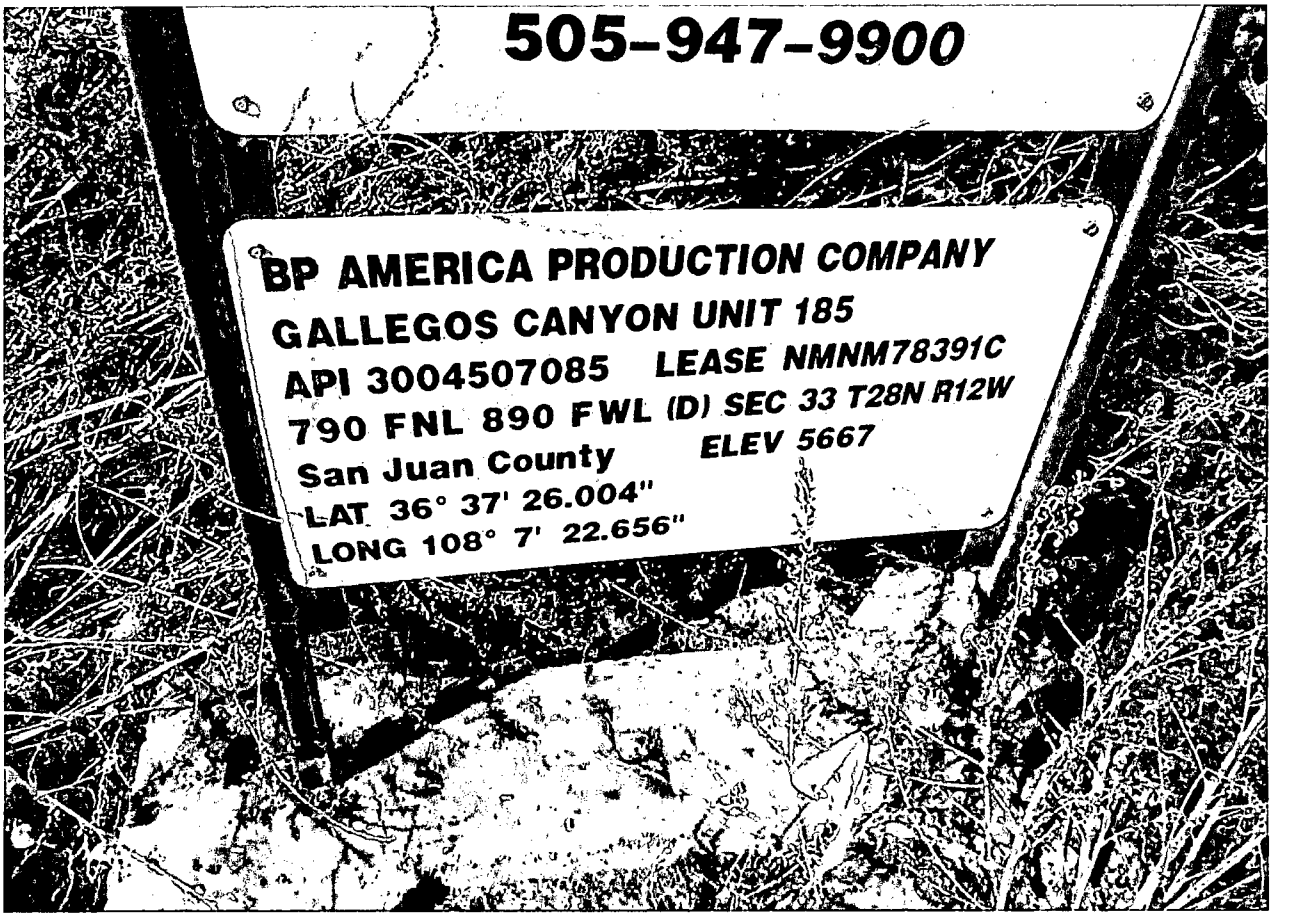
505-947-9900
BP AMERICA PRODUCTION COMPANY
GALLEGOS CANYON UNIT 185
API 3004507085 LEASE NMNM78391C
790 FNL 890 FWL (D) SEC 33 T28N R12W
San Juan County ELEV 5667
LAT 36° 37' 26.004"
LONG 108° 7' 22.656"

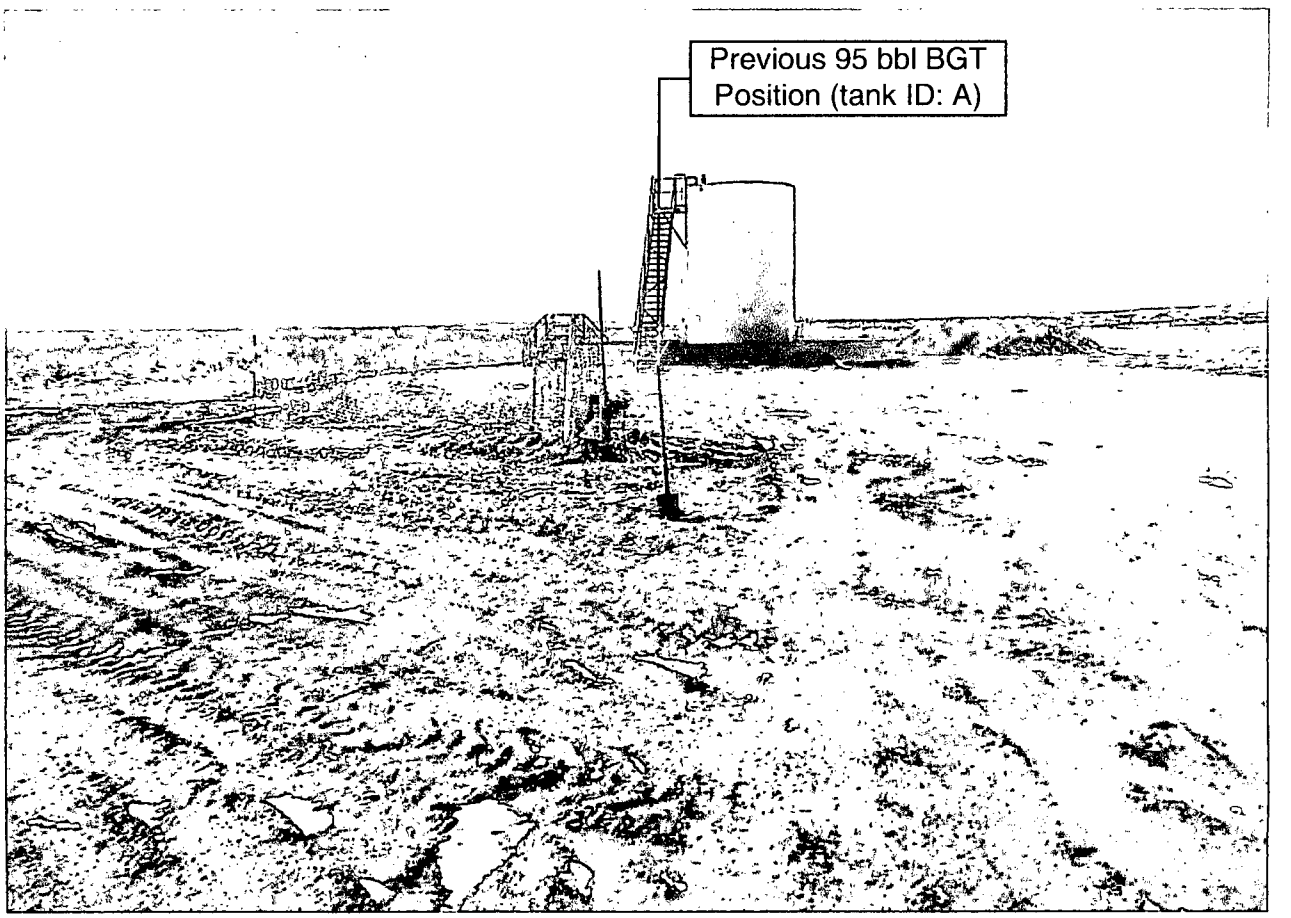
Previous 95 bbl BGT
Position (tank ID: A)
