State of New Mexico Energy, Minerals and Natural Resources Department Oil Conservation Division

Sundry Notices and Reports on Wells	
	API # (assigned by OCD) 30-045-07937
1. Type of Well	5. Lease Number
GAS	Fee
	6. State Oil&Gas Lease #
2. Name of Operator	7. Lease Name/Unit Name
BURLINGTON	
RESCURCES OIL & GAS COMPANY	Dallabetta

Dallabetta #1 **Pertinent Data Sheet**

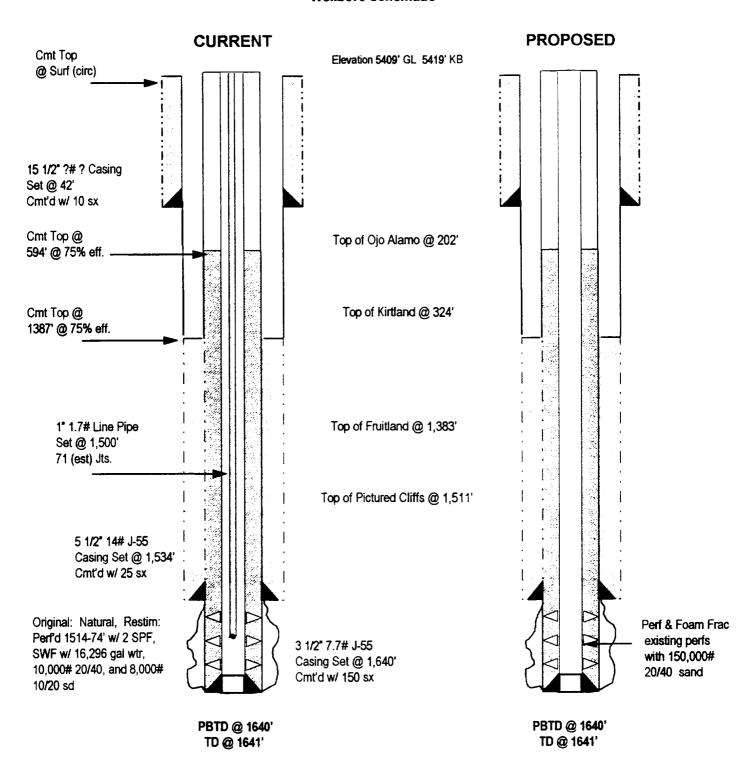
Fulcher Kutz Pictured Cliffs Field Wellbore Schematic

Section 20 N, T-29 -N R-11 -W San Juan, New Mexico
