Pit, Closed-Loop System, Below-Grade Tank, or Proposed Alternative Method Permit or Closure Plan Application

BP AMERICA PRODUCTION COMPANY
SAN JUAN BASIN, NORTHWEST NEW MEXICO

BELOW-GRADE TANK CLOSURE PLAN

W. D. Heath A 11
API No. 3004520965
Unit Letter K, Section 9, T29N, R9W

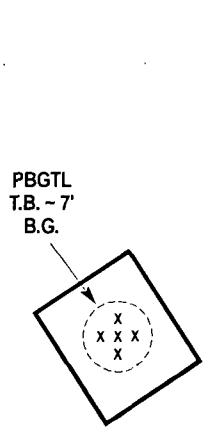
SITE SKETCH

CONSISTENCY (NON COHESIVE SOILS): [LOOSE / FIRM] / DENSE / VERY DENSE

MOISTURE: DRY / [SLIGHTLY MOIST] / MOIST / WET / SATURATED / SUPER SATURATED

DISCOLORATION/STAINING OBSERVED: YES / [NO] EXPLANATION -

APPARENT EVIDENCE OF A RELEASE OBSERVED AND/OR OCCURRED : YES / [NO] EXPLANATION :

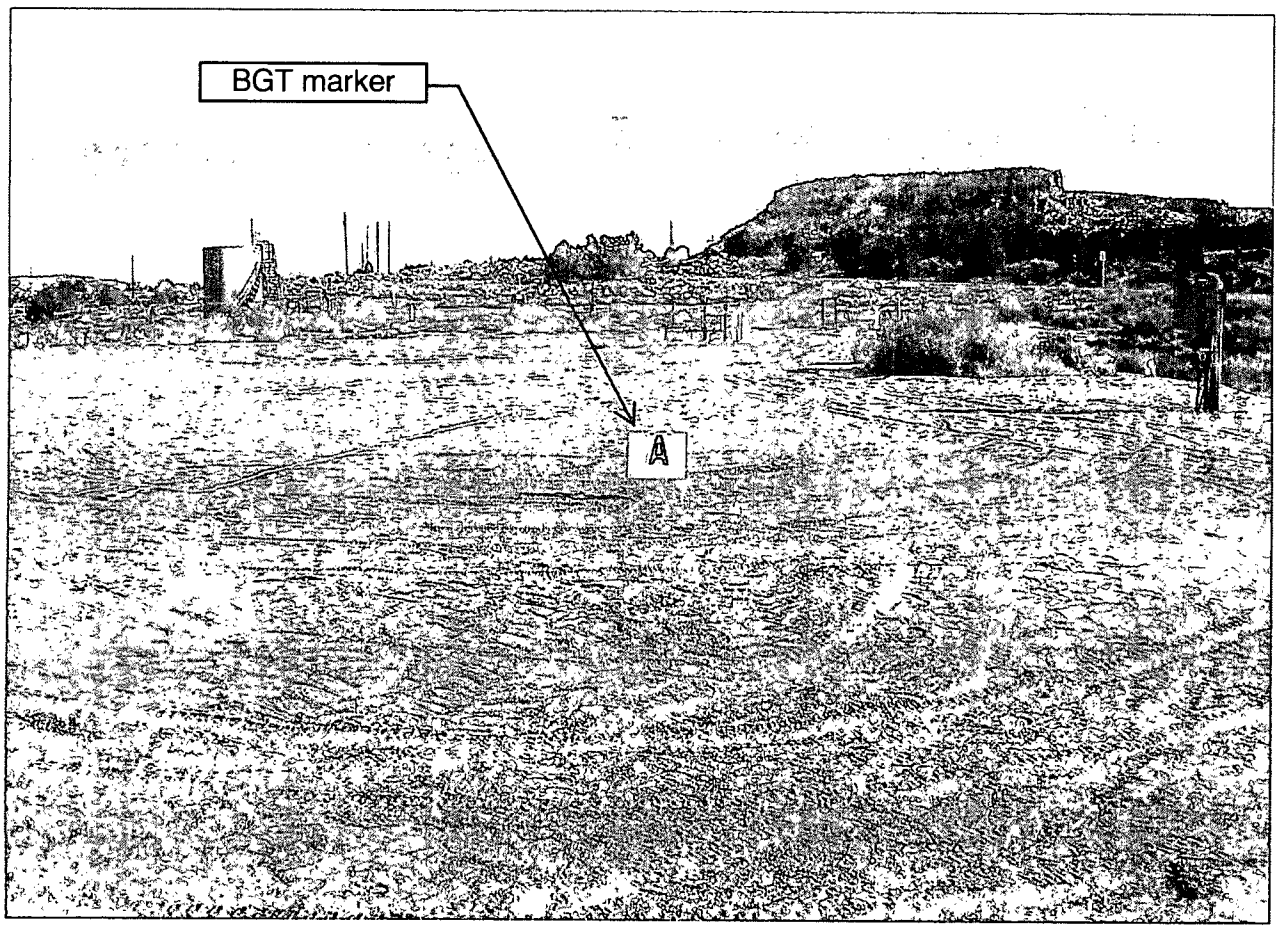
BGT marker
A

OR
505-947-9900
BP AMERICA PRODUCTION COMPANY
W D HEATH A 011
API 3004520965 LEASE NMSF076337
1550 FSL 1450 FWL (K) SEC 9 T29N R9W
San Juan County ELEV 5738
LAT 36° 44' 11.652"
LONG 107° 47' 17.448"
