## Release Notification and Corrective Action

Name of Company	Devon Energy Production Company	Contact	Randall Gladden, Production Foreman
Address	6488 Seven Rivers Hwy Artesia, NM 88210	Telephone No.	575-513-9463
Facility Name	Rio Blanco 33 Federal #1	Facility Type	Salt Water Disposal
Surface Owner	Private	Mineral Owner	Federal
		API No	30-025-36359

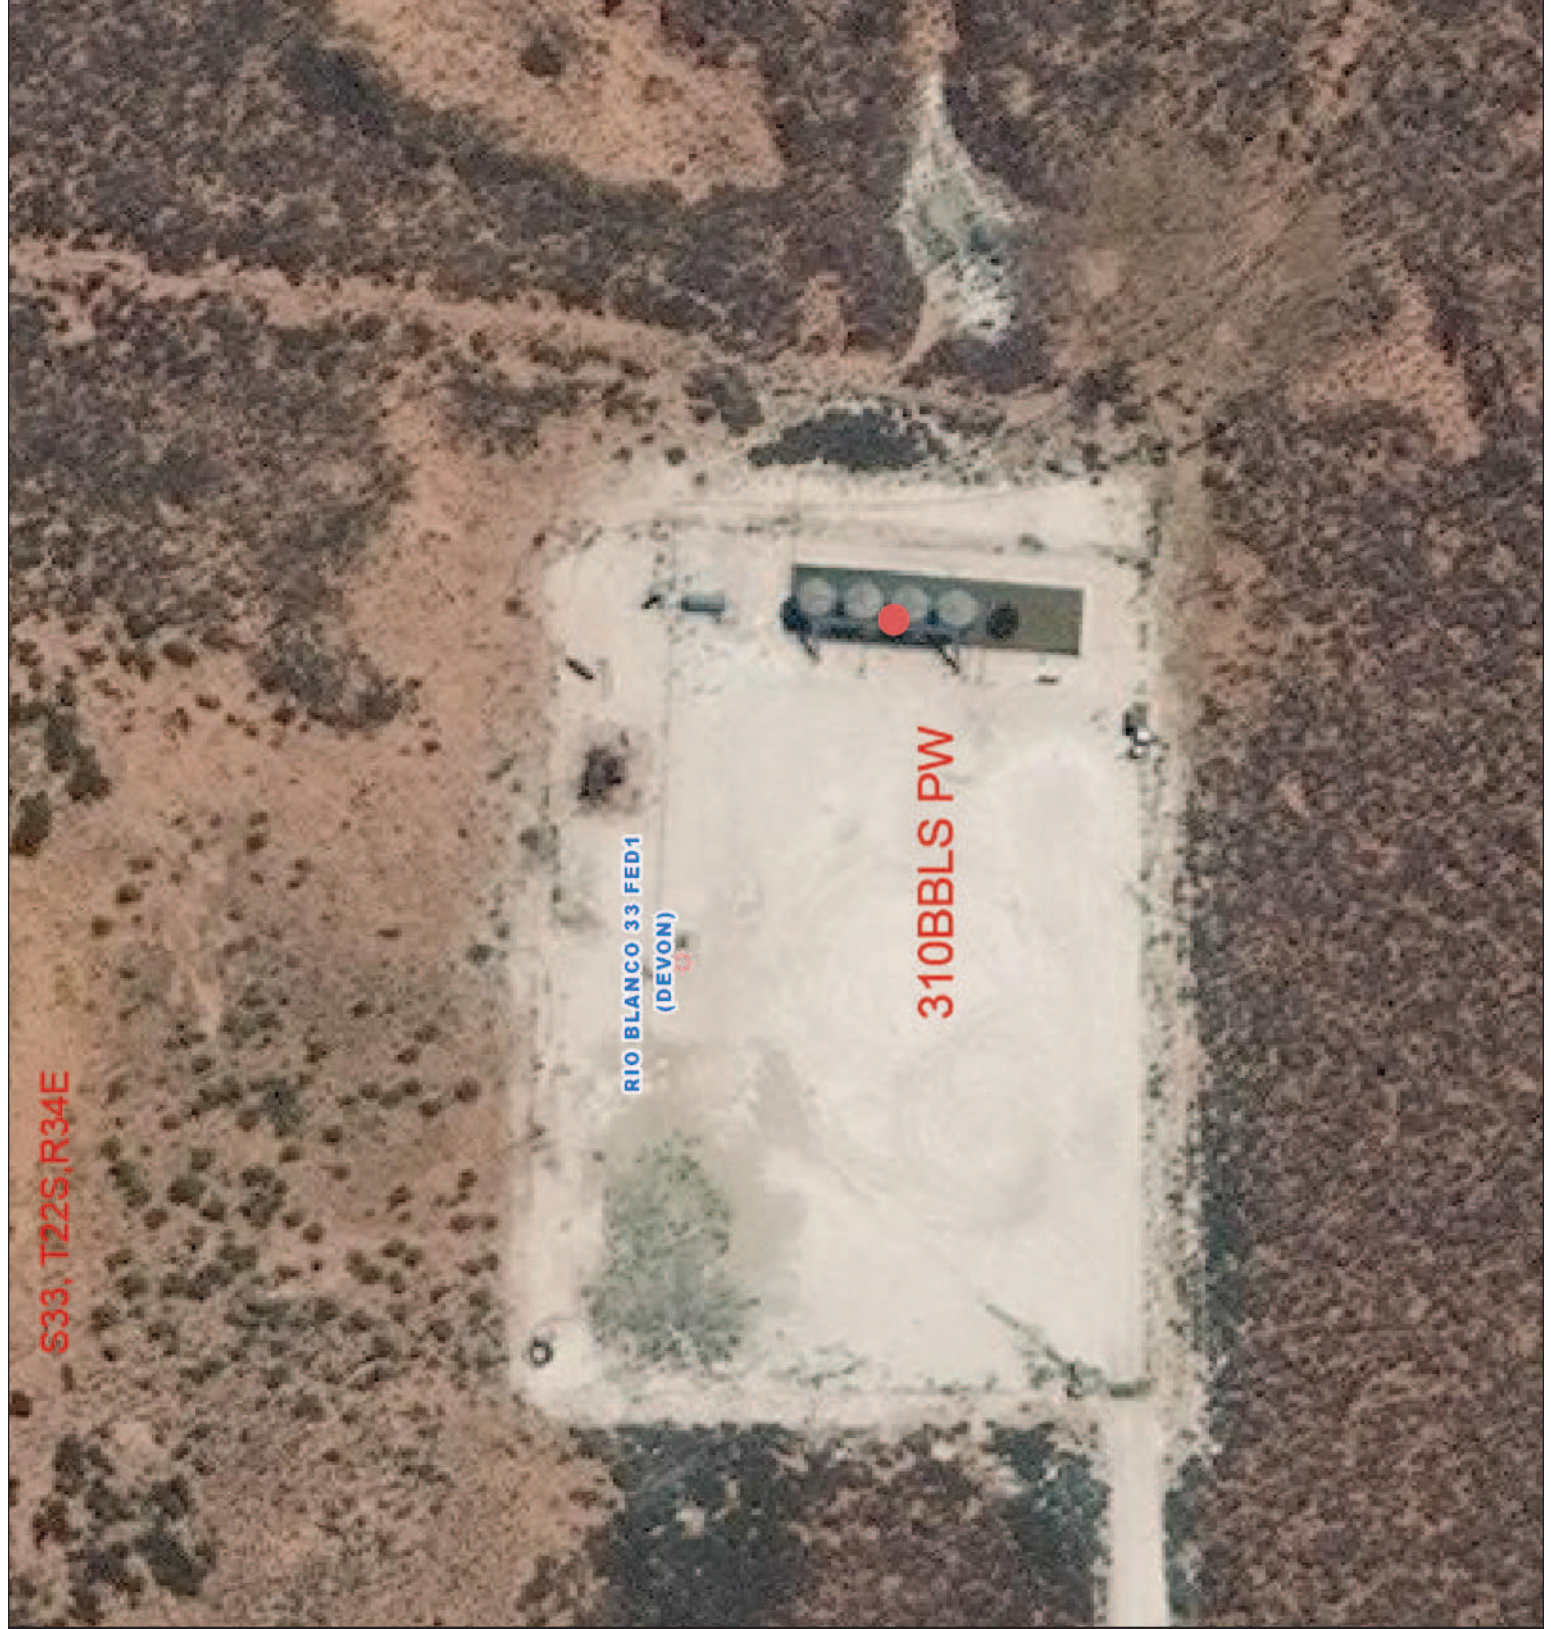
RIO BLANCO 33 FED1  
(DEVON)

310BBLS PW

**Describe Cause of Problem and Remedial Action Taken.\***  
Lightning struck a 500BBL fiberglass produced water tank causing it to catch fire and structurally compromising it. The wells were immediately shut in. The fire department assisted in extinguishing the fire.
