Pit, Closed-Loop System, Below-Grade Tank, or Proposed Alternative Method Permit or Closure Plan Application

1.
Operator: BP AMERICA PRODUCTION COMPANY OGRID #: 778
Address: 200 Energy Court, Farmington, NM 87401
Facility or well name: FIELDS A 007R
API Number: 3004526996 OCD Permit Number:
U/L or Qtr/Qtr G Section 34.0 Township 32.0N Range 11W County: San Juan County
Center of Proposed Design: Latitude 36.943149 Longitude -107.975774 NAD: ☐ 1927 ☒ 1983
Surface Owner: ☒ Federal ☐ State ☐ Private ☐ Tribal Trust or Indian Allotment

BELOW-GRADE TANK CLOSURE PLAN

Fields A 7R Tank A (95 bbl)
API No. 3004526996
Unit Letter G, Section 34, T32N, R11W

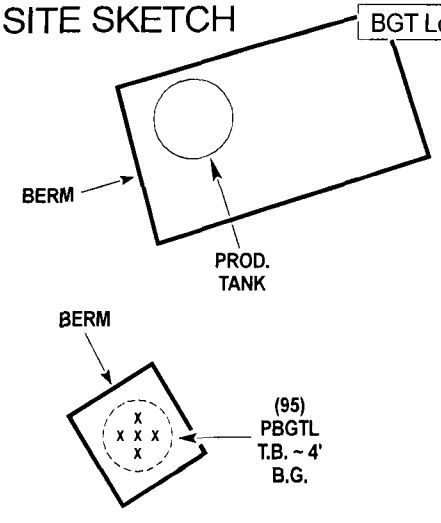
PLOT PLAN circle: attached

DISCOLORATION/STAINING OBSERVED: YES / NO EXPLANATION - ~~45 BGT MEDIUM GRAY - NO HYDROCARBON ODOR~~

APPARENT EVIDENCE OF A RELEASE OBSERVED AND/OR OCCURRED : YES / NO EXPLANATION:

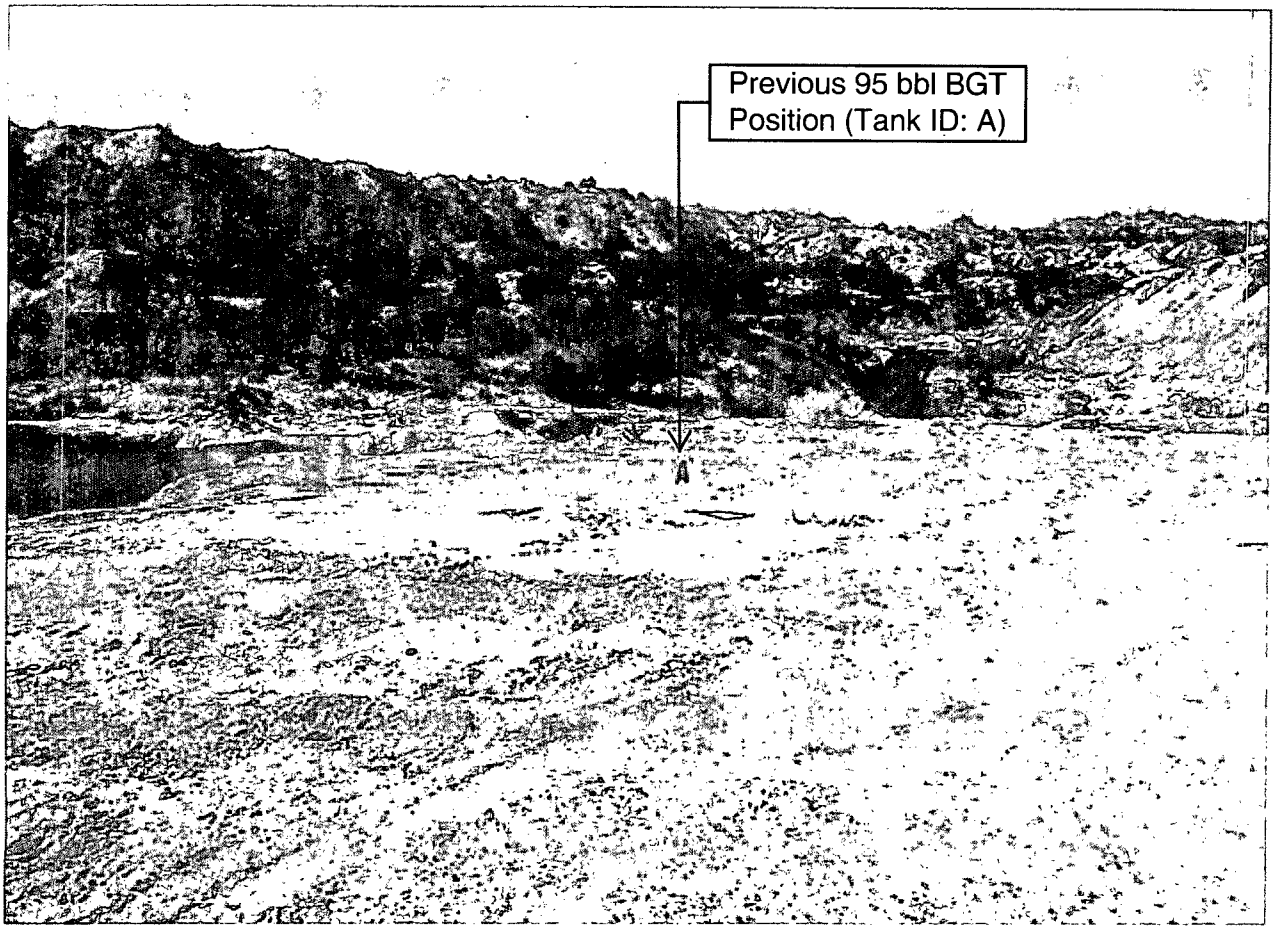
Previous 95 bbl BGT
Position (Tank ID: A)
A

9. If the sampling demonstrates that a release has not occurred or that any release does not exceed the concentrations specified above, then BP shall backfill the excavation, with compacted, non-waste containing, earthen material; construct a division-prescribed soil cover, re-contour and re-vegetate the location. The location will be reclaimed if it is not with in the active process area
The area under the BGT was backfilled with clean soil and is still within the active well area.
