**Release Notification and Corrective Action**

Name of Company: Lynx Operating Company	Contact: Ed Pittinger
Address: 600 N. Marienfeld, Suite 918, Midland, TX 79701	Telephone No.: 432-686-2101
Facility Name: Pat McClure "A" Battery	Facility Type: Production Battery

## WORK PLAN

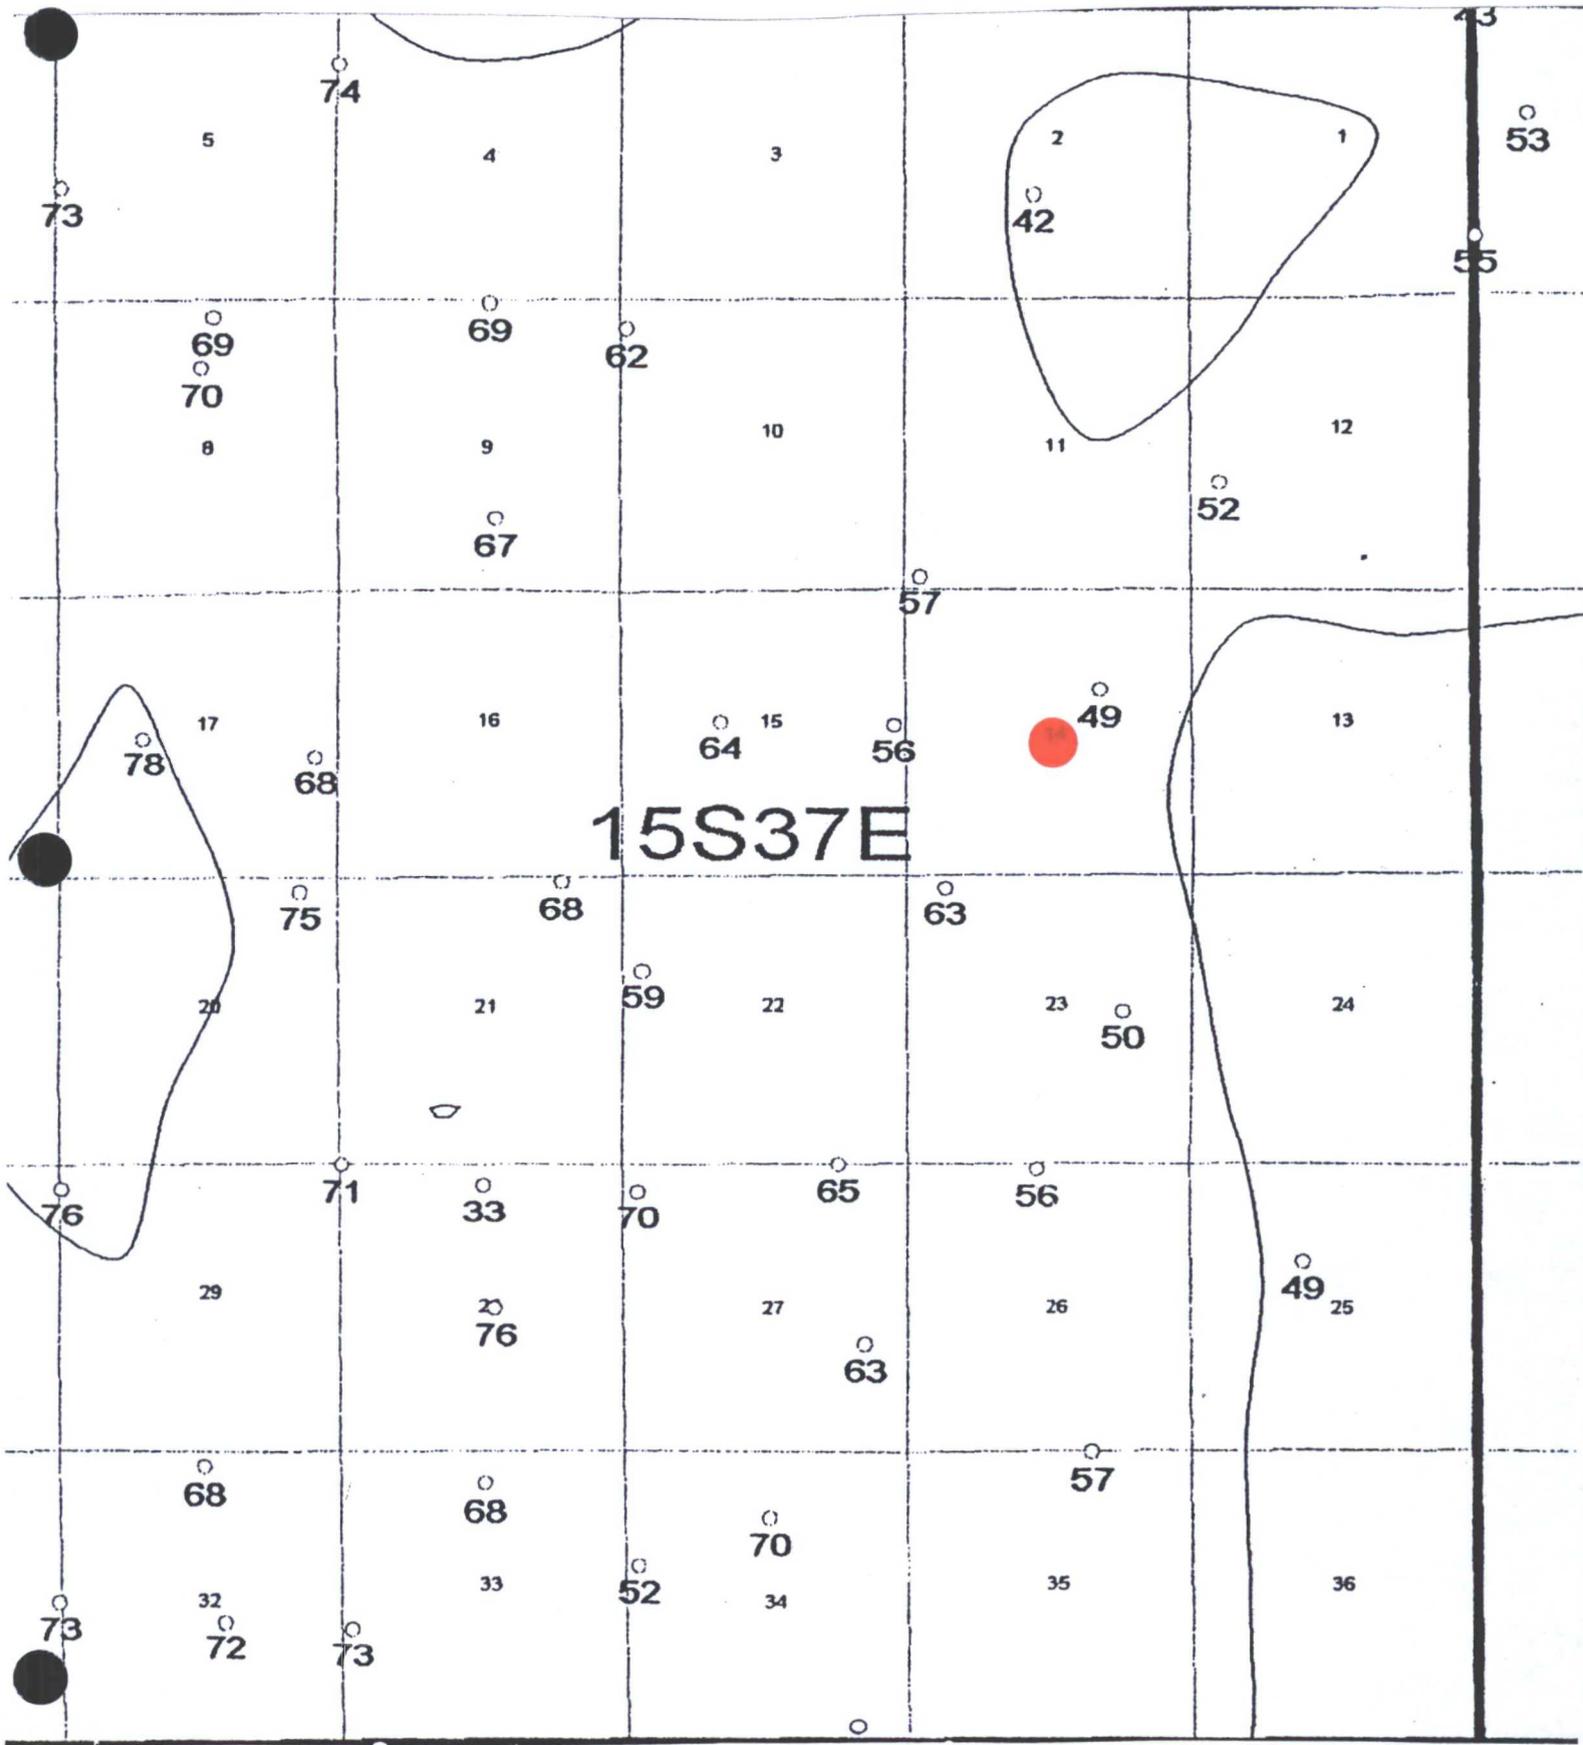
# Groundwater Map

According to the water information, the depth of groundwater occurs at approximately 50 ft.
