Pit, Closed-Loop System, Below-Grade Tank, or Proposed Alternative Method Permit or Closure Plan Application

1.
Operator: BP AMERICA PRODUCTION COMPANY OGRID #: 778
Address: 200 Energy Court, Farmington, NM 87401
Facility or well name: GALLEGOS CANYON UNIT 555
API Number: 3004530683 OCD Permit Number:
U/L or Qtr/Qtr O Section 12.0 Township 28.0N Range 12W County: San Juan County
Center of Proposed Design: Latitude 36.66994 Longitude -108.06256 NAD: ☐ 1927 ☒ 1983
Surface Owner: ☐ Federal ☒ State ☐ Private ☐ Tribal Trust or Indian Allotment

BELOW-GRADE TANK CLOSURE PLAN

Gallegos Canyon Unit 555
API No. 3004530683
Unit Letter O, Section 12, T28N, R12W

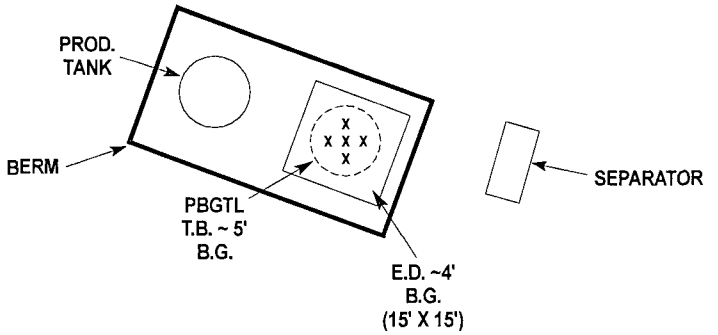
PLOT PLAN circle: attached

DISCOLORATION/STAINING OBSERVED: YES / [NO] EXPLANATION -

APPARENT EVIDENCE OF A RELEASE OBSERVED AND/OR OCCURRED : YES [NO] EXPLANATION:

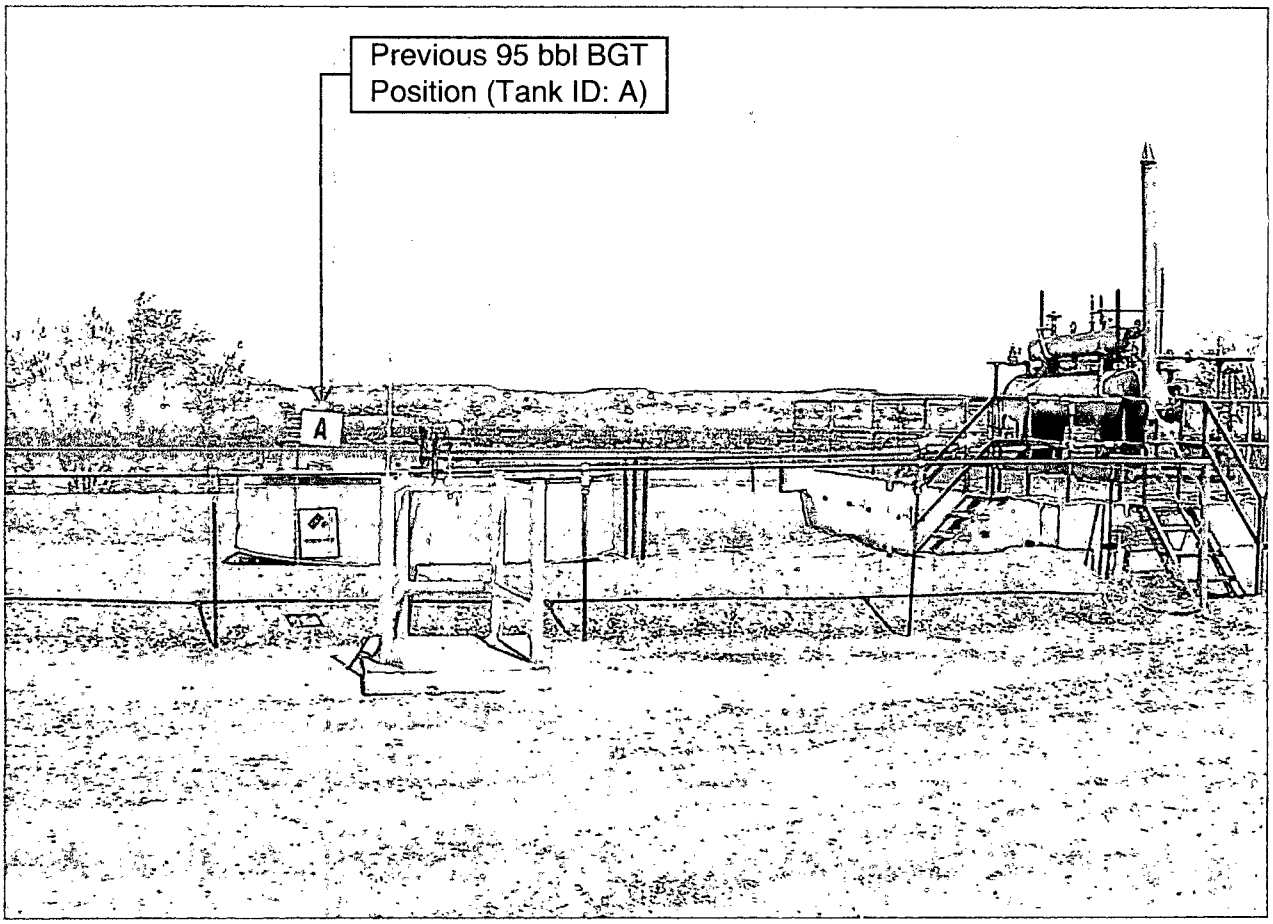
Previous 95 bbl BGT
Position (Tank ID: A)
A

Describe Area Affected and Cleanup Action Taken.* BGT was removed and the area underneath the BGT was sampled. The excavated area was backfilled and compacted and is covered by the LPT.
