Pit, Below-Grade Tank, or Proposed Alternative Method Permit or Closure Plan Application

1.
Operator: BP America Production Company OGRID #: 778
Address: 200 Energy Court, Farmington, NM 87401
Facility or well name: Florance Gas Com J 16
API Number: 3004509800 OCD Permit Number:
U/L or Qtr/Qtr A Section 6 Township 30N Range 9W County: San Juan
Center of Proposed Design: Latitude 36.845274 Longitude -107.815455 NAD: ☐ 1927 ☒ 1983
Surface Owner: ☒ Federal ☐ State ☐ Private ☐ Tribal Trust or Indian Allotment

BELOW-GRADE TANK CLOSURE PLAN

Florance Gas Com J 16 Tank A (95 bbl)
API No. 3004509800
Unit Letter A, Section 6, T30N, R9W

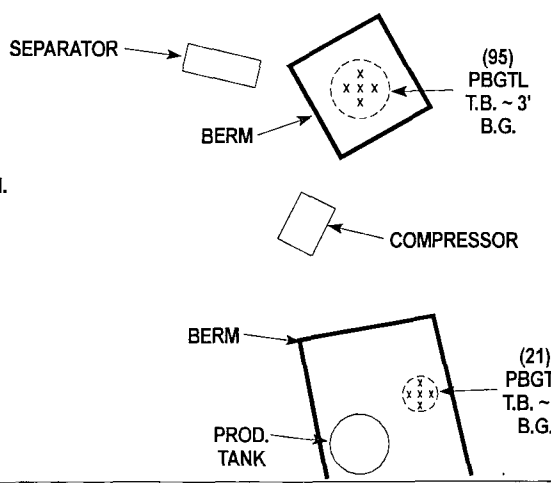
PLOT PLAN circle: attached

DISCOLORATION/STAINING OBSERVED: [YES] NO EXPLANATION - BLACK BENEATH 21 BGT

APPARENT EVIDENCE OF A RELEASE OBSERVED AND/OR OCCURRED [YES] NO EXPLANATION: AT 21 BGT

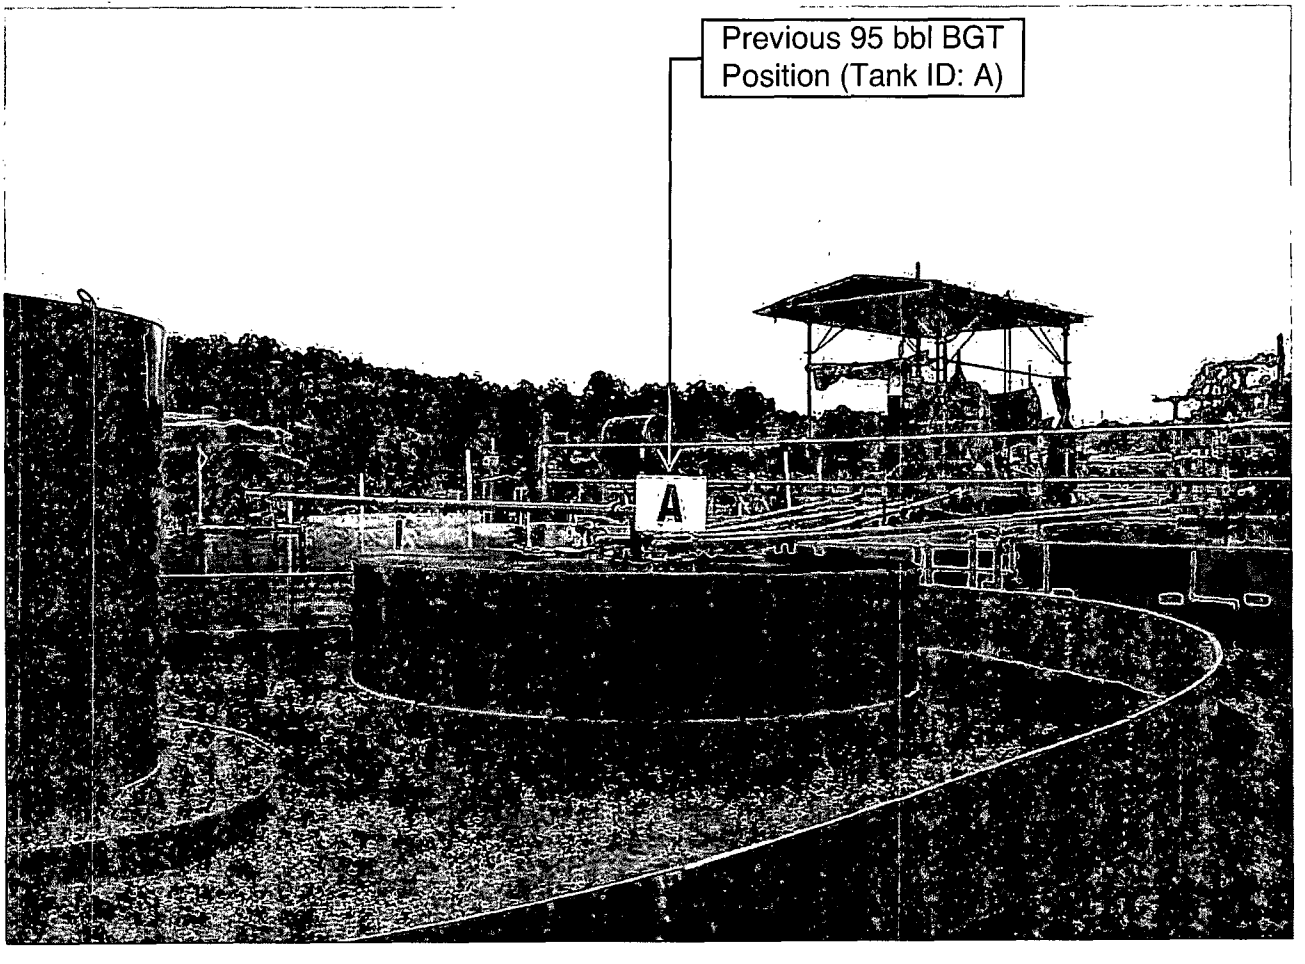
Previous 95 bbl BGT
Position (Tank ID: A)
A

9. If the sampling demonstrates that a release has not occurred or that any release does not exceed the concentrations specified above, then BP shall backfill the excavation, with compacted, non-waste containing, earthen material; construct a division-prescribed soil cover, re-contour and re-vegetate the location. The location will be reclaimed if it is not with in the active process area
The area under the BGT was backfilled with clean soil. It is covered by the LPT and is still within the active well area.

10. BP shall reclaim the BGT location and all areas associated with the BGT including associated access roads to a safe and stable condition that blends with the surrounding undisturbed area. BP shall substantially restore the impacted surface area to the condition that existed prior to oil and gas operations by placement of the soil cover as provided in Subsection H of 19.15.17.13 NMAC, re-contour the location and associated areas to a contour that approximates the original contour and blends with the surrounding topography and re-vegetate according to Subsection I of 19.15.17.13 NMAC.
The area over the BGT is covered by the LPT and is still within the active well area. This area will be reclaimed when the well is plugged and abandoned as part of final reclamation.
