**Gallegos Canyon Unit 102E**

Dakota  
API # 30-045-26253  
T-29N, R-13-W, Sec. 13  
San Juan County, New Mexico

| | Action Type:<br>[UF-WBS] Wellbore Schematic (WELLBORE SCHEMATICS) |

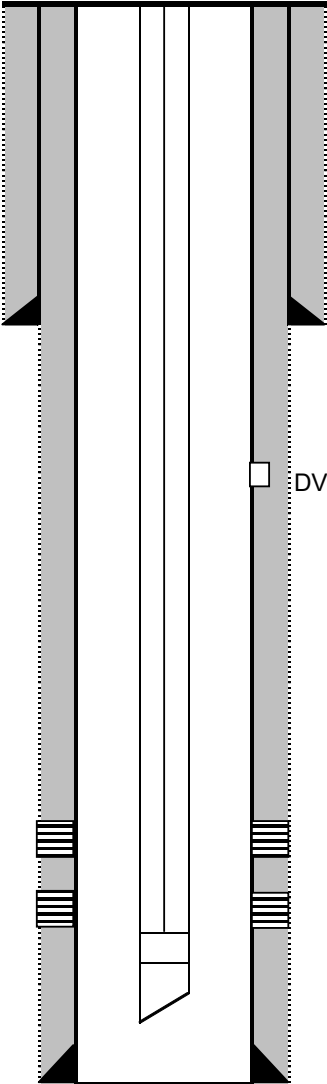
Estimated Formation Tops  
Ojo Alamo - 210'  
Fruitland - 1048'  
Pictured Cliffs - 1368'  
Cliffhouse - 2968'  
Menefee - 3118'  
Point Lookout - 3853'  
Gallup - 5085'  
Dakota - 5946'

**Dakota Perforations**

5946-5974'  
6016-6065'  
Fraced w/ 71,780 gal 70Q foam,  
78,000# 20/40 brady snd

K.B. 5520'  
G.R. 5505'

12-1/4" Hole  
8-5/8", 24#, K-55 @ 326'  
Cmt w/ 248 cu ft Class B  
circulated to surface

DV Tool @ 3095'

3/4" Rods  
8-1.25" Sinker Bars  
2"x1.25"x14 RHAC

1.78" F Nipple @ 6115'  
2-3/8" EOT @ 6133'

7-7/8" Hole  
4 1/2", 11.6#, K-55 @ 6175"  
Cmt w/ 1425  
Stage 1: 1231 cu ft Class B  
Stage 2: 1556 cu ft Class B  
Circulated to surface both stages.

PBTD: 6170'  
TD: 6175'
