Pit, Closed-Loop System, Below-Grade Tank, or Proposed Alternative Method Permit or Closure Plan Application

BP AMERICA PRODUCTION COMPANY
SAN JUAN BASIN, NORTHWEST NEW MEXICO

BELOW-GRADE TANK CLOSURE PLAN

Lenis A. Shane USA 1
API No. 3004520205
Unit Letter N, Section 14, T29N, R9W

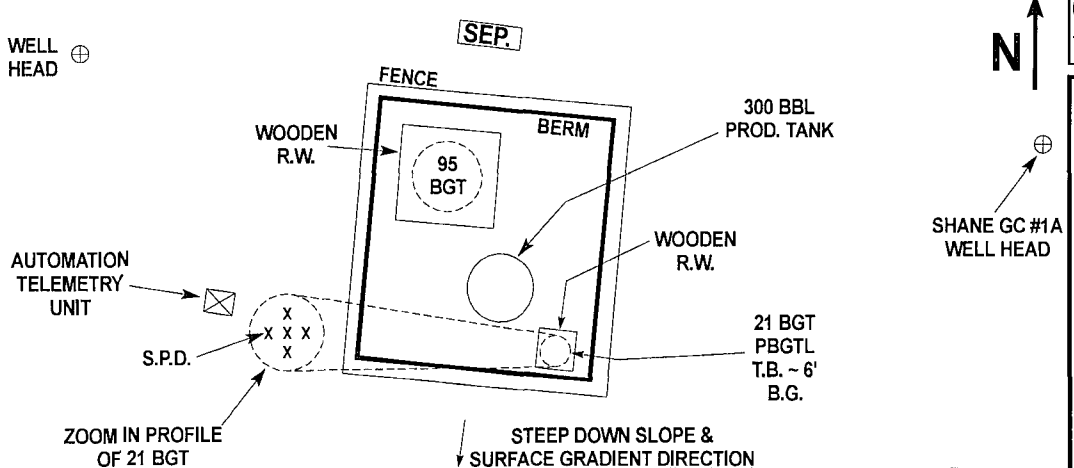
SITE SKETCH

DISCOLORATION/STAINING OBSERVED: YES [NO] EXPLANATION -

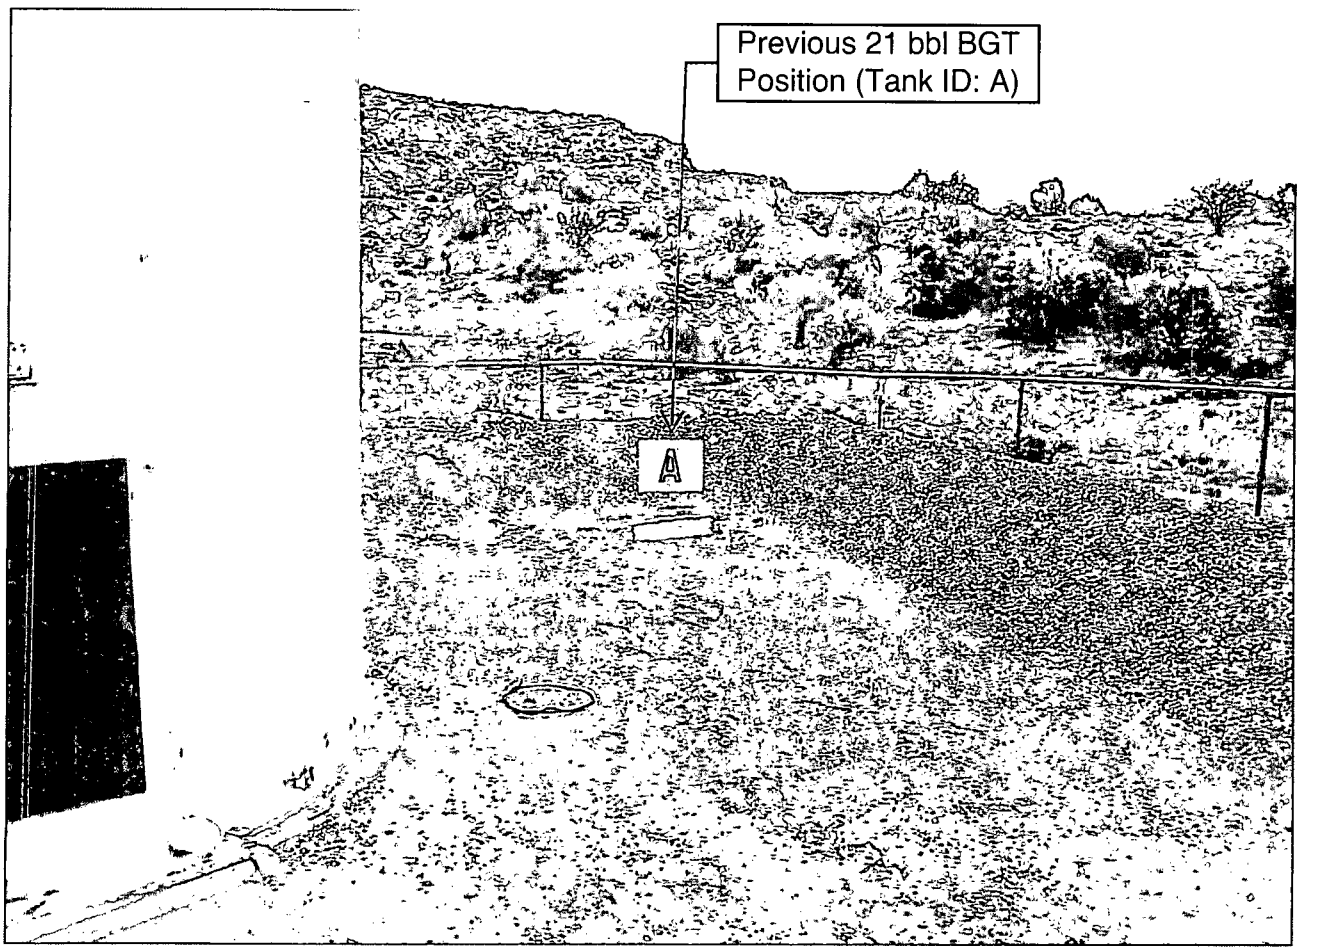
Previous 21 bbl BGT
Position (Tank ID: A)
A

Soil under the BGT was sampled and TPH, BTEX and chloride levels were below the stated limits. Sampling data is attached.

Describe Area Affected and Cleanup Action Taken.* BGT was removed and the area underneath the BGT was sampled. The area under the BGT was backfilled and compacted and is still within the active well area.

9. If the sampling demonstrates that a release has not occurred or that any release does not exceed the concentrations specified above, then BP shall backfill the excavation, with compacted, non-waste containing, earthen material; construct a division-prescribed soil cover, re-contour and re-vegetate the location. The location will be reclaimed if it is not with in the active process area
The area under the BGT was backfilled with clean soil and is still within the active area.
