SOUTHERN UNION GAS COMPANY

Basin Environmental Service Technologies, LLC

Environmental Site Summary

Project Name: Drip Tank #111 (NMOCD IRP#-1820)

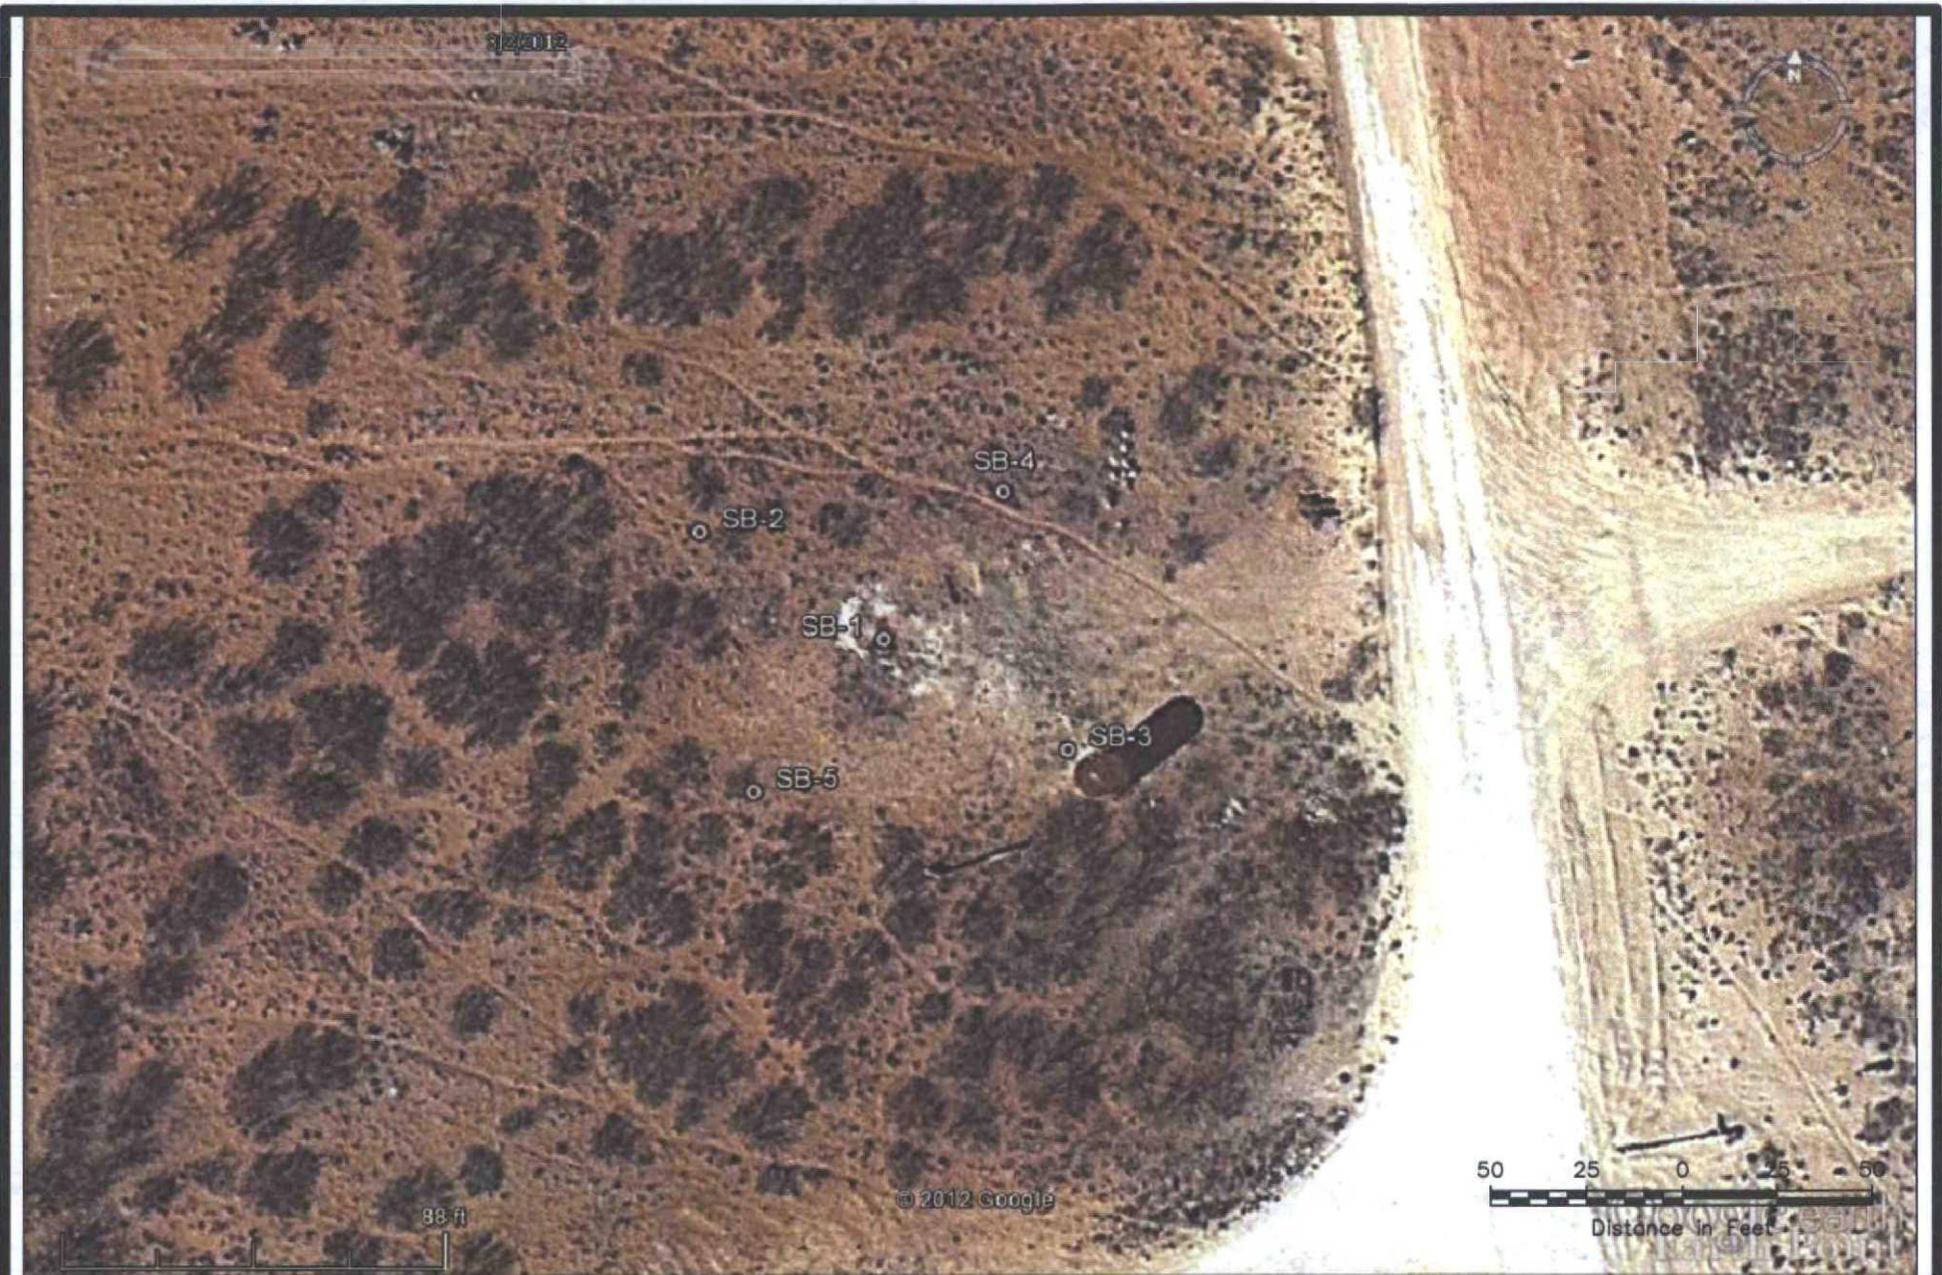
Proposed Soil Boring/Monitor Well Locations:

○ Proposed Soil Boring

- Attachment #1: Site Location Map
- Attachment #2: Site & Sample Location Map
- Attachment #3: Land Owner Access Agreement
